**Tillamook County Documentation  
For Support of Chief Justice Findings  
Under 2014 House Bill 5703  
(Ch. 121 OR Laws 2014)**

*BWE COPY - SUPPLEMENTAL INFORMATION*

TILLAMOOK COUNTY  
COURTHOUSE & HOSPITAL

APRIL 1993

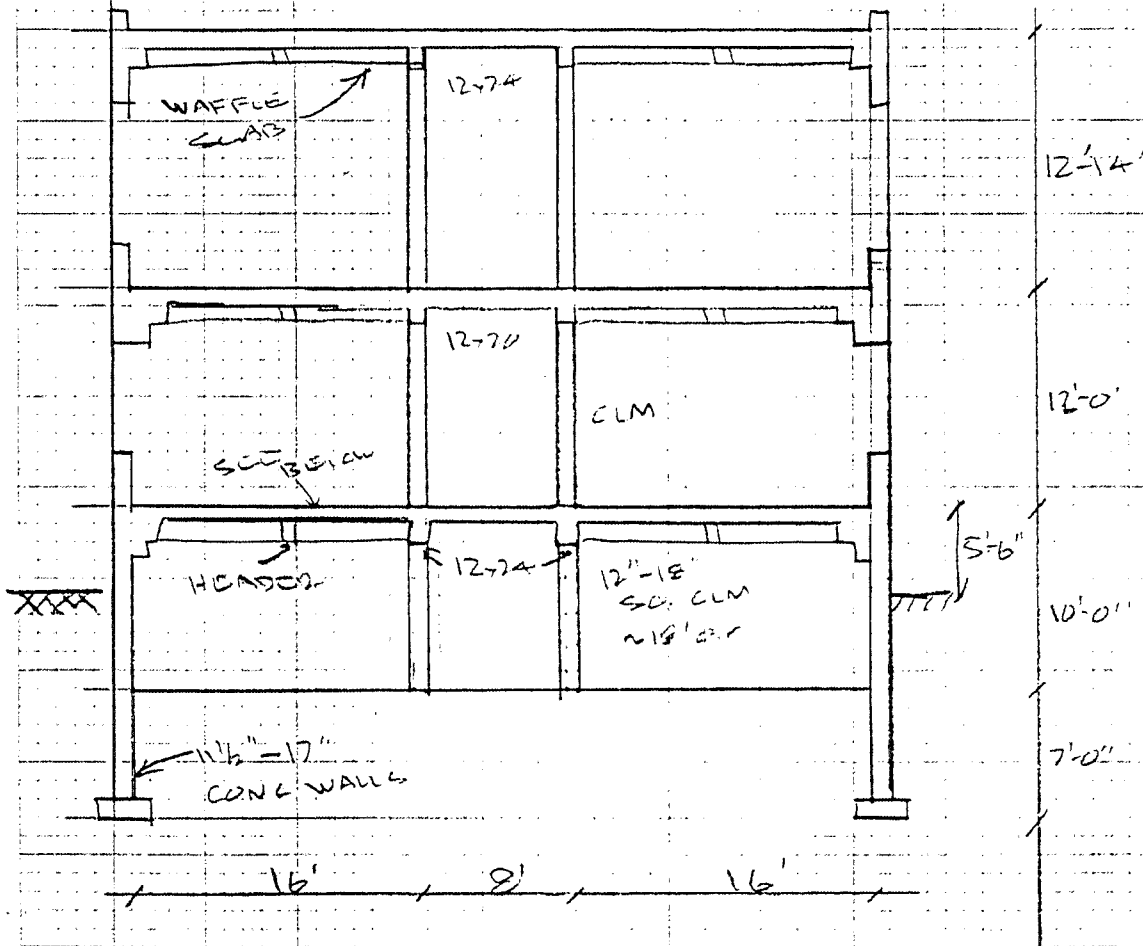
TYPICAL CONC  
BASEMENT PLUS TWO FLOOR:

TILAMOOK COURT HOUSE

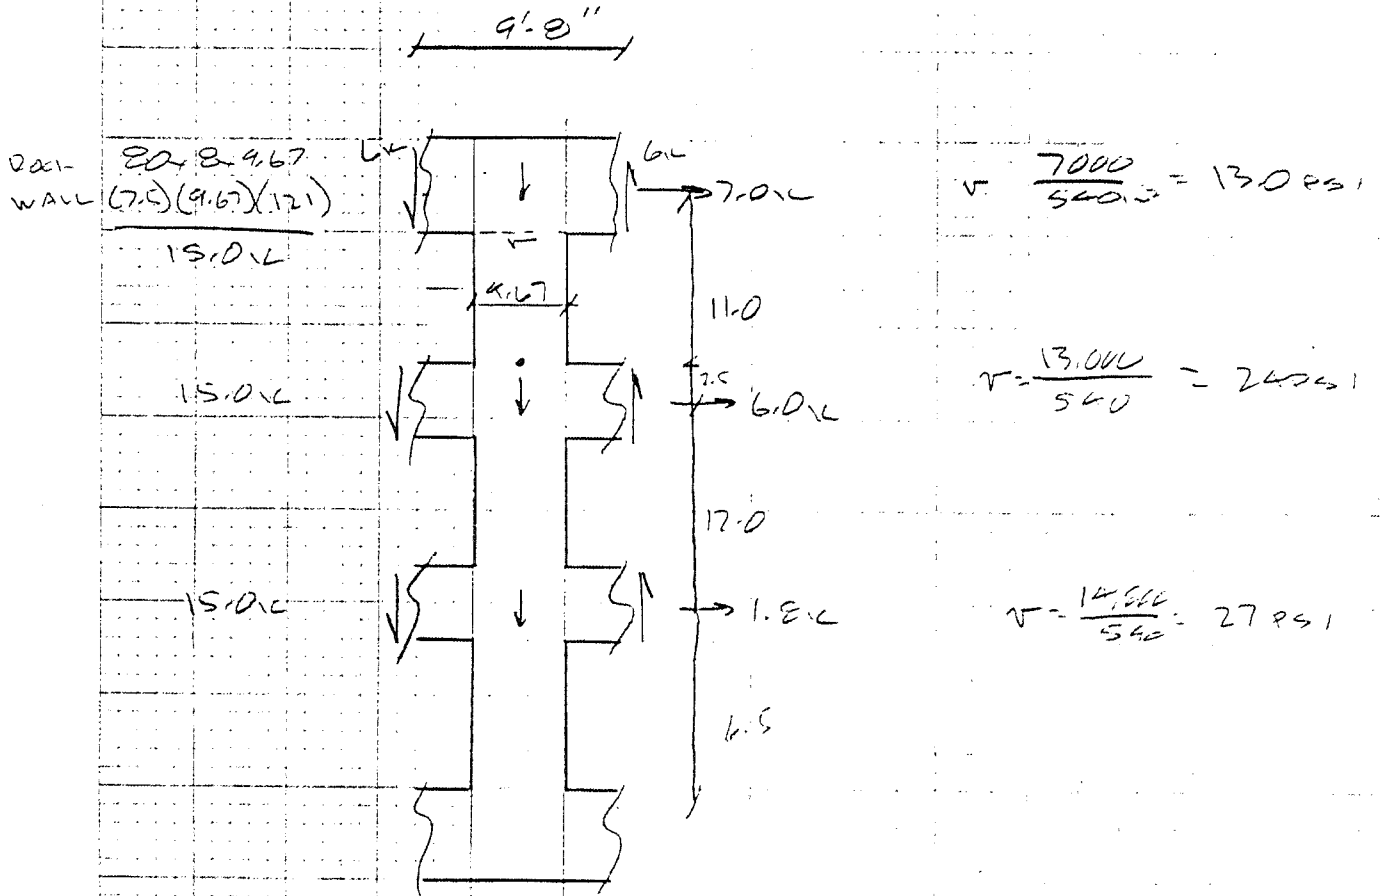
- 1) COLUMNS OVERSTRESSED IN BENDING UP TO 100%
- 2) BEAMS ARE CLOSE IN STRONG DIRECTION AND 100% OVER IN WEAK DIRECTION

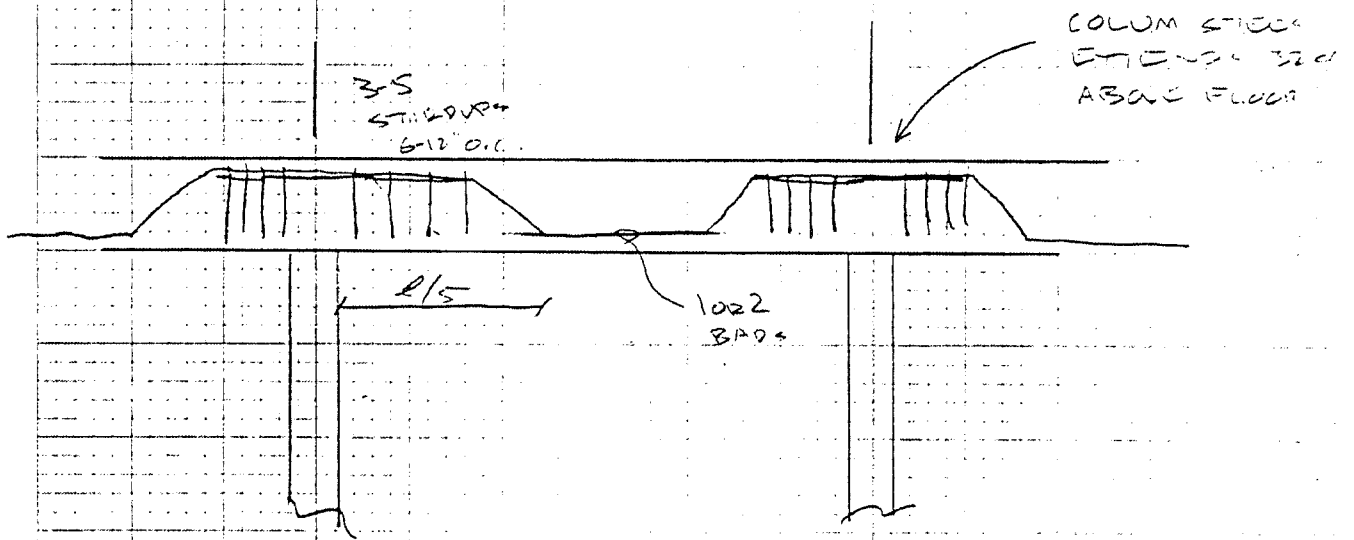
# TYPICAL BEAM JOINT

- \* NO REINFORCEMENT FOR REVERSED BENDING
- \* NO SHEAR PINS IN CENTERS OF BEAMS
- \* COLUMN SPLICES NEAR POINTS OF MAXIMUM BENDING.
