Tier 1 Report of
Facility Condition Assessment

For
Department of Administrative Services
Revenue Building
955 Center Street NE
Salem
Oregon 97310

Date of Report: November 07, 2014

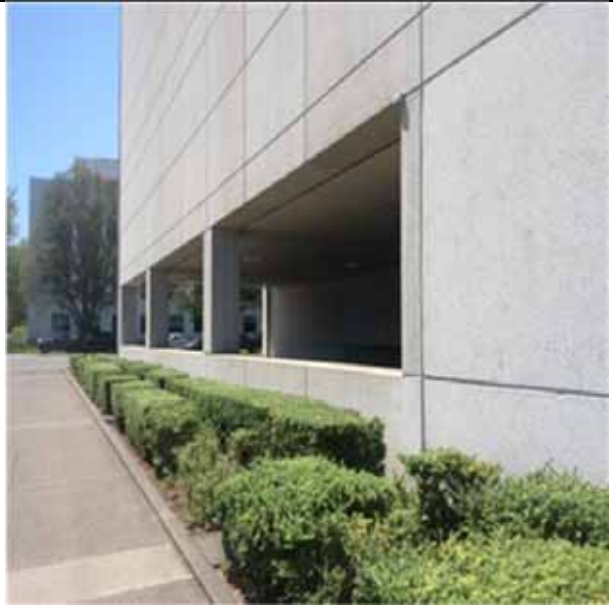
A1032 Structural Slab on Grade.1:- View of typical slab-on-grade concrete.

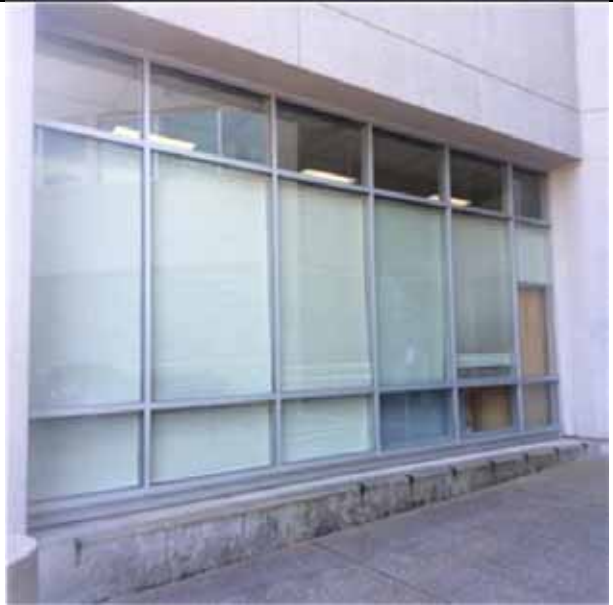
B2021 Windows.1:- View of typical aluminum window units.

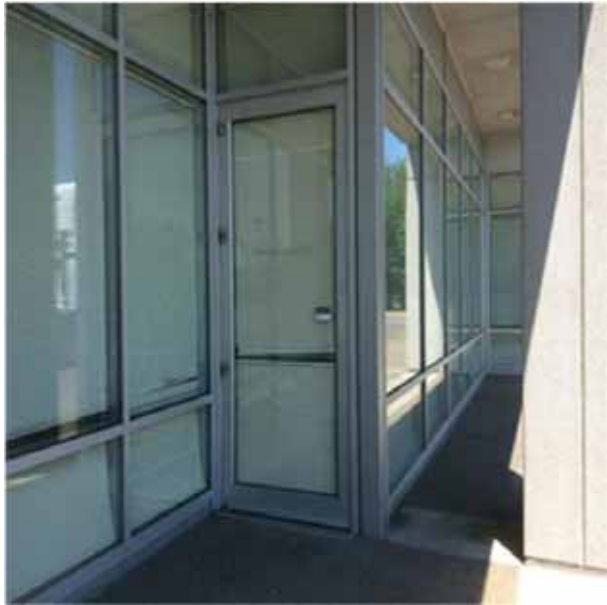
B2023 Storefronts.1:- View of typical glazed metal framed windows.

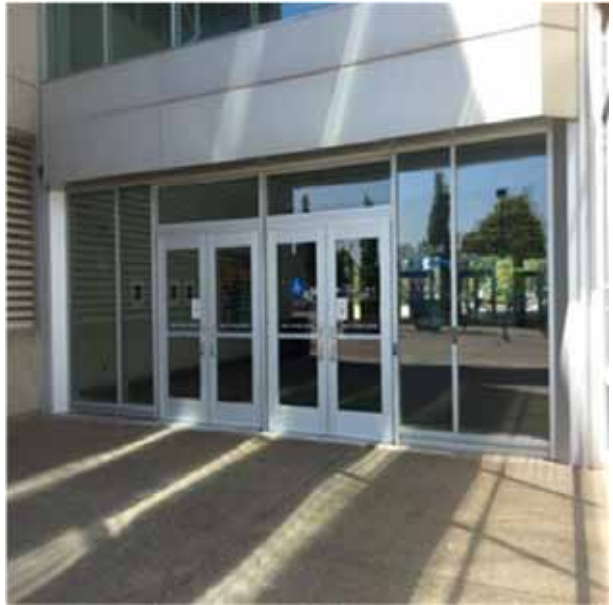
B2031 Glazed Doors & Entrances.1:- View of typical single aluminum glazed door.

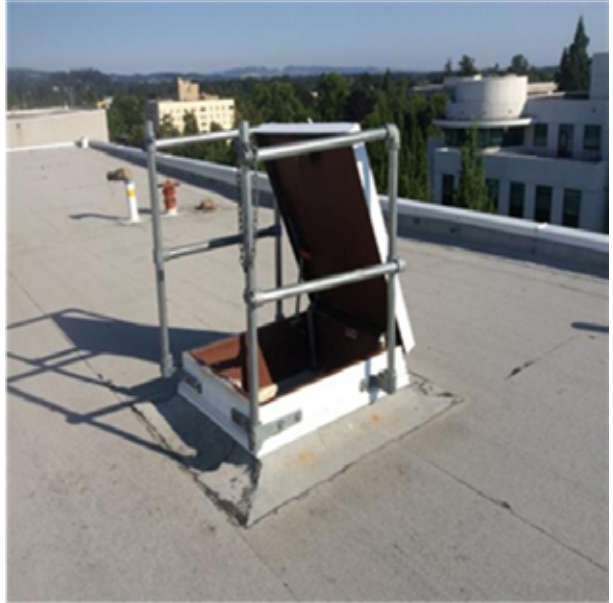
B3011 Roof Finishes.2:- View of typical built-up roof covering.

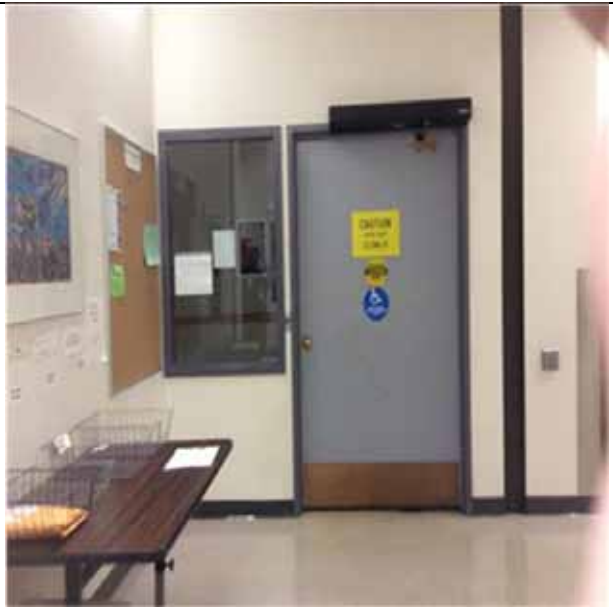
C1021 Interior Doors.1:- View of typical single wood door.

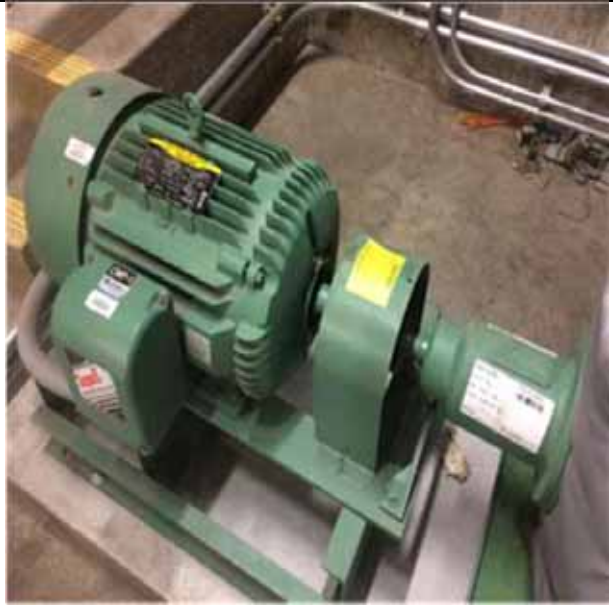
D3044 Hot Water Distribution.1:- View of pump/motor HWP-01.

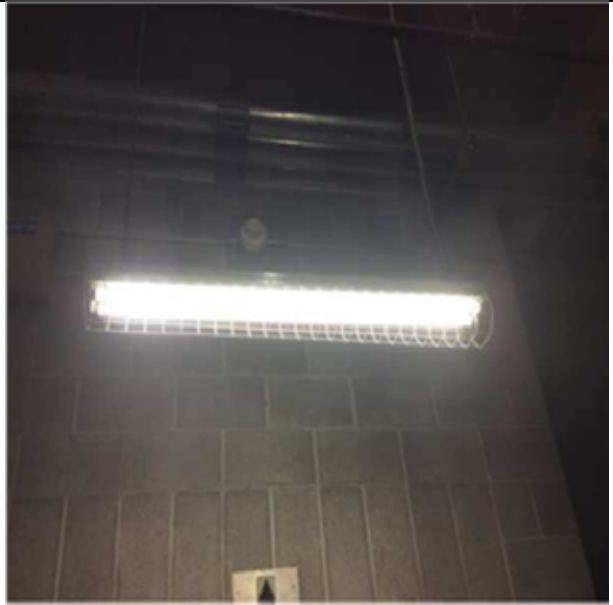
D5022 Lighting Equipment.1:- View of the 2' x 4' light fixtures.

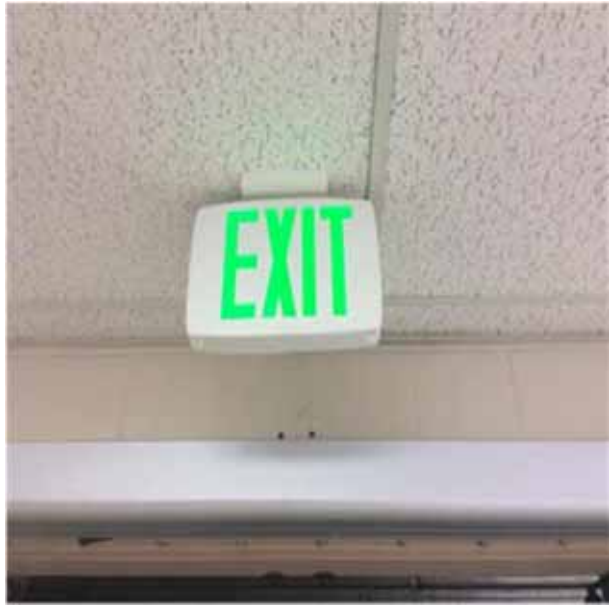
D5092 Emergency Light & Power Systems.1:- View of one of the emergency light fixtures.
