Bank erosion along the River Murray between Hume Dam and the Ovens Junction

With a focus on the impacts of vessel wash

April 2017

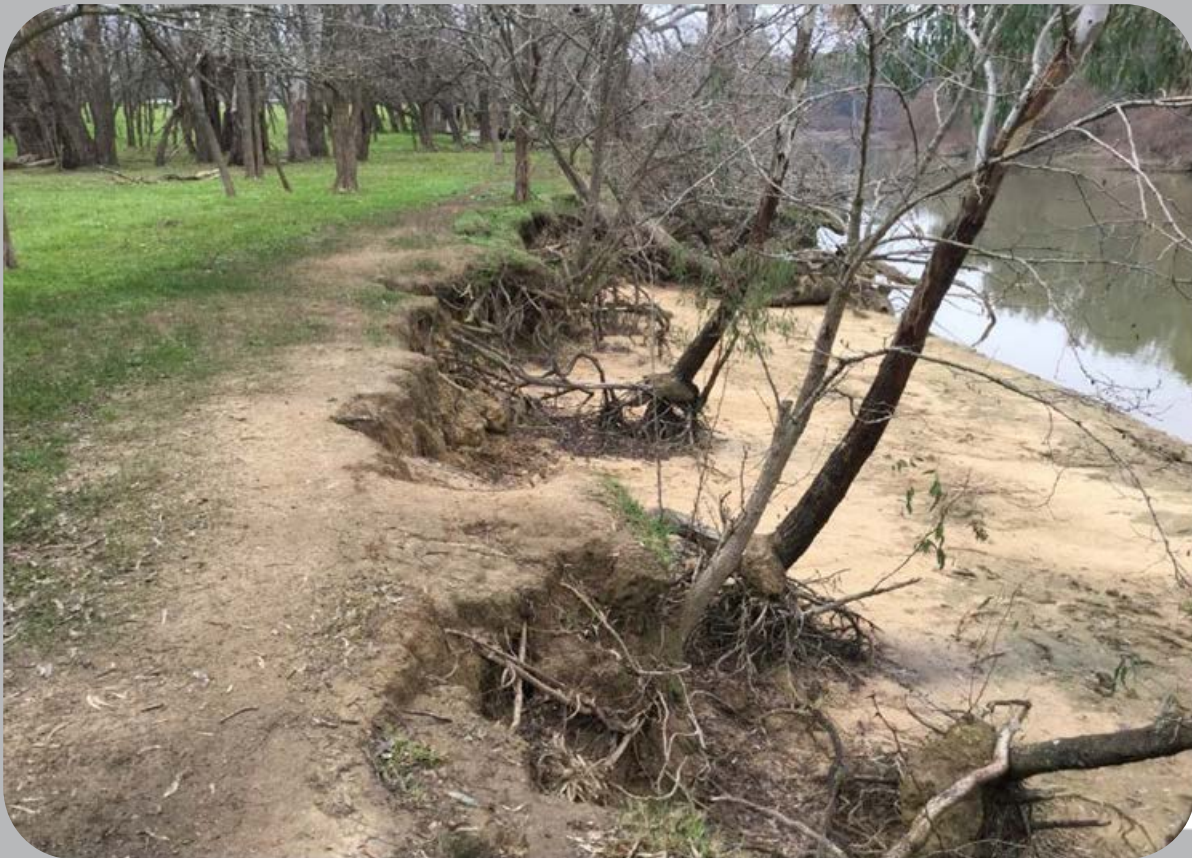
Cover image: Bank erosion on a property between Corowa and Bundalong (photo by Ben Berry)

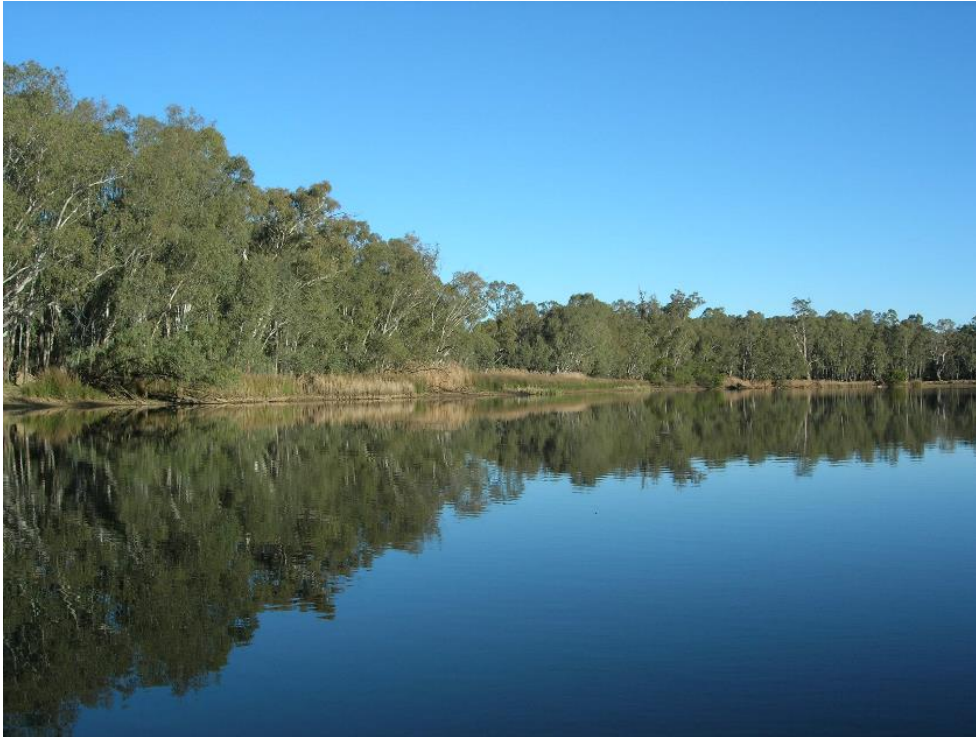
Figure 1: An intact section of river bank with good cover of bank vegetation

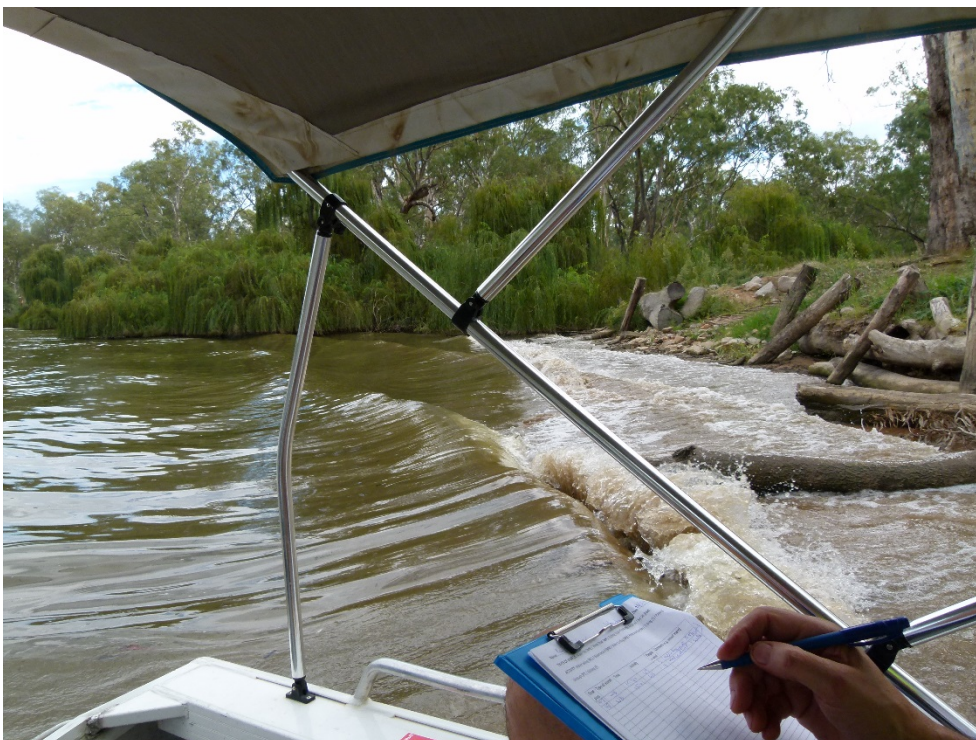
Figure 2: Boat wash breaking on the bank of the River Murray, near Corowa

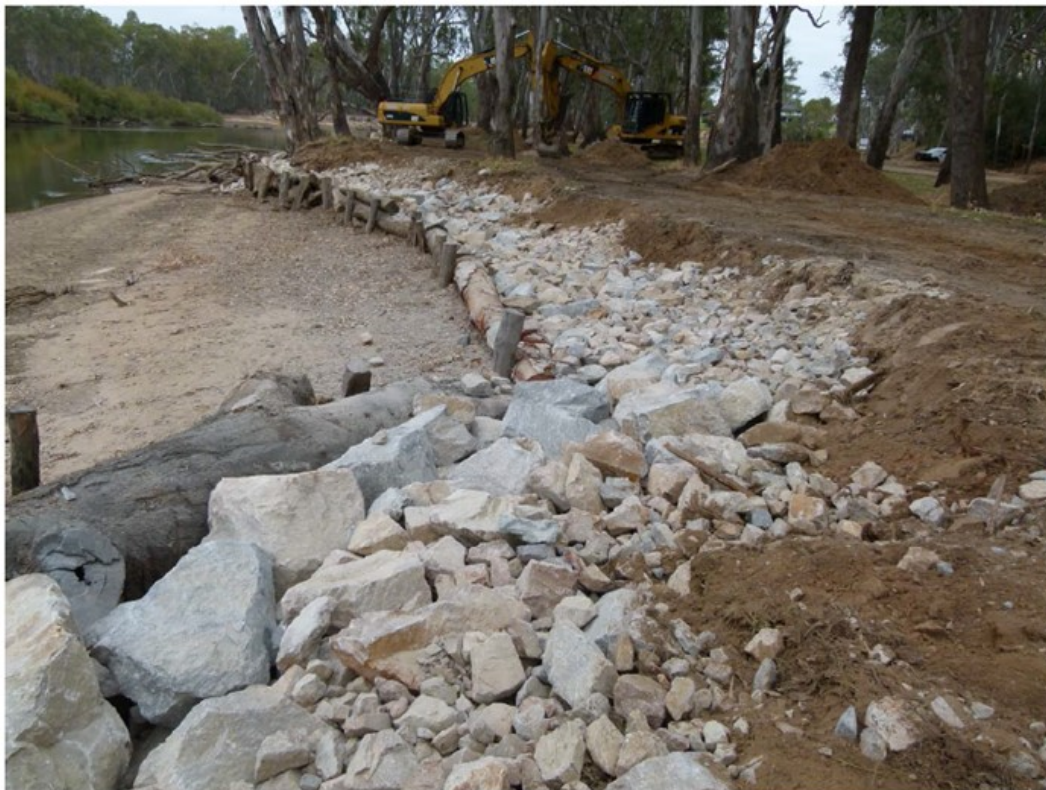
Figure 12: Retrofitted rock beaching behind the log revetment to protect against vessel wash. Note the elongated sloping ledge - a common feature seen in areas that are subjected to high levels of vessel wash, where the upper vertical face retreats much faster than the toe of the bank.

However, after only five years the log revetment had effectively failed and this is thought to be due to undermining due to vessel wash (Figure 10-11). In 2016 another \$670,000 was spent to repair the damaged river bank protection works and to reinforce the river banks with rock beaching to protect against boat wash (Figures 12-14).

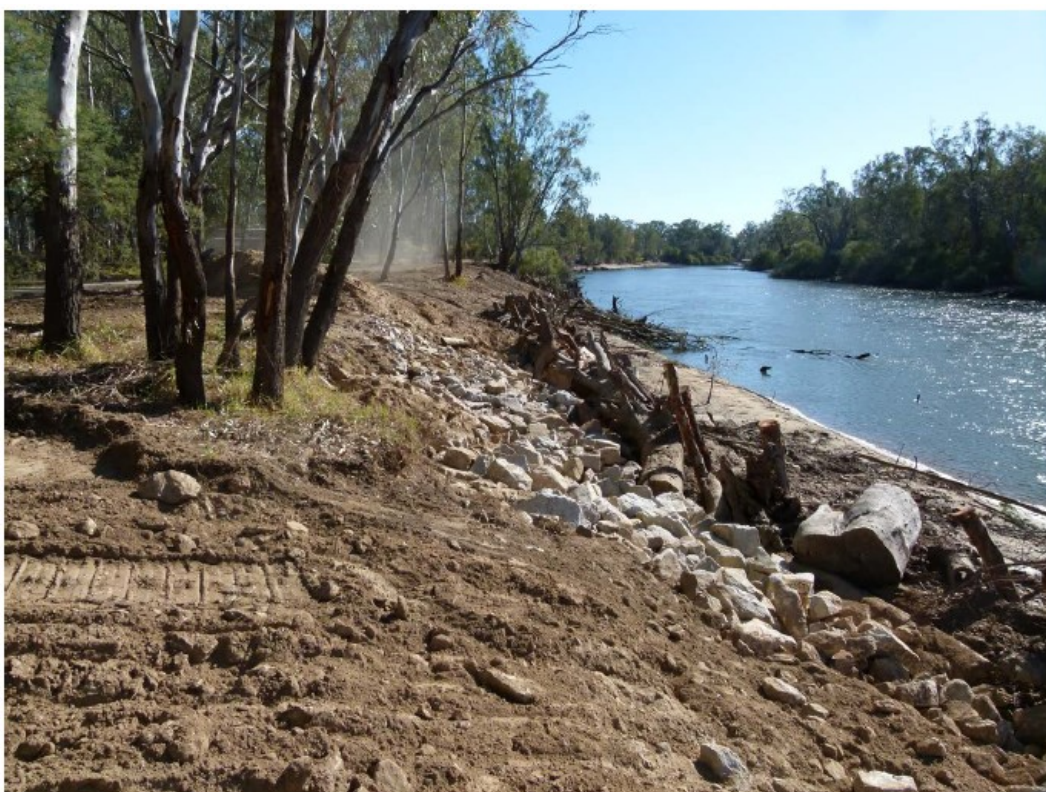
Figure 13: Ball Park log revetment being repaired and retro-fitted with rock beaching and backfilled.

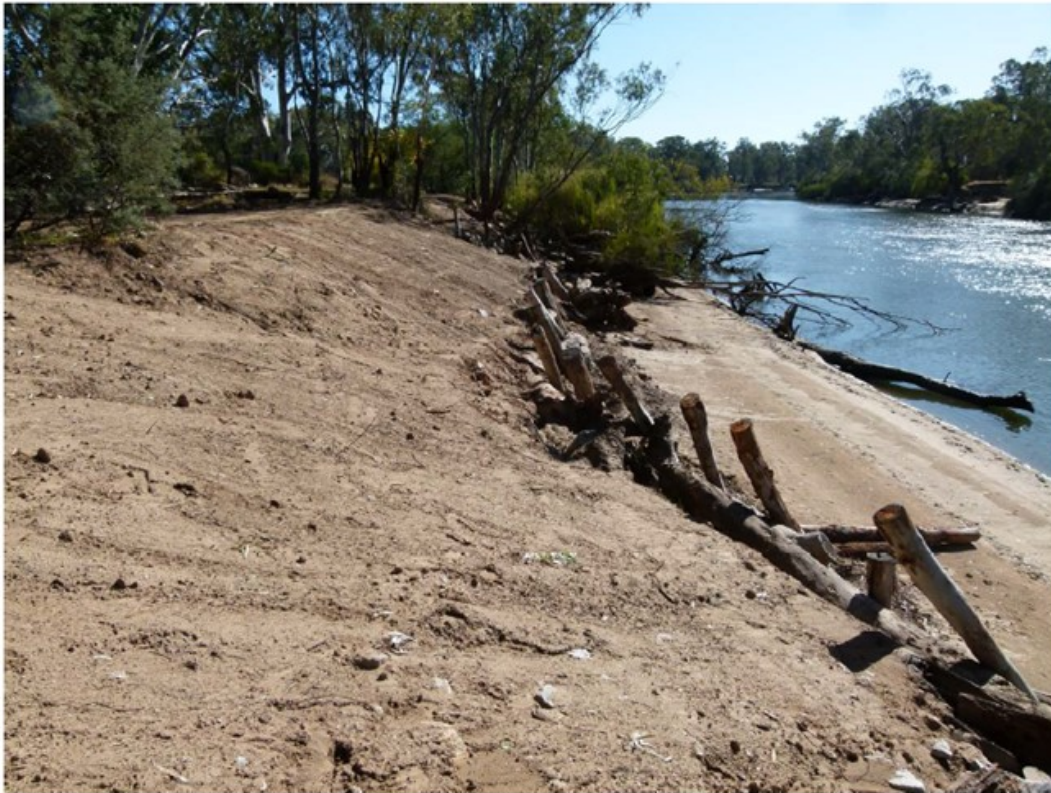
Figure 14: Ball Park logs now repaired with the aim of being able to withstand the impact of vessel wash.

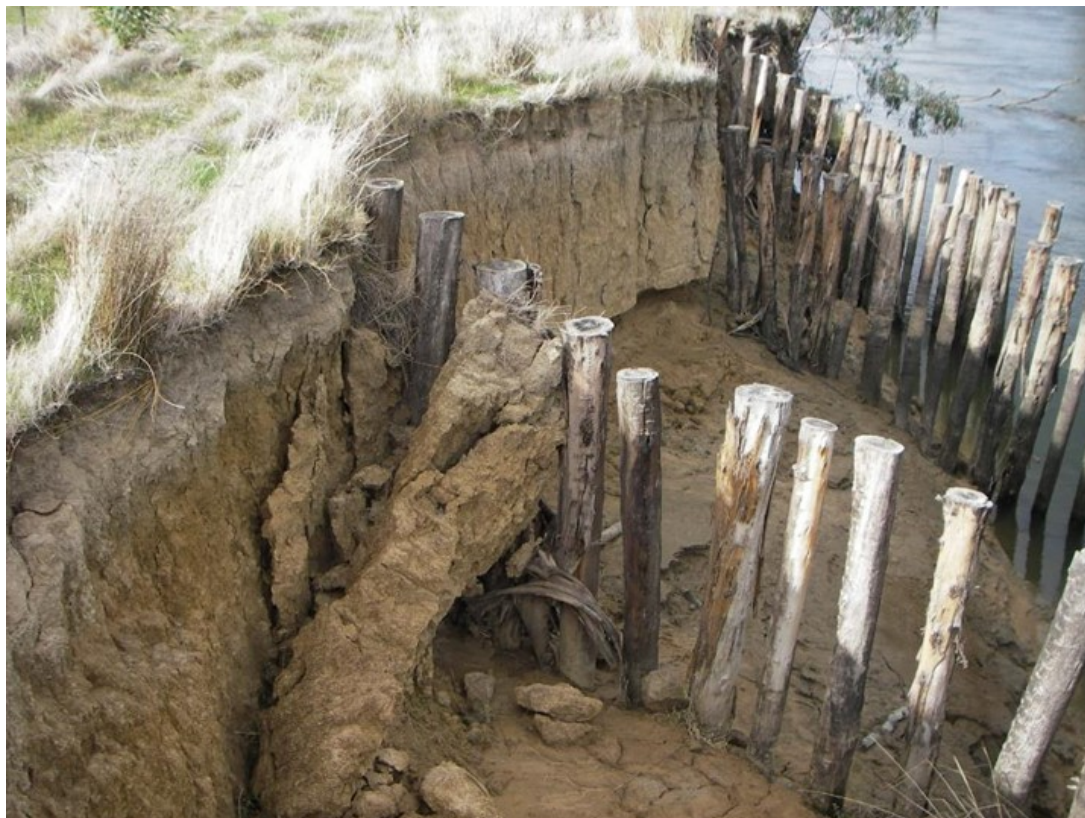
Figure 18: Bank sheering behind pile fields.
