Bank erosion along the River Murray between Hume Dam and the Ovens Junction

With a focus on the impacts of vessel wash

April 2017

MDBA publication no: 09/17

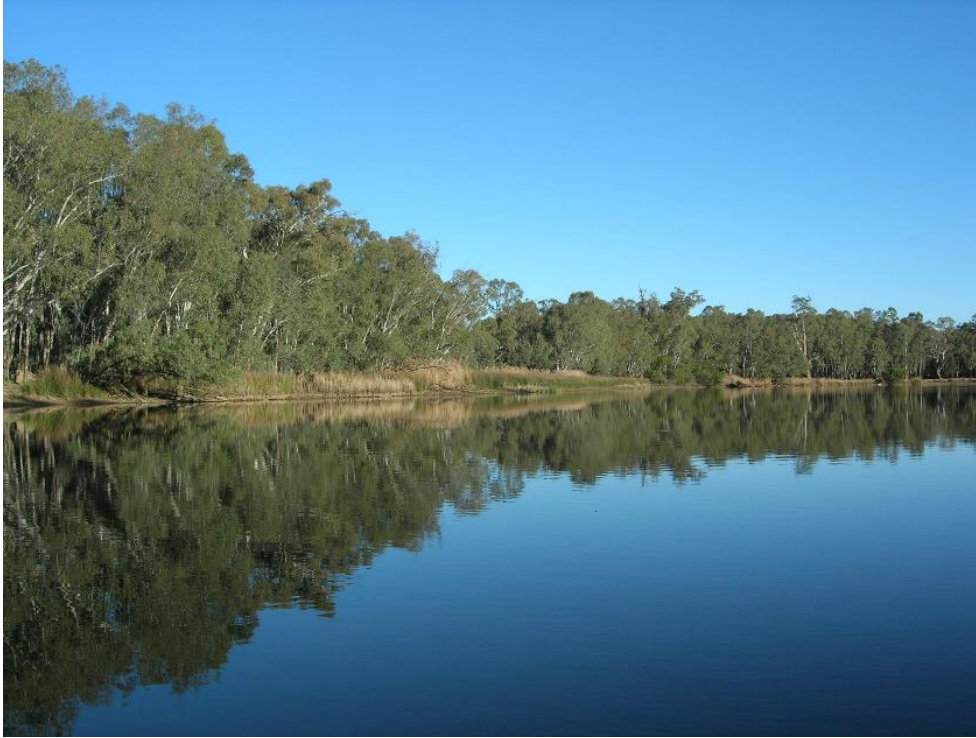
Figure 1: An intact section of river bank with good cover of bank vegetation

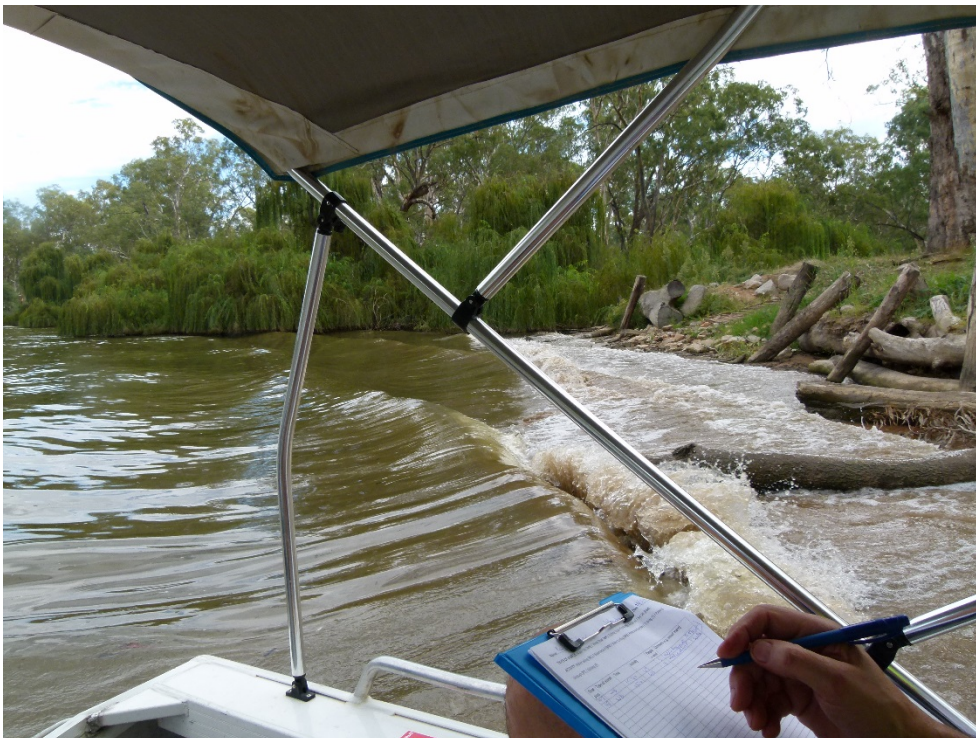
Figure 2: Boat wash breaking on the bank of the River Murray, near Corowa

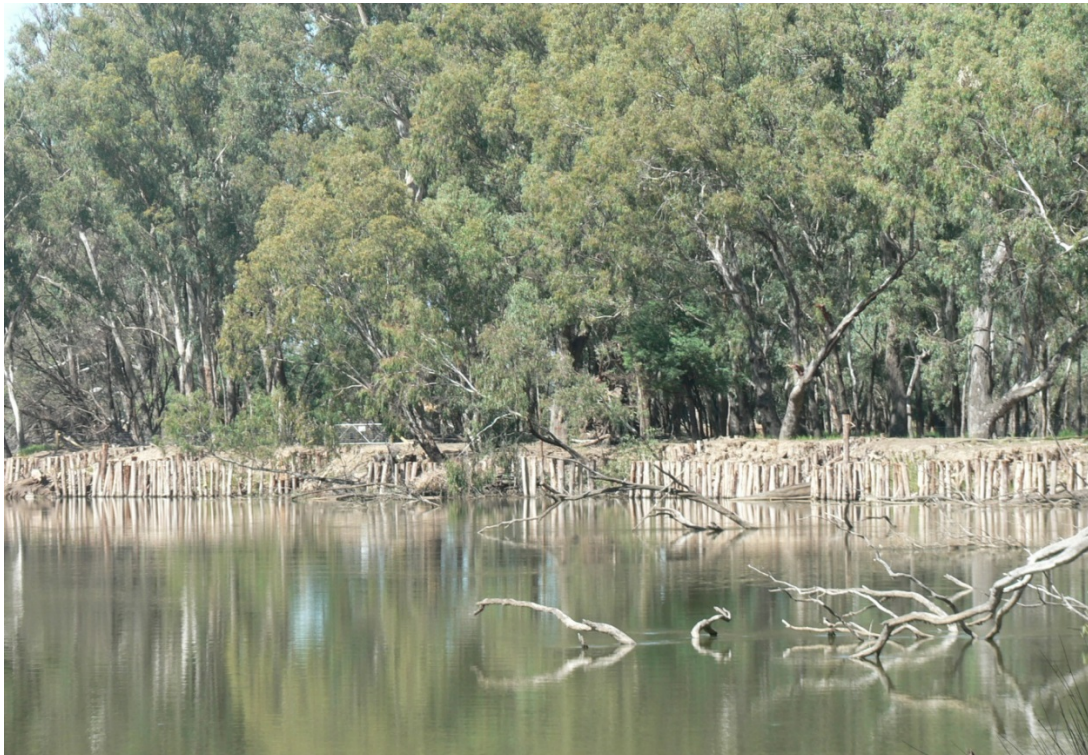
Figure 3: Pile fields are one type of river work technique implemented to reduce rates of erosion. These structures were designed to be sympathetic to the natural behaviour of the river. They are ineffective at addressing erosion caused by boat waves as these wave travel perpendicular to the bank.

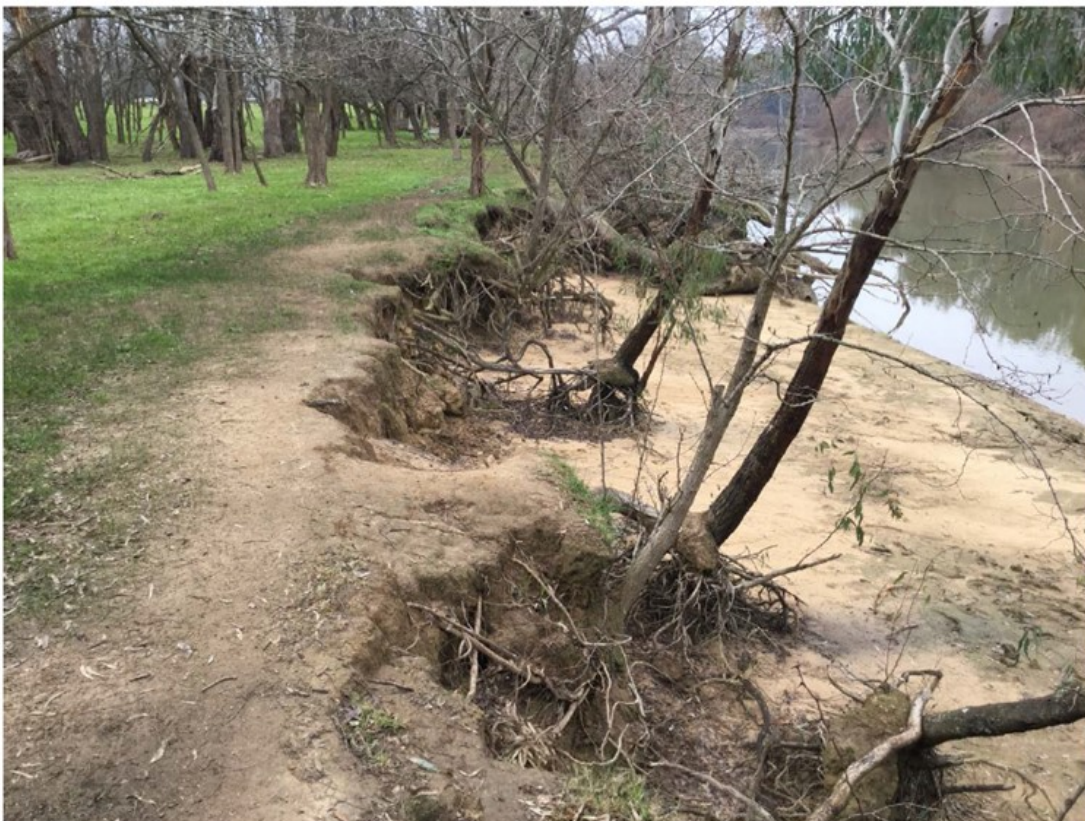
The relatively stable water level also results in vessel wash impacting on a concentrated section of the bank profile, rather than being spread across it. This tends to accelerate the formation of a notch at the water level, which undermines the upper bank profile and leads to subsequent block collapse. This increases the rate of retreat of the upper bank profile, leading to the development of a pronounced elongated ledge (Figure 4). This is a common bank profile seen in high boat use areas. In such cases, both river regulation and boating clearly play important roles, but their effects are compounded through interaction.

Figure 4: Erosion near Corowa that is typical of the impacts of boating.

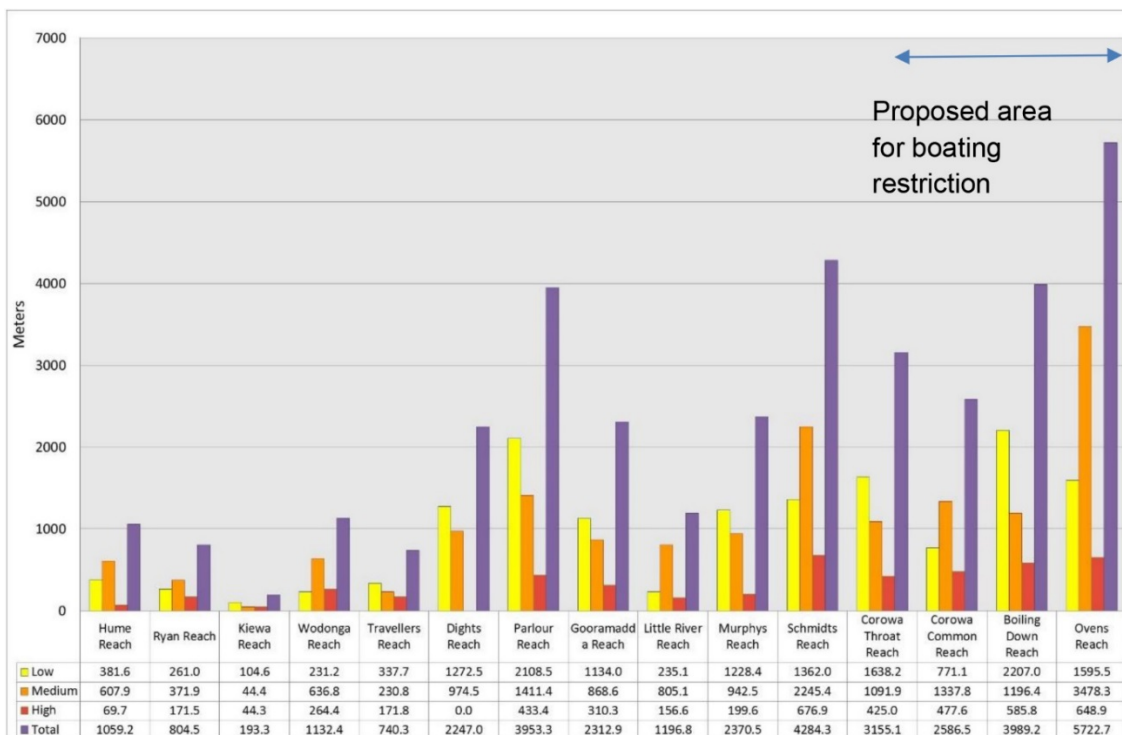
The monitoring program divides the reach into 15 sub-reaches along the main stem of the River Murray. The majority of erosion generally occurs in the mid and lower parts of the reach, from just upstream of Corowa (Schmidt's reach) to the junction with the Ovens River (Ovens reach). This can be seen from the 2012 monitoring when there was a full set of comparative data (Figures 5 and 6). In 2012, several lower reaches had more than 14% of the river bank identified as a priority for erosion works (Figure 6).

Figure 5: Length of low, medium, high and total erosion in each sub-reach in 2012. Upper reaches are shown on the left and lower reaches shown on the right.

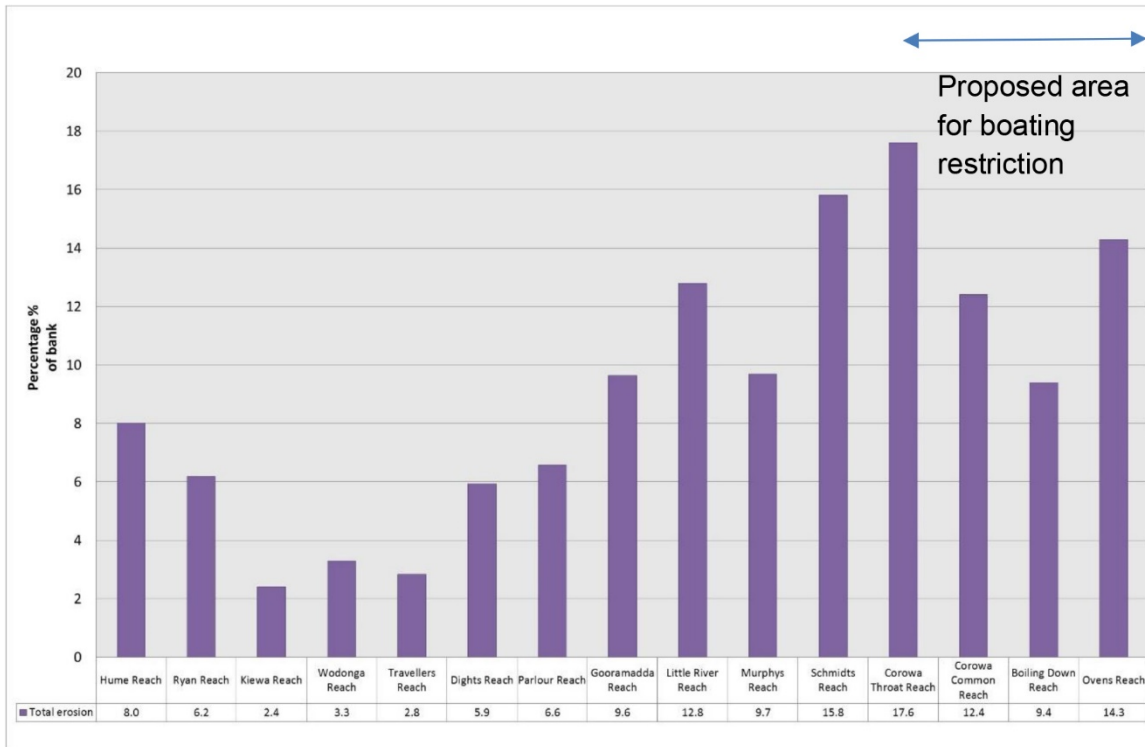
Figure 6: Percent of total bank erosion in each sub-reach in 2012. Upper reaches are shown to the left and lower reaches are shown to the right.

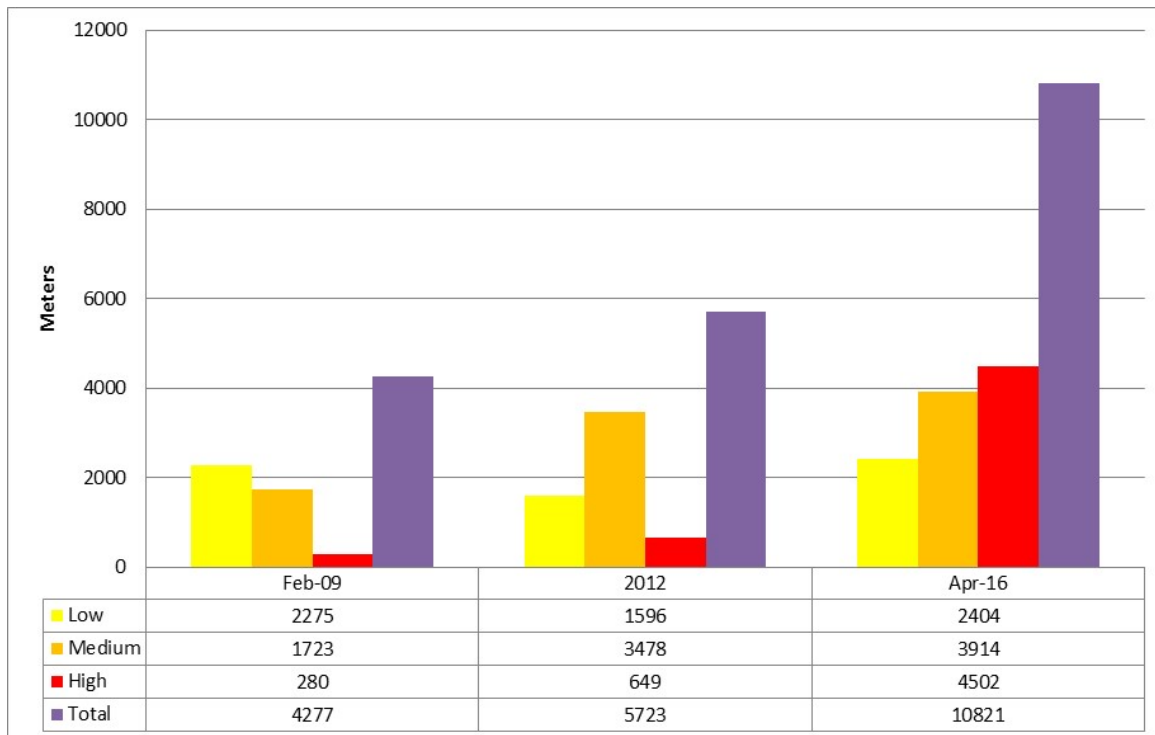
In recent years there has been a significant increase in erosion along the lower parts of the reach. For example, sections of river banks in the Ovens reach have significantly deteriorated in the past seven years (Figure 7). In 2009, there was about 4.2 km of erosion sites and only 280 metres of this was classified as high priority. By 2016 there was more than 10 km of erosion sites with 4.5 km of this being high priority. This represents a doubling of all erosion sites and a twenty-fold in increase in high priority erosion in this area. At present, 27% of the river banks along the Ovens reach are now categorized as actively eroding.

Figure 7: Length of low, medium, high and total erosion in the Ovens sub-reach from 2009 to 2016. Data in 2012 same as that presented in Figure 5.

The approximate costs to protect these sites with rock to make the river banks resilient to boat wash is approximately \$250 per lineal meter. To treat the 4.5 km of high priority erosion sites in this reach with rock would cost \$1,125,000.

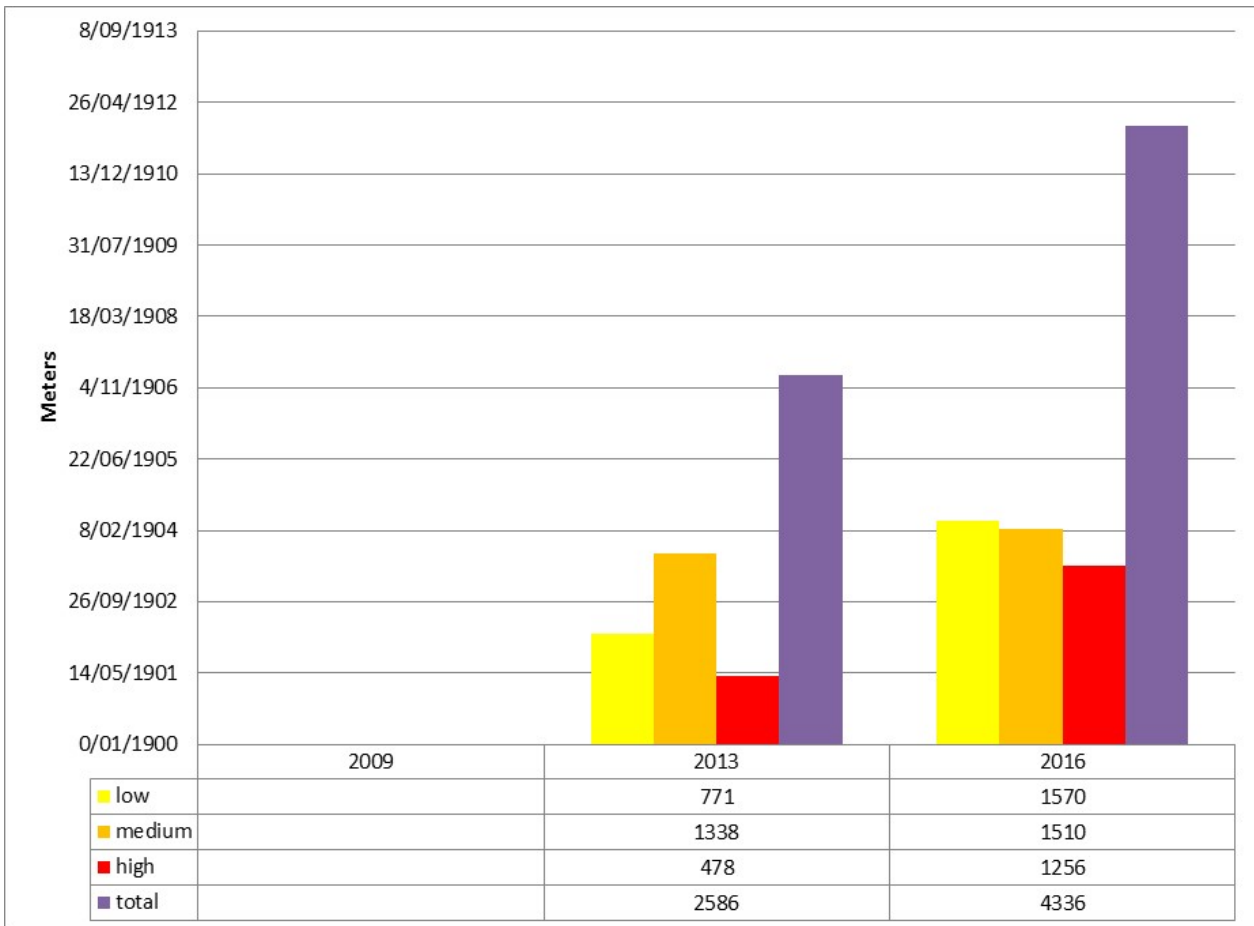
The recent increase in erosion is not isolated to the Ovens reach. There has also been a significant increase in high priority sites occurring in the Corowa Common reach between 2013-2016 (Figure 8).

Figure 8: Length of low, medium, high and total erosion in the Corowa Commons sub-reach from 2013 to 2016.

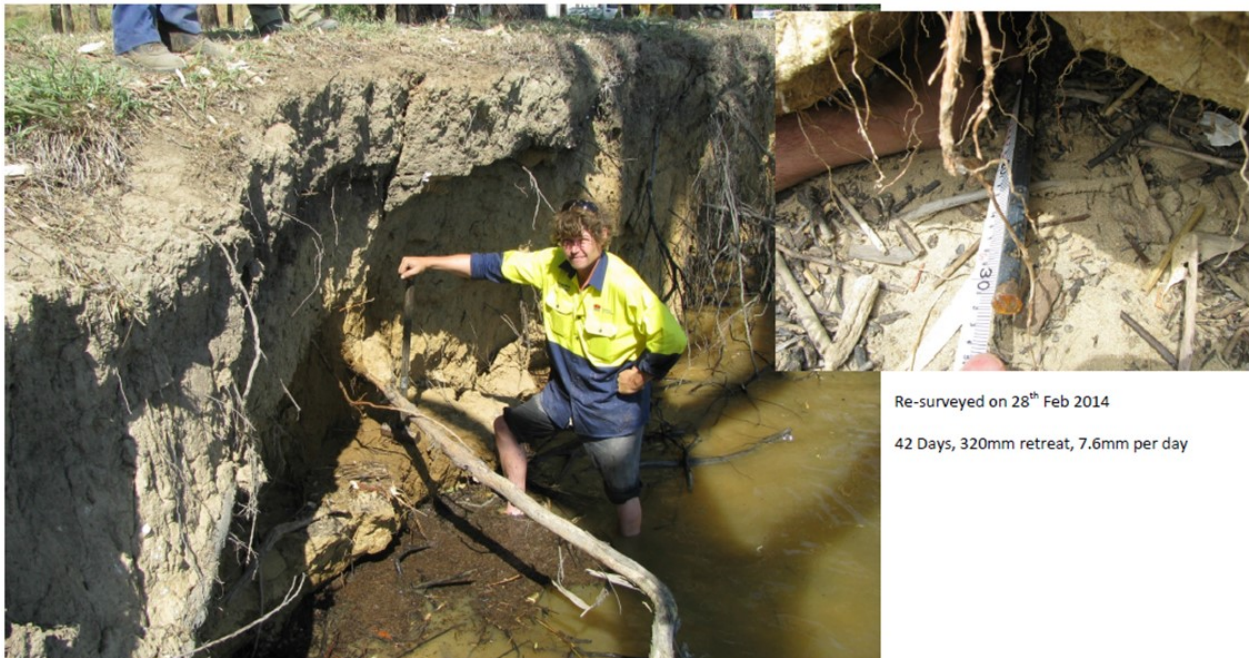
Horizontal Pin monitoring has also been used to determine the direct impact of boating in some areas. During 42 days of anecdotally high boating activity at the Hawke property (Corowa) in the summer of 2014, 320 millimetres of bank retreat was recorded, averaging 7.6 millimetres per day (Figure 9).

Re-surveyed on 28th Feb 2014
42 Days, 320mm retreat, 7.6mm per day

Horizontal Monitoring Pins installed 17th January 2014

Figure 9: Horizontal pin monitoring at the Hawke property (Corowa) during summer 2014.

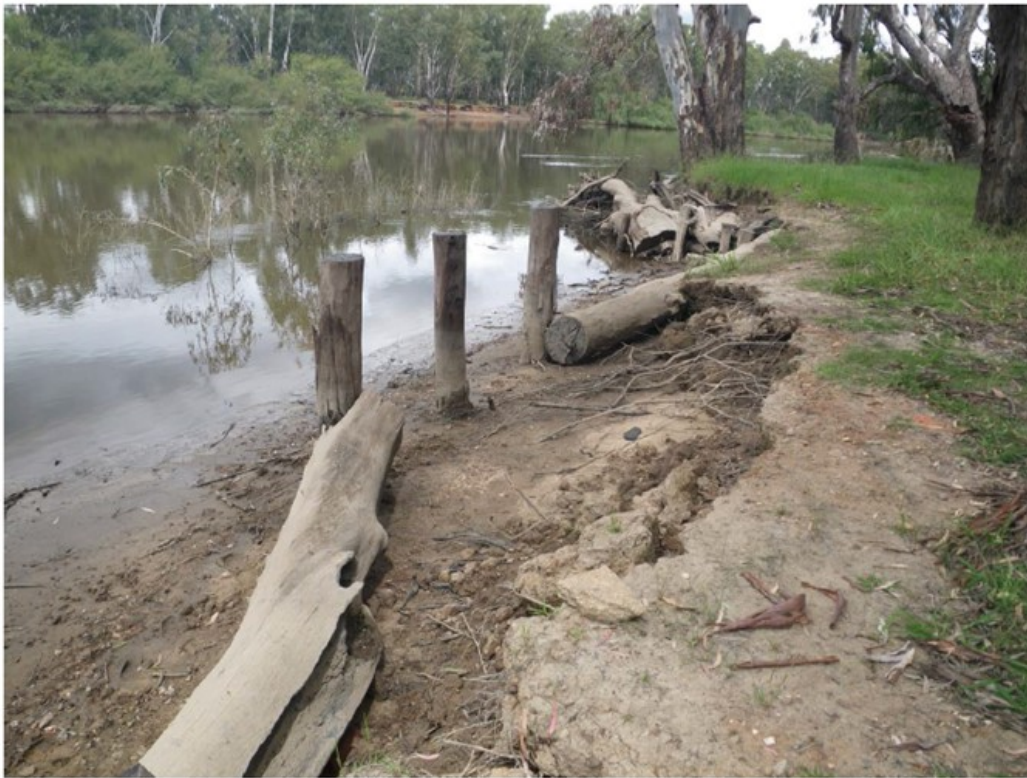
However, after only five years the log revetment had effectively failed and this is thought to be due to undermining due to vessel wash (Figure 10-11). In 2016 another \$670,000 was spent to repair the damaged river bank protection works and to reinforce the river banks with rock beaching to protect against boat wash (Figures 12-14).

Figure 10: Undermined log revetment leading to ongoing retreat of the upper bank.

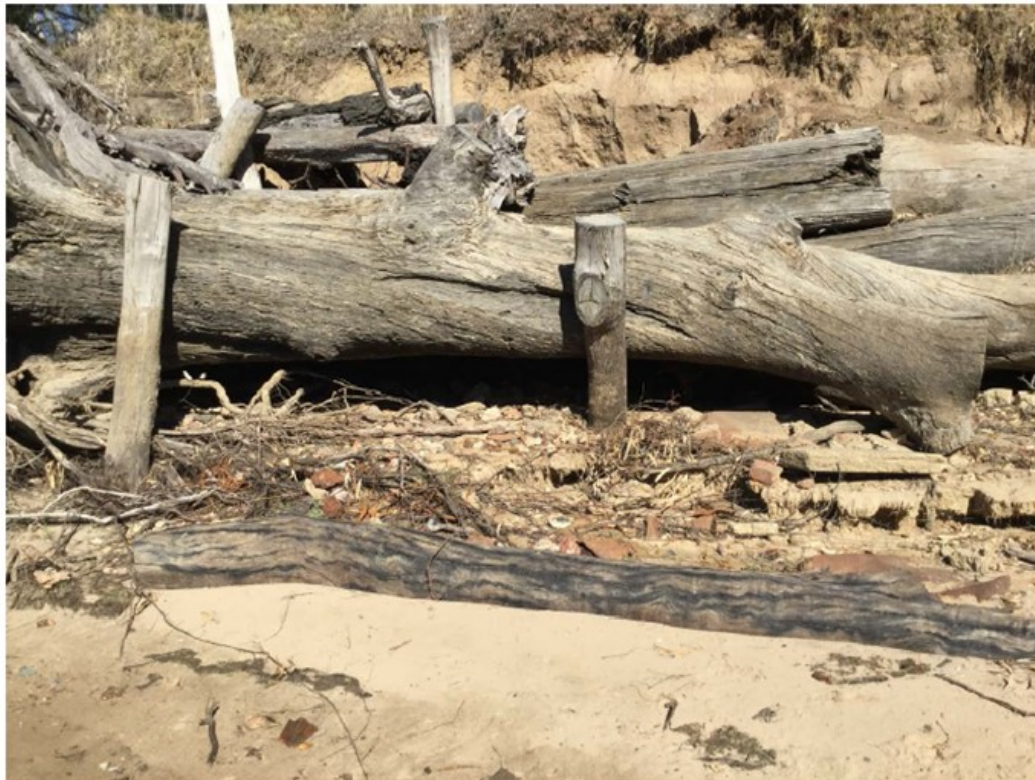
Figure 11: Ball Park log revetment undermined from boat wash.

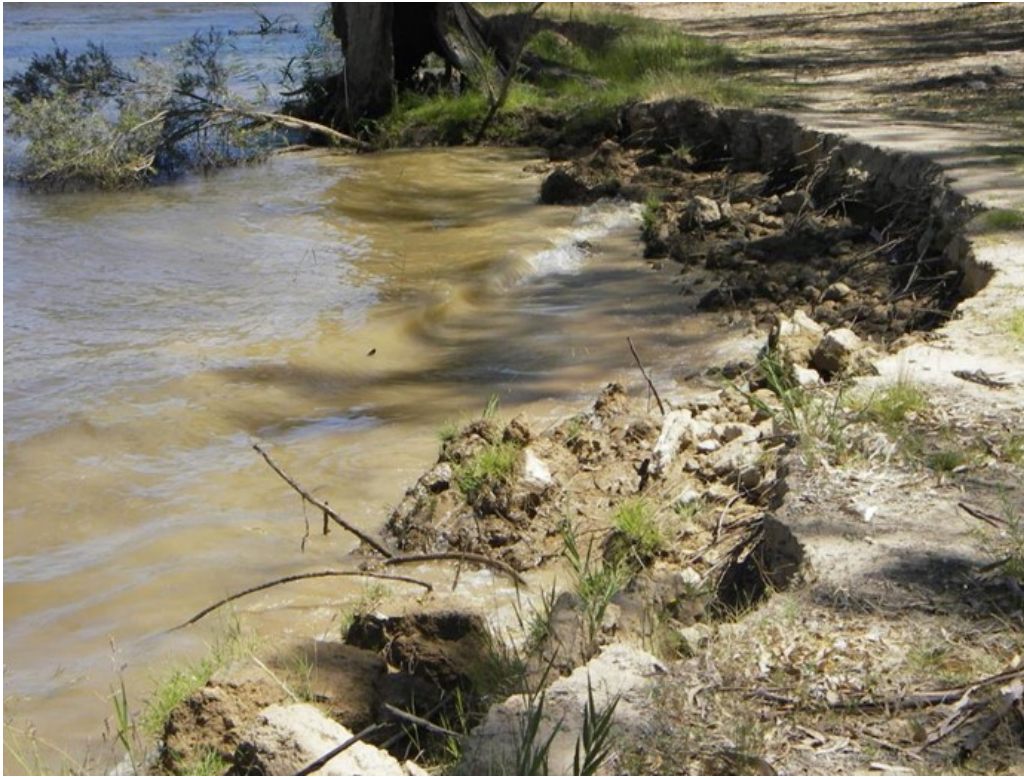
Figure 15: Steep bank erosion with waves breaking.

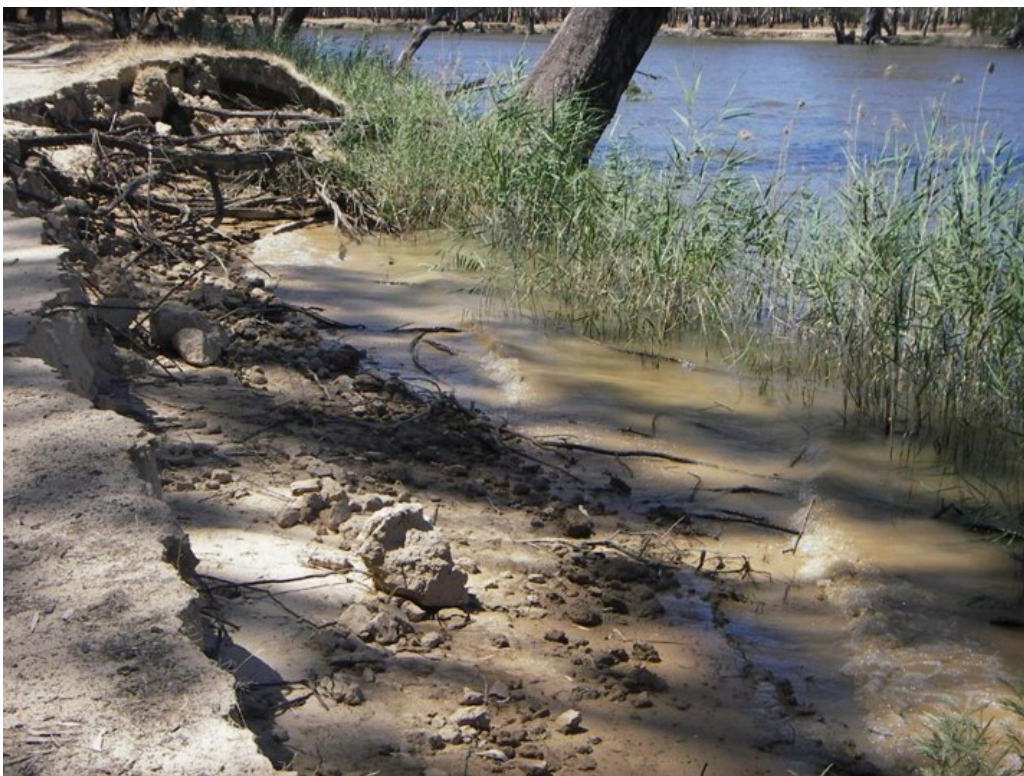
Figure 16: Bank erosion with a stand of Common Reed growing adjacent to bank.

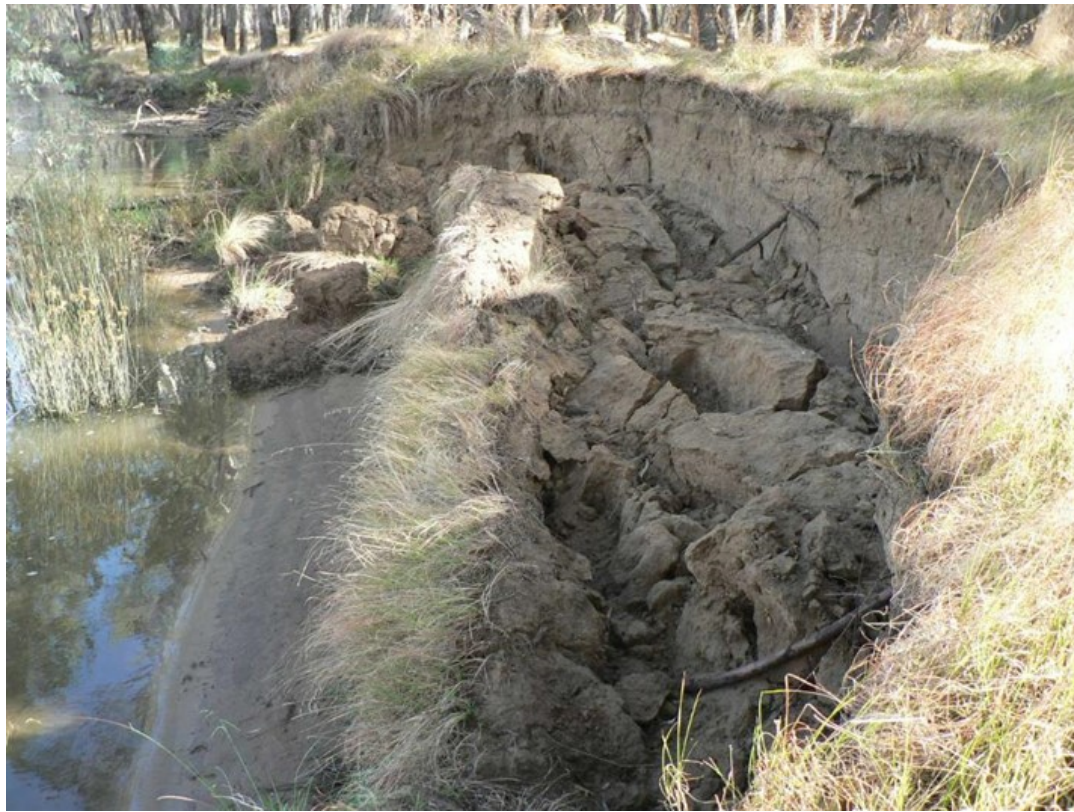
Figure 17: Severe bank slumping of grassy bank face.

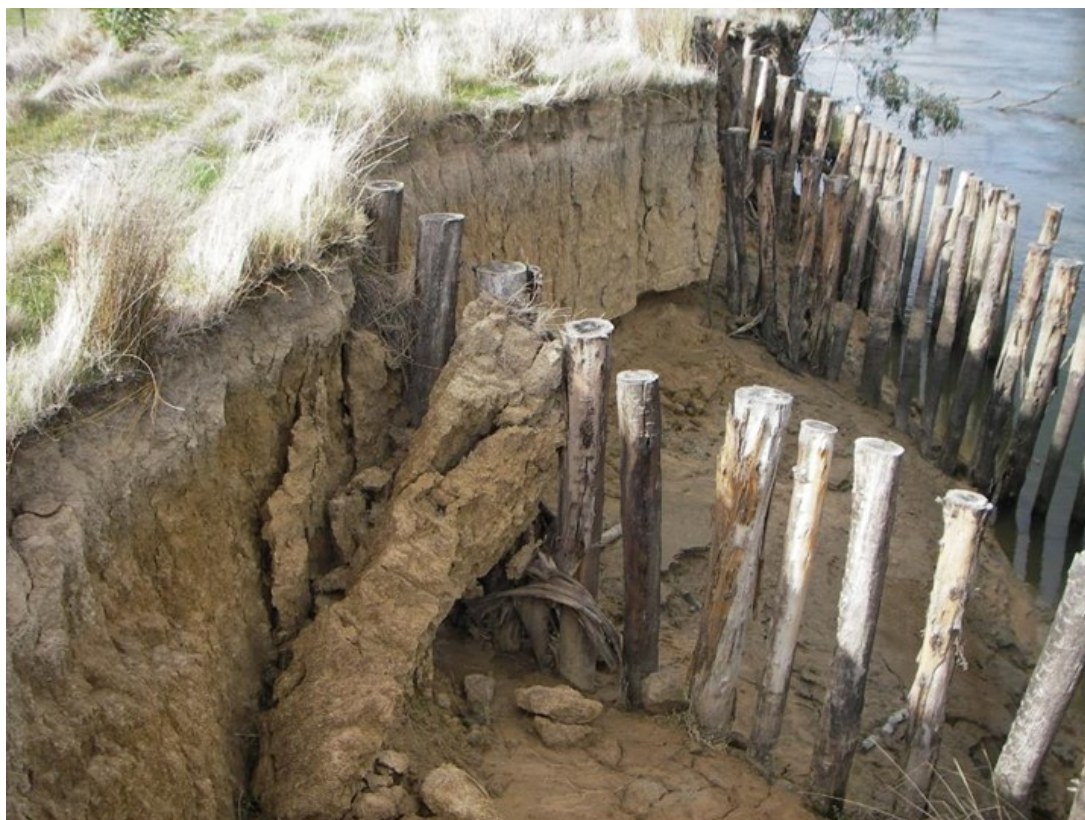
Figure 18: Bank sheering behind pile fields.
