### ***Landowner Property Damage*** (2019-03-05v7)

What follows are a small sample of the costs incurred by Property Owners within the Willamette River Newberg Pool. These ten properties are shown as “Property Owner #1, #2, #3, etc.: Location”. We have been asked to omit their names and addresses so that these do not appear in the public record (for obvious privacy and safety reasons). If the Committee wishes to contact a homeowner directly, please ask us to obtain permission. Below is a Summary Table of Costs incurred for the last 5-6 years or planned. Please keep in mind that this is just a sample of the growing impact of larger and larger high-energy wake.

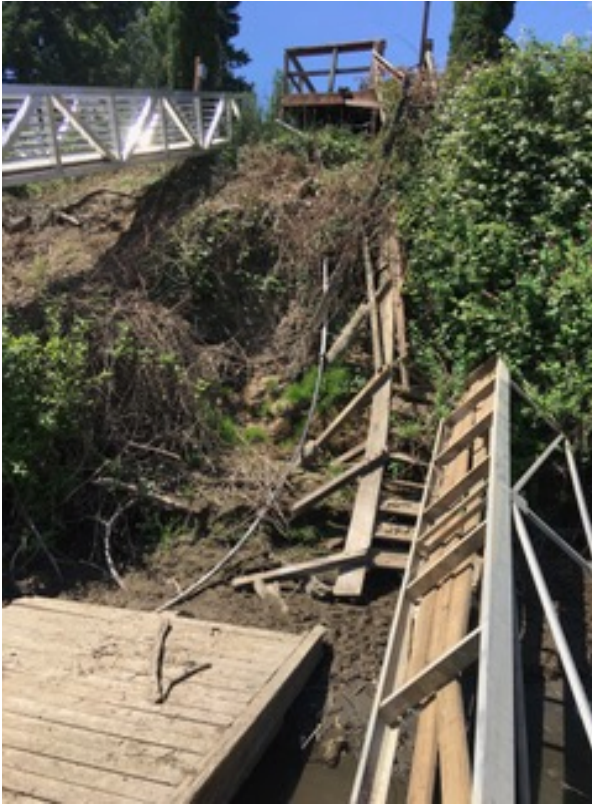
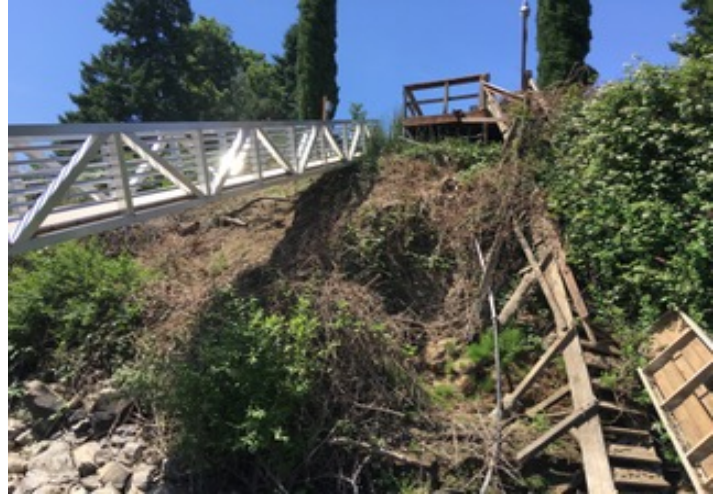
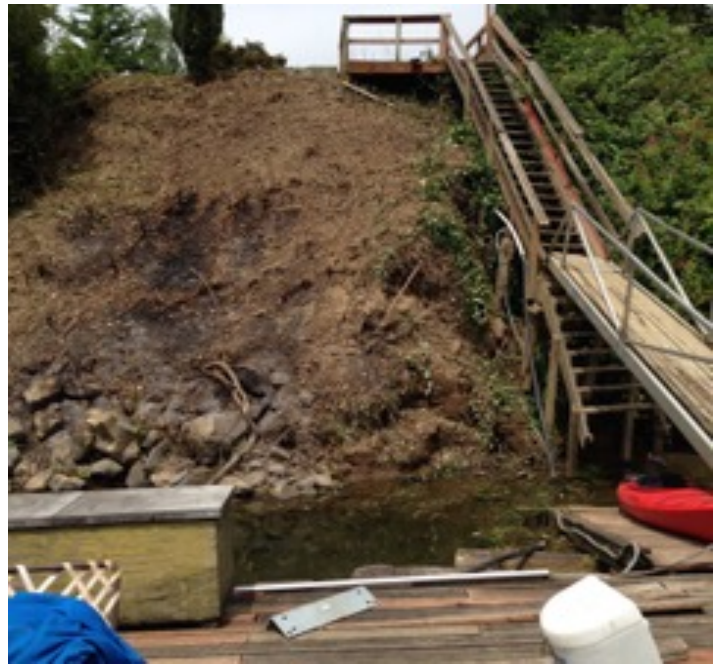
2015-Stairs to dock: We replaced the ramp and installed three concrete steps up into the yard to anchor the ramp for \$36,800. Steve Notman of Steve's Marine did the work. Then it cost an additional \$1,000 to haul the old ramp out. The old steps and ramp had been fine for 55 years.

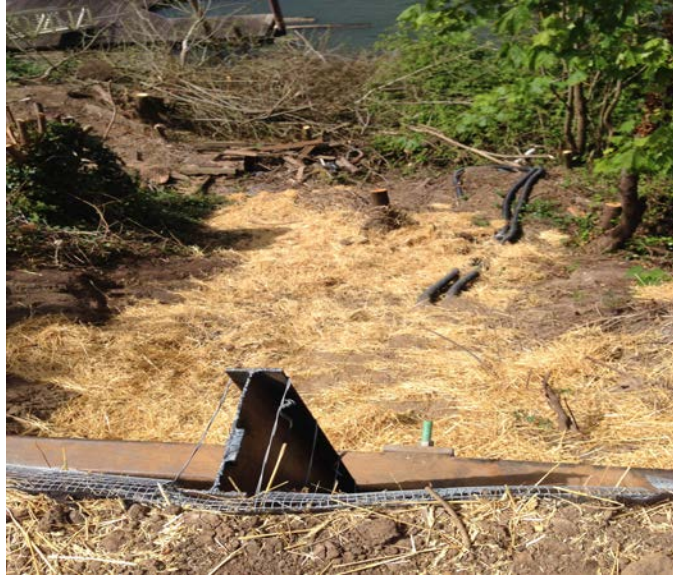
Photo #1 (westernmost point of our property): caused by a broken pipe on our property, the water undercut the bank causing a portion of it to slide into the river. Whether any erosion caused by high energy waves was not considered at this time. Our Geotechnical Engineer surveyed our and neighboring properties and noted a crack at the top of the riverbank that runs about 1/4 mile to the west of our house. Extensive retaining wall was installed costing approx. \$46k. May 2015

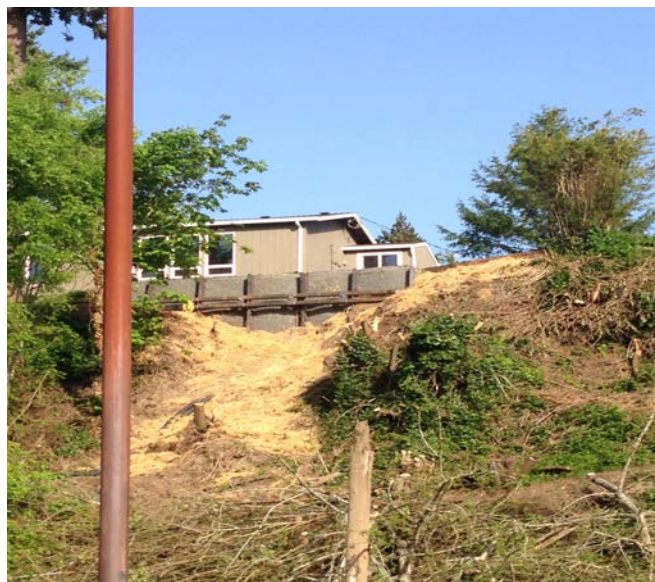
Photo #2 (center of property): Crack in riverbank soil caused the top of the "middle" portion of our riverbank to slide. We installed the first portion of our lower retaining walls at this time. Cost approx. \$14k. February 2016.

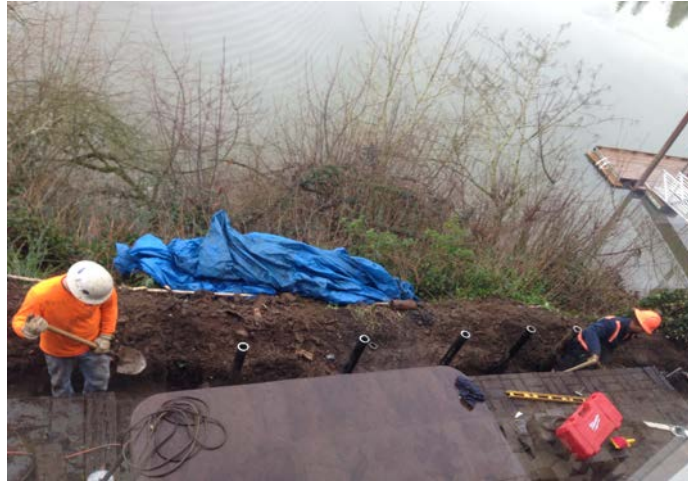
Even with taking our broken pipe and heavy rain into consideration, it seems obvious to us (Photo #3) was augmented by the undercutting of the bank by high energy waves. All retaining wall work was done by Pli Systems, Inc.

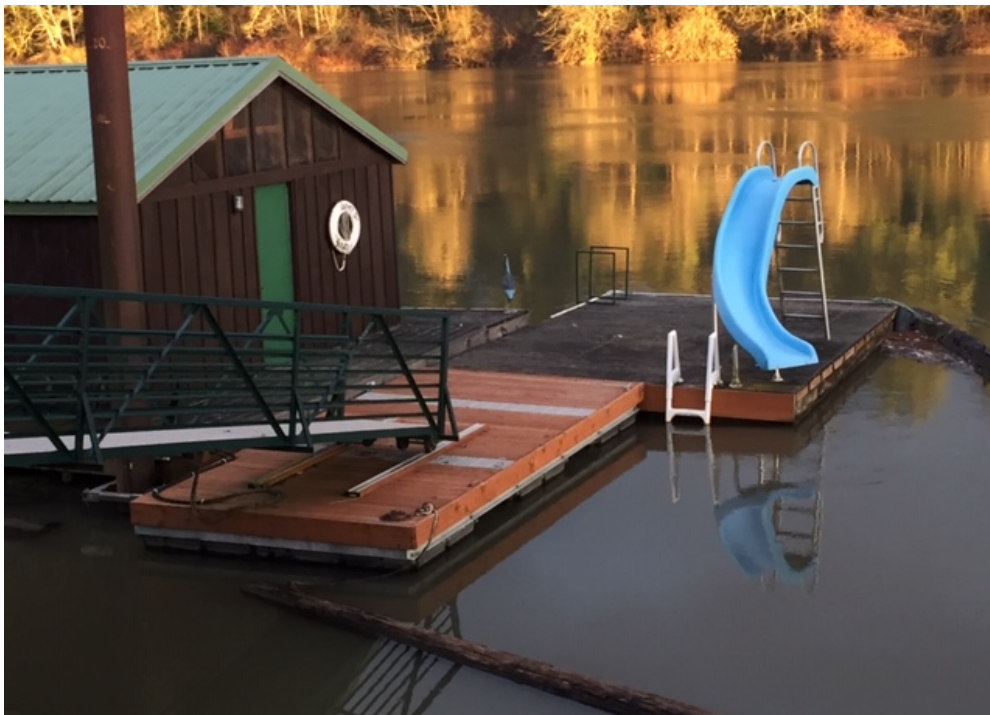
The first photo shows our float next to the boathouse. The lighter colored portion is the newer portion of what once was a single float. This was a single float when we purchased the property in 2001, and we believe for many years prior going back to when our previous owner had the boathouse installed in 1957. We do not know if there had been any repairs prior to our purchase.

In 2016, the float was broken, we believe in a large part, due to the high-energy wakes that have become a problem on this stretch of the Upper Willamette (River Mile 40). Because of the length of the original float being perpendicular to the high energy waves, and because the original float was not designed for this size wake, the spine of the structure was broken. To address the issue of the wake, instead of repairing the float to a single structure, we had the connection hinged to allow the two portions to move without a rigid structure. This seems to have worked since then, but the result is that when the big waves hit, it requires a lot of balance to stay upright when standing on either portion.

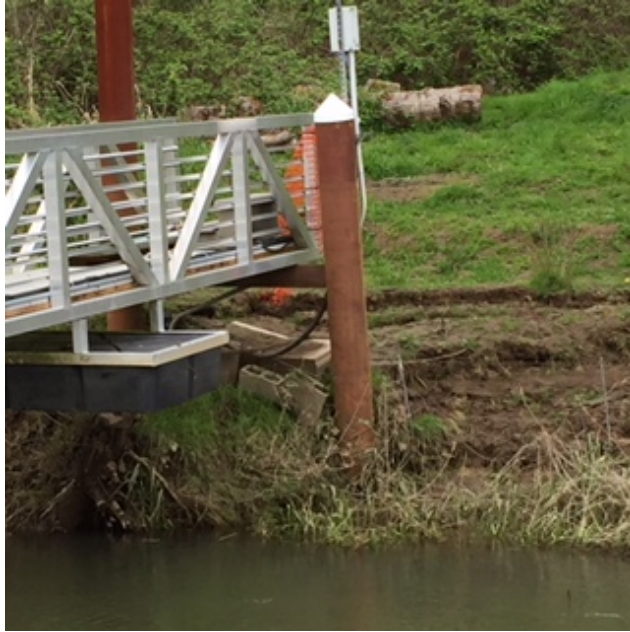
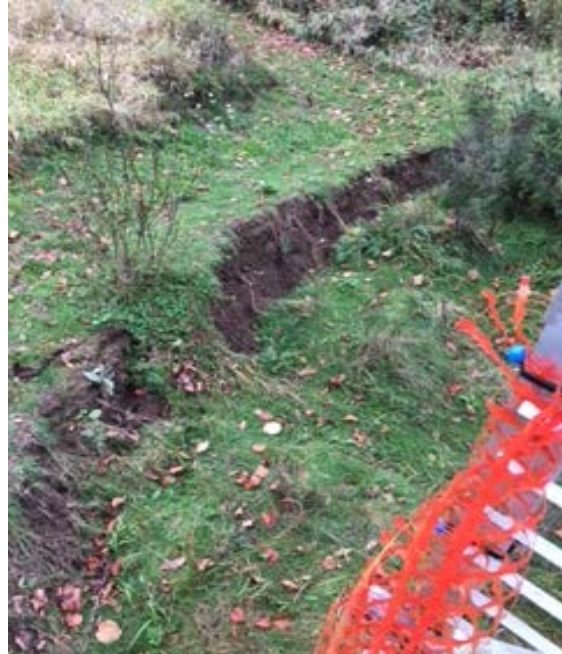
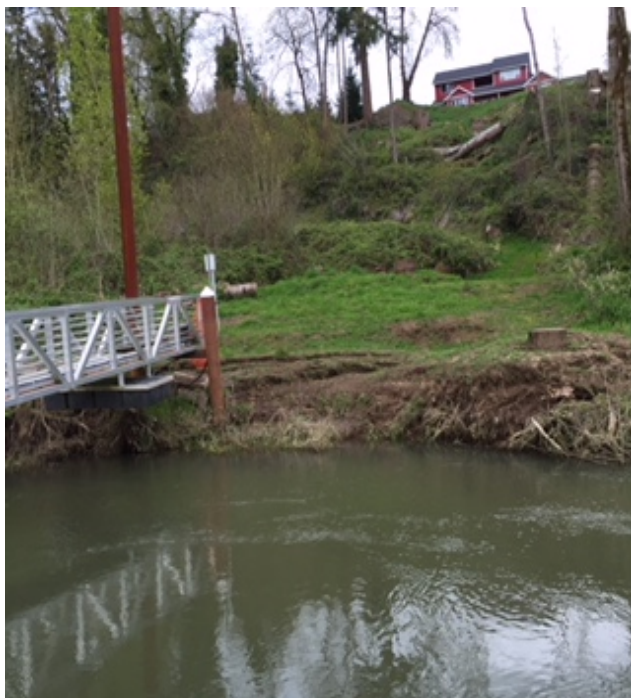
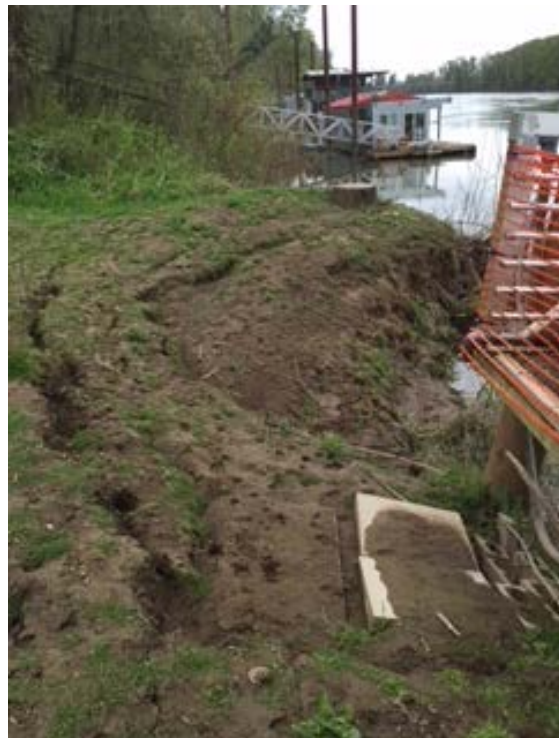
Photos of property shoreline and dock damage in the Dog Ridge area, followed by the Invoice to repair the damage.

**Hang ramp and cut crossbeam.  
Pull ramp pile and redrive.  
\$1,100.00 hourly rate covers tug, crane, 7 man crew and material  
barge.  
11:30 to 1:30**

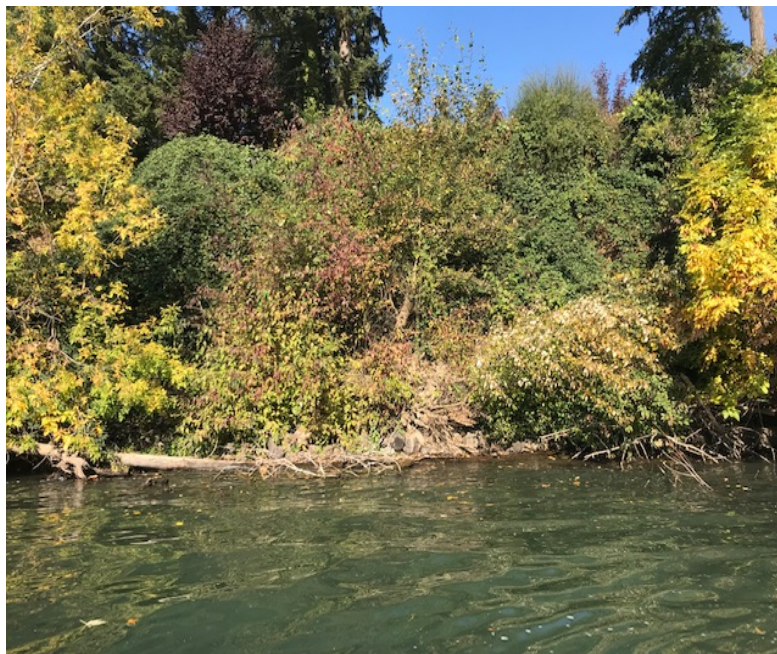
We have lived on the Willamette River since the beginning of 2003. In 2014, we began noticing undercutting along parts of our shoreline. As we were restricted by the state to place rip rap, we were left hoping for the best. Our situation was then complicated when our neighbors lost over 15 ft of their vertically sloping shoreline. As they felt their hands were tied by regulations, they chose to illegally dump \$30,000 worth of boulders over the top of their property onto the shoreline. The effects of doing this was not only significant to the fish & wildlife, but it also places the adjoining properties at greater risk because it changes how the water flows. In 2016, we had a vertical slide resulting in over 10 ft loss of embankment on the west side of our property due to the undercutting. This undercutting we attribute directly to high energy waves. Unfortunately, we did not get pictures before this occurred. On the east side of our property, we are now seeing a large cutout and we believe our ramp, stairs and deck are in jeopardy. We also attribute this to high energy waves. The boulders that were placed along our neighbors shoreline is causing the wave energy to flow back up when it hits all the rock. In 2017 we had an engineer do a site visit and we were told verbally that to remediate both areas would cost around \$150,000. We chose not to get this in writing for 2 reasons. First of all, the engineer said he would only work above the Ordinary High Water (OHW) Mark because of permitting issues with the State. We believe that working only above the OHW level is not going to permanently resolve the problem and the restoration work will be at risk due to high wave energy. Secondly, we also felt that once we had a written estimate, it would bring our property value down. This scenario is not unique to our family and is shared with many other landowners. We are literally between a rock and a hard place.

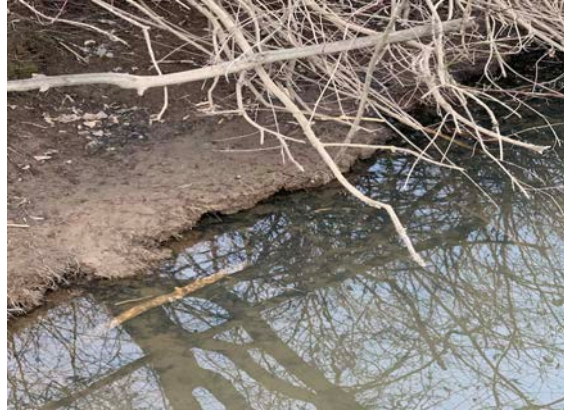
By Fall Of 2015, high energy wakes had repeatedly damaged our shoreline, dock and boat (tearing off cleats even with spring lines in place). We were faced with having to replace our entire dock and add a Hydro-Hoist boat lift to better protect our boat. The work was completed in late Fall 2015, for a total cost of \$47,125. Unfortunately, our shoreline continues to get undermined resulting in trees becoming unstable – either falling into the river or needing to be taken down before causing additional damage. See the attached letter from R&B Tree Services (Page 2 at the beginning of this Property Damage Report).

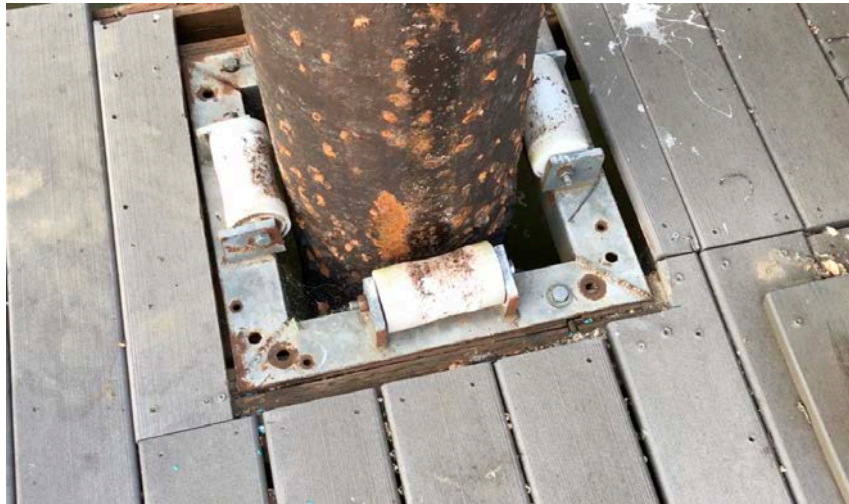
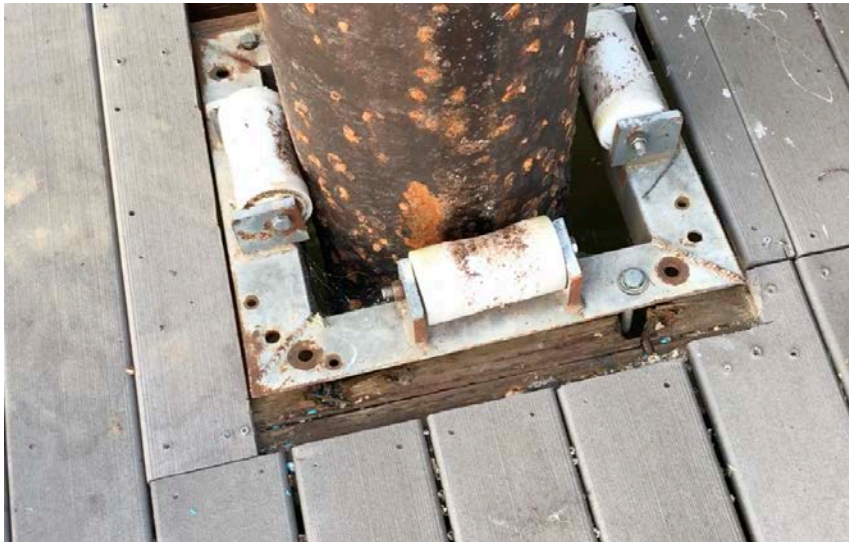
Bolts have continued to be re-drilled, as the force of the wakes slamming the dock against the fixed piling is pulling the “collar” away from the dock and the metal plate below it. Picture 1 shows the collar flat before a wake impacts it. Picture two shows how the entire plate pulls away from the dock when a large wake hits the dock. The cost of repairing this is around \$1,000 per year. The entire system needs to be replaced. The decking on our dock is just a couple years old.
