Testimony in Support of the Dayton Street Bridge Replacement Project

Re: Falls City Pedestrian Bridge over Little Luckiamute River Special Inspection
DOWL Job No. 2870.80850.01

Bridge Inspection Report

REPAIR EXHIBIT

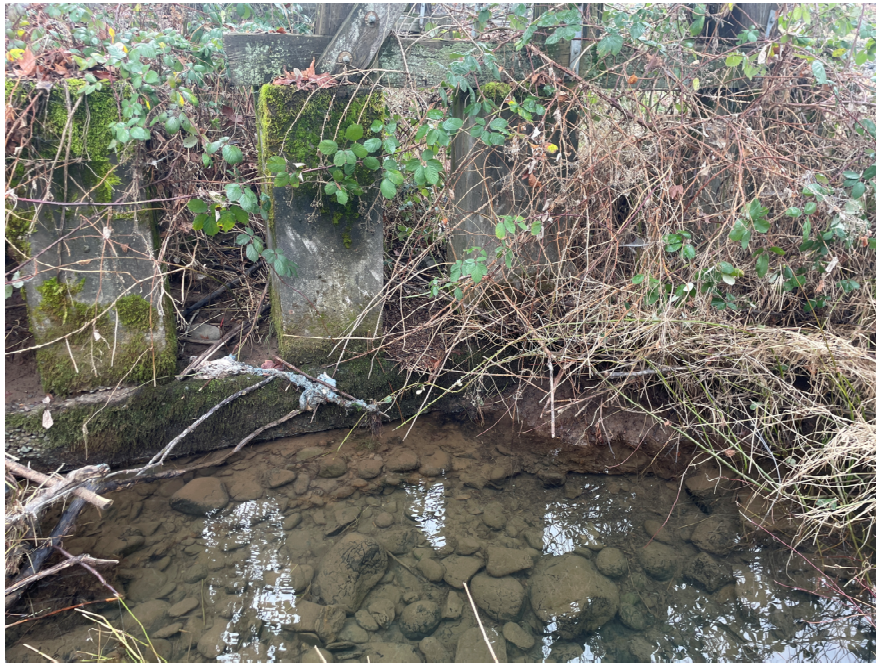
The bridge foundation consists of timber columns supported by concrete spread footings with timber caps and sills. Many of the timber members are in very poor condition with large amounts of decay. The concrete spread footings are mostly exposed, with bents 3, 4, and 5 within the active channel flow. Bents 3 and 4 are heavily abraded exposing the large aggregates in the concrete. The bent 5 footing appears to be slightly undermined along the stream side. All of the footings appear to be founded on erodible river rock materials.

Bent 5 Footing Undermining

| <u>Element</u> | <u>Note</u> |
|---|---|
| 6000 | Bent 3, 4 and 5 footings are fully exposed. Bent 5 footing is slightly undermined along the river side up to 6-feet long and penetrates under the footing by 8-inches. Footing founded on erodible gravels. Bent 4 footing unable to access due to water level. |

| <u>Priority</u> | <u>Element</u> | <u>Maintenance</u> | <u>Est. Cost</u> |
|---|---|--|---|
| Urgent | 221 | Mitigate Scour | \$50,000 |

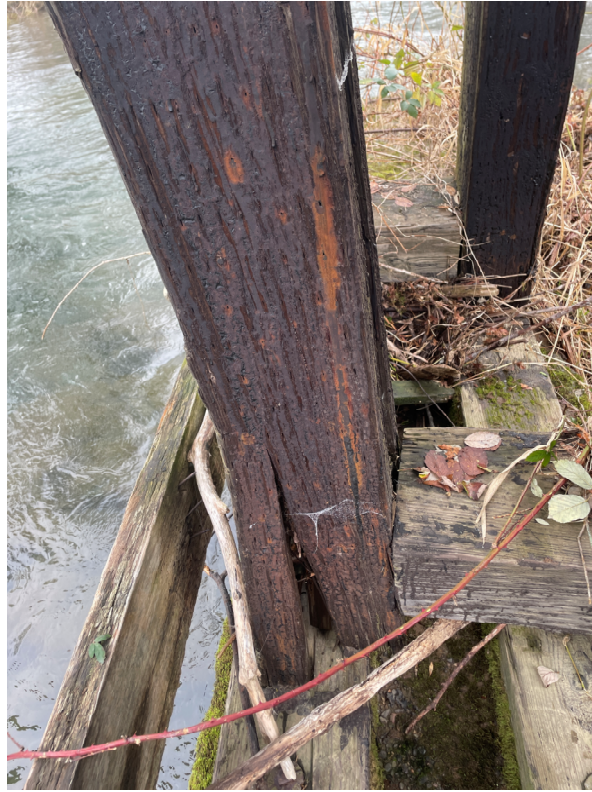
The timber columns are in very poor condition with many being a 1-inch shell. Most of the decay is located in the bottom portion of the column. The middle column at bent 4A appears to be heavily decayed and had been struck by drift shifting the column to the north. Due to this movement, the middle column at bent 4B has also shifted approximately 8-inches and has lost 75% of its bearing.

Bent 4A Middle Column Broken

| <u>Priority</u> | <u>Element</u> | <u>Maintenance</u> | <u>Est. Cost</u> |
|---|---|--|---|
| Critical | 206 | Replace Decayed Columns | \$150,000 |

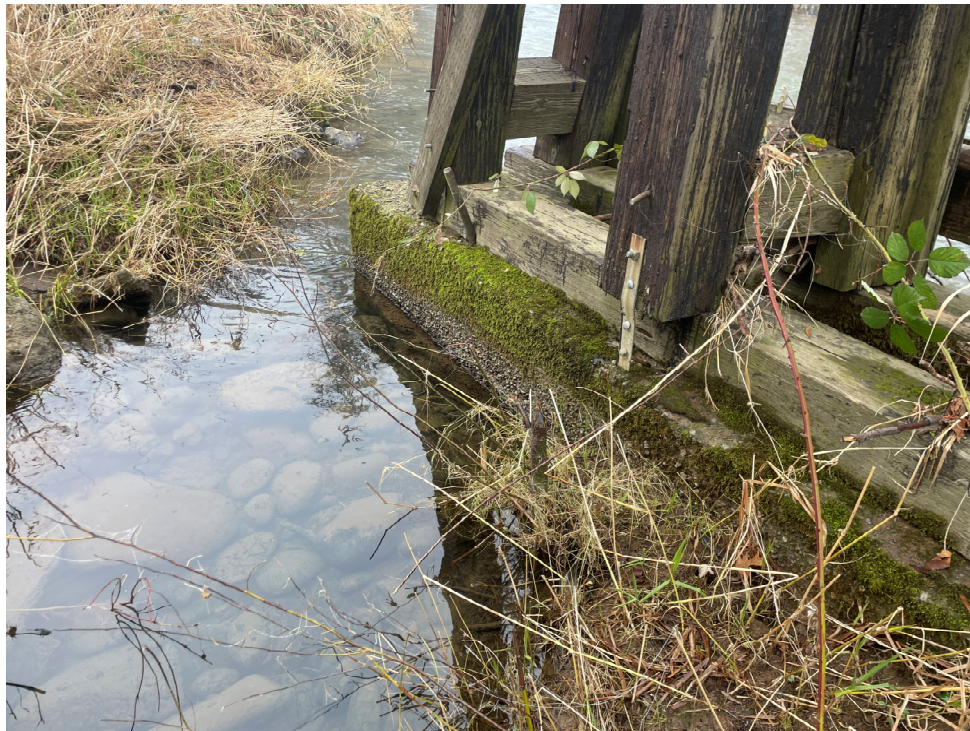
Bent 4B Middle Column Loss of Bearing

| <u>Element</u> | <u>Note</u> |
|---|---|
| 2240 | Bent 4B middle column has been shifted 8-inches towards bent 5 causing the column to only have 25% bearing on the timber sill. |
