# Use and Effects of Studded Tires on Oregon Pavements

BRUCE E. BRUNETTE AND JAMES R. LUNDY

The use and effects of studded tires in Oregon are investigated, updating a 1974 report. Studded-tire use was surveyed, rut measurements collected, studded-tire traffic estimated, and pavement wear and damage analyzed. Studded-tire use in Oregon varies geographically. Half of the vehicles equipped with studs use them on all wheels, representing a significant change from 1974 practices. More than 23 percent of vehicles used studded tires in 1994. Studded-tire pavement wear coefficients were calculated and found to be half those reported previously. The coefficients for rigid and flexible pavements are 0.20 mm (0.008 in.) and 0.86 mm (0.034 in.), respectively, per 100,000 studded tire passes. Studded-tire wear will shorten pavement life on high-volume routes in Oregon. Asphalt pavements experiencing average daily traffic (ADT) volumes of 35,000 and 20 percent studded-tire use will reach the threshold rut in 7 years. Portland cement concrete (PCC) pavements experiencing 120,000 ADT and 20 percent studded-tire use will develop the threshold rut depth of 19 mm in 8 years. These estimates substa

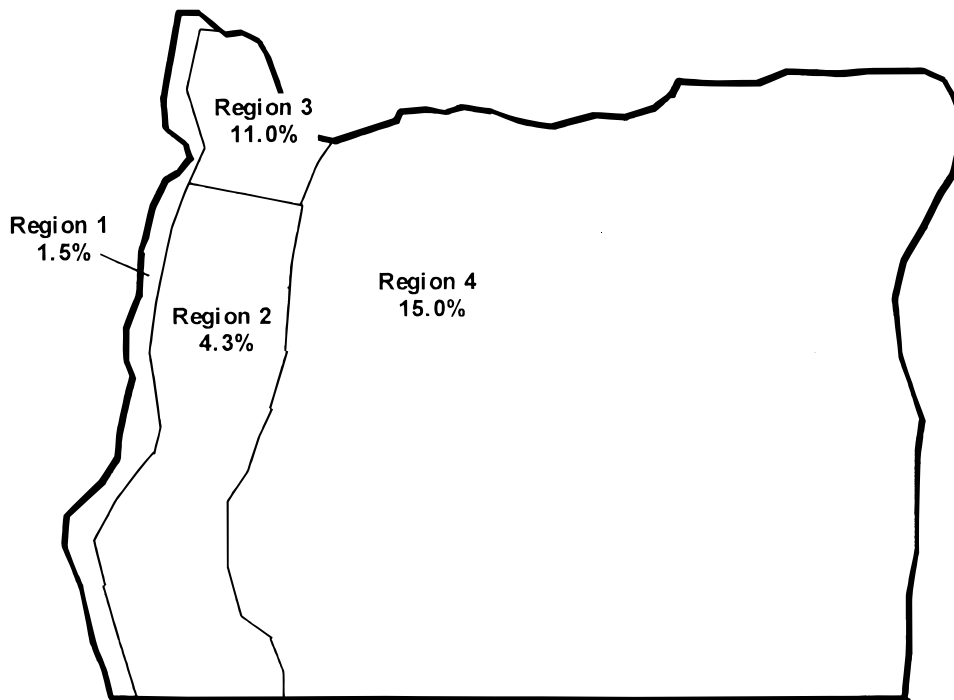
FIGURE 1 Historic Oregon studded tire use rate, reported in 1974 (3).

ODOT research efforts culminated in the publication of an internal document (3) in 1974 that reported that the use of studded tires varied by region (see Figure 1). In 1974, the statewide average of studded-tire use was 9.2 percent. The report also documented that almost all vehicles equipped with studded tires used them on only one axle, typically the drive axle.

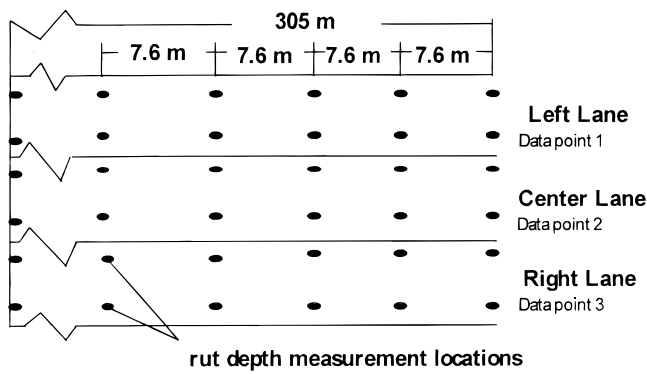
FIGURE 2 Rut depth measurement technique.

All the rut depth information for the project was obtained from manual rut measuring techniques. The manual measurements involved the use of a 1.2-m-long (4-ft-long) aluminum channel straight edge, equipped with a single brass or steel dowel. The dowel is machined to allow free vertical movement, perpendicular to the straight edge, and is calibrated to measure the depth of rutting to the nearest 1.6 mm ( $\frac{1}{16}$  in.). A maximum rut depth was recorded for each wheel track and a paint dot applied to the pavement for each travel lane. The purpose of the paint dot was to mark the location of maximum rut for each wheelpath, which then could be used as a reference for recording the center-to-center distance between wheel tracks. The center-to-center distance was further used as an aid to identify the vehicle type causing the rutting.

Another rut measurement approach involved manual measurements of pavement rutting at 7.6-m (25-ft) increments, for a total distance of 305 m (1,000 ft). Because both wheelpaths were mea-

sured in each lane, a total of 80 measurements were obtained for each lane in the 305-m-long (1,000-ft-long) pavement segment. The 80 measurement points were averaged for each lane as the representative rut depth. Because the traffic distribution, rut depths, and number of studded tire passes are unique for each lane, each lane represents a distinct data point that can be compared with all others in regression analysis. Based on this premise, several data points may be established at any one measurement site. Figure 2 portrays the methodology.

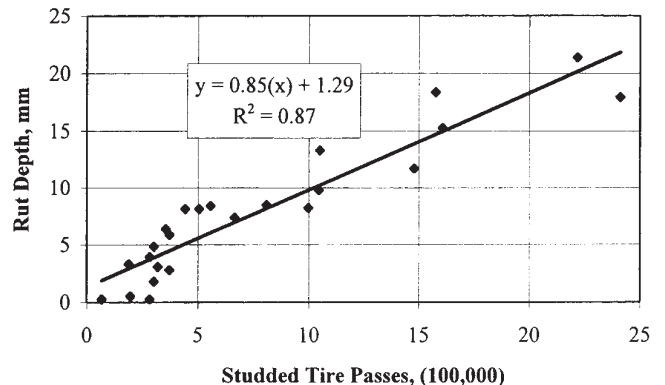
**FIGURE 3 Asphalt studded tire wear rate results.**

Figure 3 portrays the linear regression results for asphalt. The linear equation explains 87 percent of the variability in the data. The  $Y$  intercept, in part, reflects a higher initial wear rate for asphalt mixes. A lower rate of wear is reached within the first few hundred thousand studded-tire passes. Once the higher initial wear value is overcome, the average wear value for asphalt is 0.86 mm (0.034 in.) per 100,000 studded-tire passes.

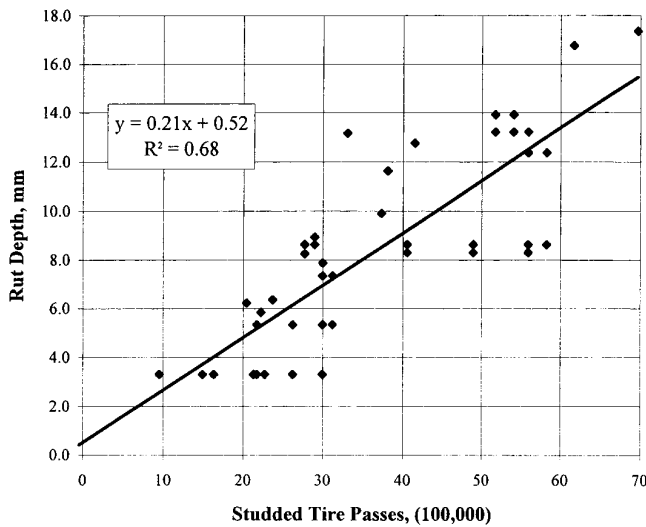
FIGURE 4 PCC studded tire wear rate results.

Figure 4 depicts the linear regression results for PCC pavements and explains 68 percent of the data variability. More scatter exists in the PCC data due in part to the age of some of the sections. It was necessary to extrapolate nearly 30 years of traffic and studded-tire use rates. This undoubtedly affects the quality of the data. The slope of the best fit line was 0.20 mm (0.008 in.) per 100,000 studded-tire passes.

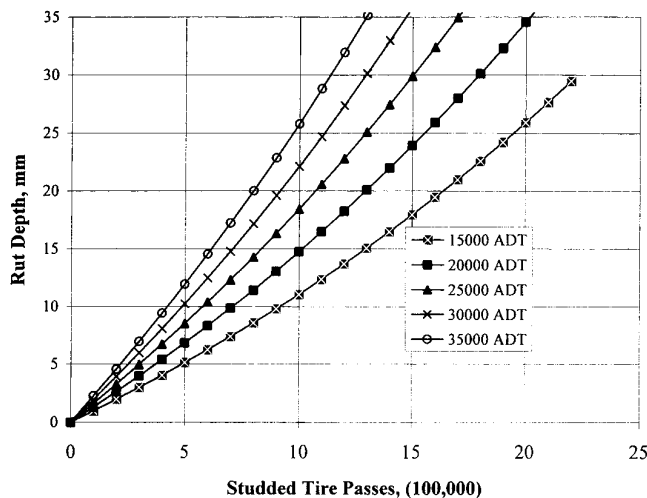
**FIGURE 5 Asphalt studded tire rut depth as influenced by ADT.**

lished by this study and assuming a constant 20 percent (rather than the actual statewide value of 23 percent) studded tire use rate. To simulate situations found in Oregon, traffic growth, percentage of cars, seasonal percentages, lane percentages, and other typical conditions were factored into the analysis. The pavement structures considered included a four-lane asphalt facility and a six-lane PCC pavement. Traffic volumes were varied to determine trends in studded tire surface wear and the time required to reach the 19-mm (3/4-in.) rut depth threshold.

wear substantially shortens the time to reach the threshold rut, reducing pavement life expectancy. At traffic levels equivalent to 35,000 ADT, the time to reach the limiting rut is about 7 years, or one-half the design life expectation for asphalt.

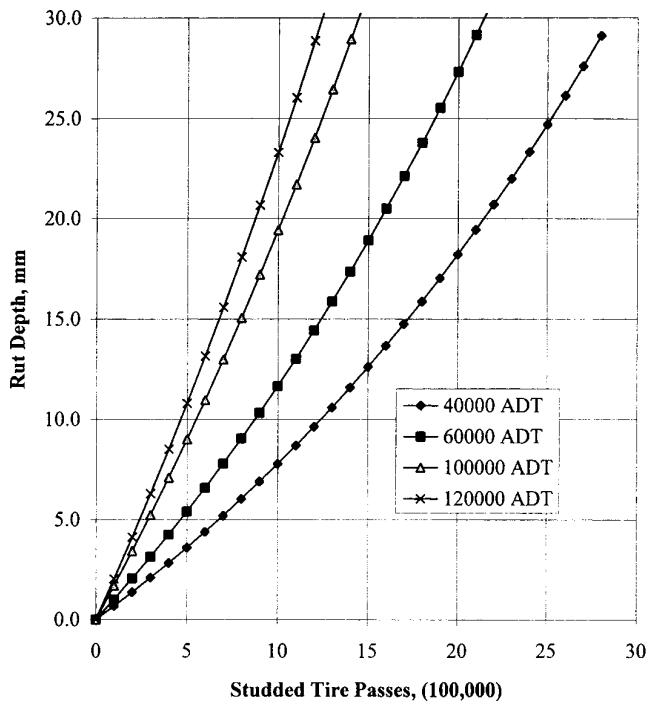
FIGURE 6 PCC studded tire rut depth as influenced by ADT.

The results for PCC pavements are portrayed in Figure 6 and illustrate a similar pattern. Based on the scenarios generated, a 24-year life is consistent with traffic volumes less than 40,000 ADT. At traffic levels of 120,000 ADT, such as that experienced in the Portland area, the estimated time to reach the threshold rut is less than 10 years.
