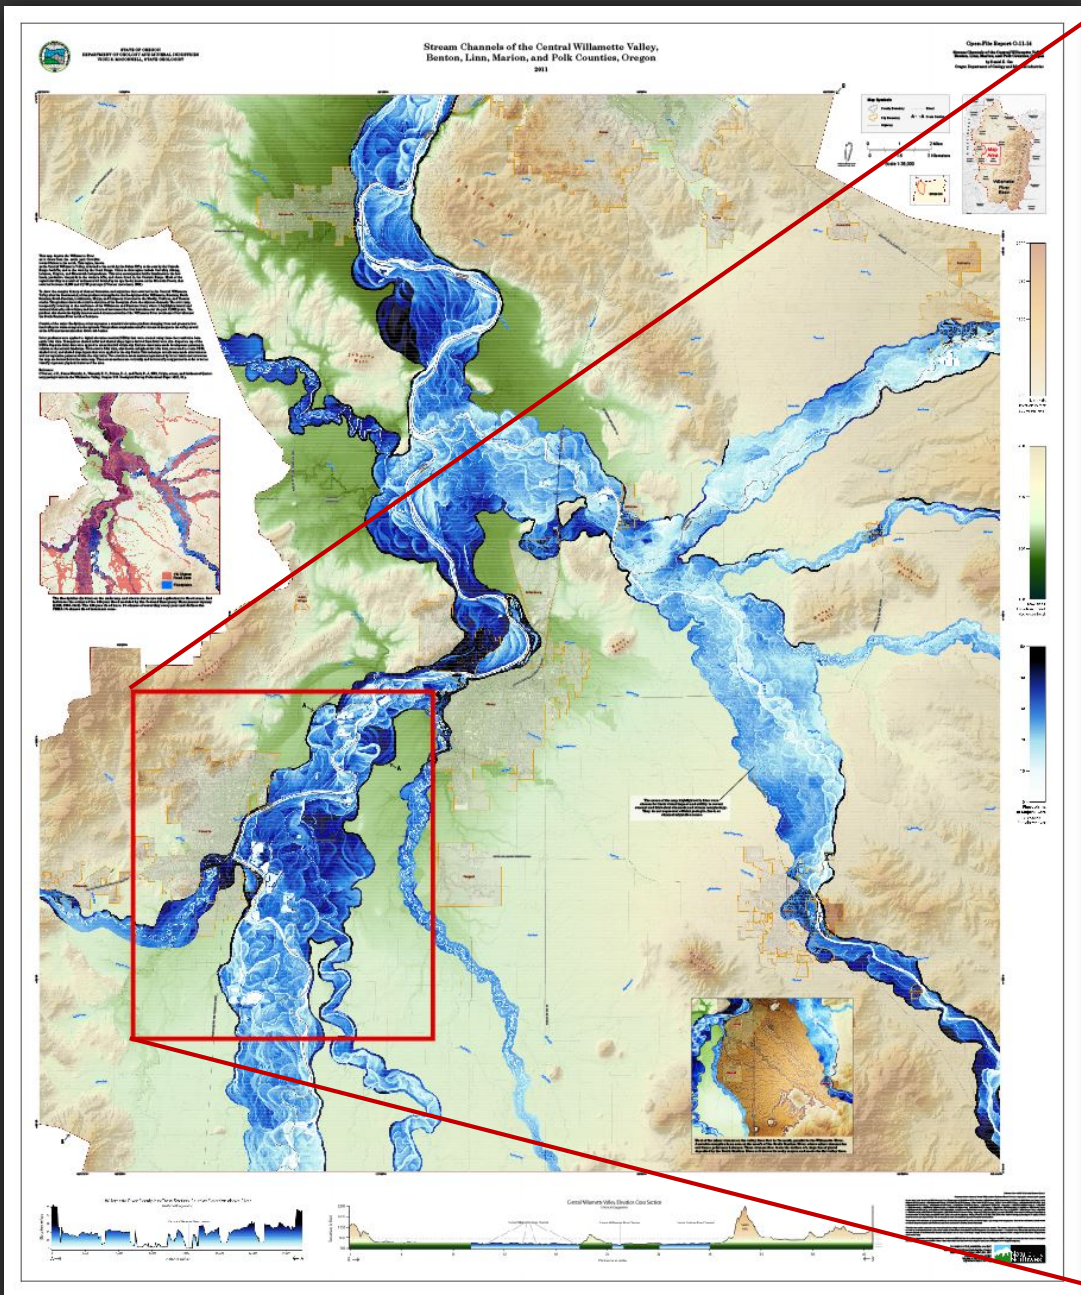
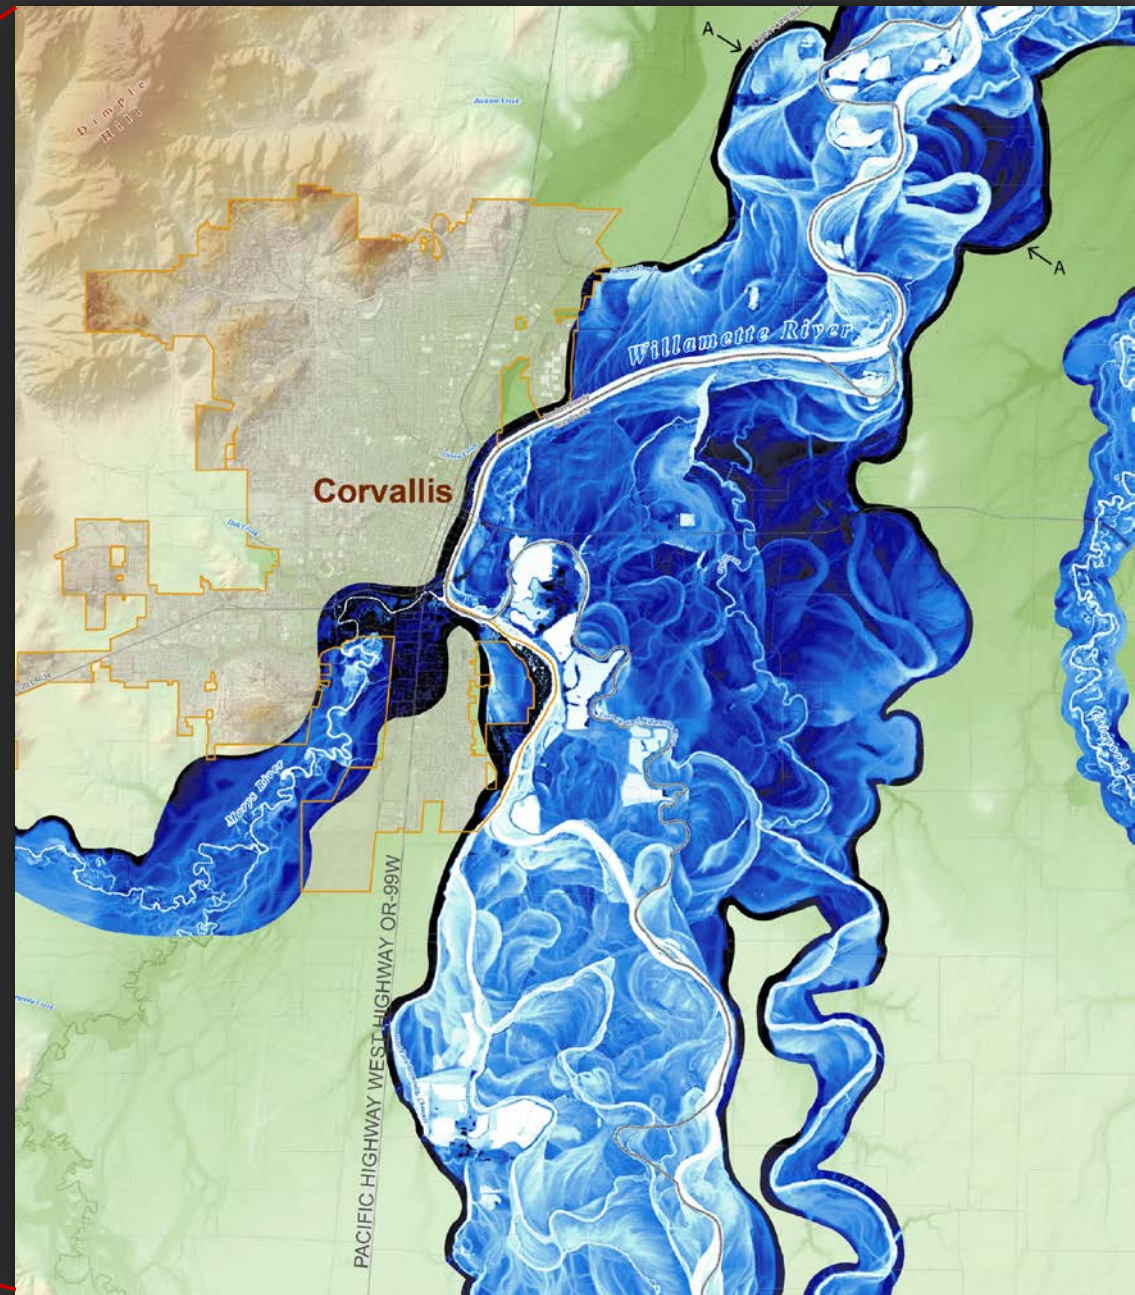
Figure 1: Example of historical channel features visible in lidar imagery. Full image (left) and enlarged excerpt (right) from DOGAMI Open-File Report O-11-14, Stream channels of the Central Willamette Valley, Benton, Linn, Marion, and Polk Counties, Oregon (<https://www.oregongeology.org/pubs/ofr/O-11-14.pdf>)

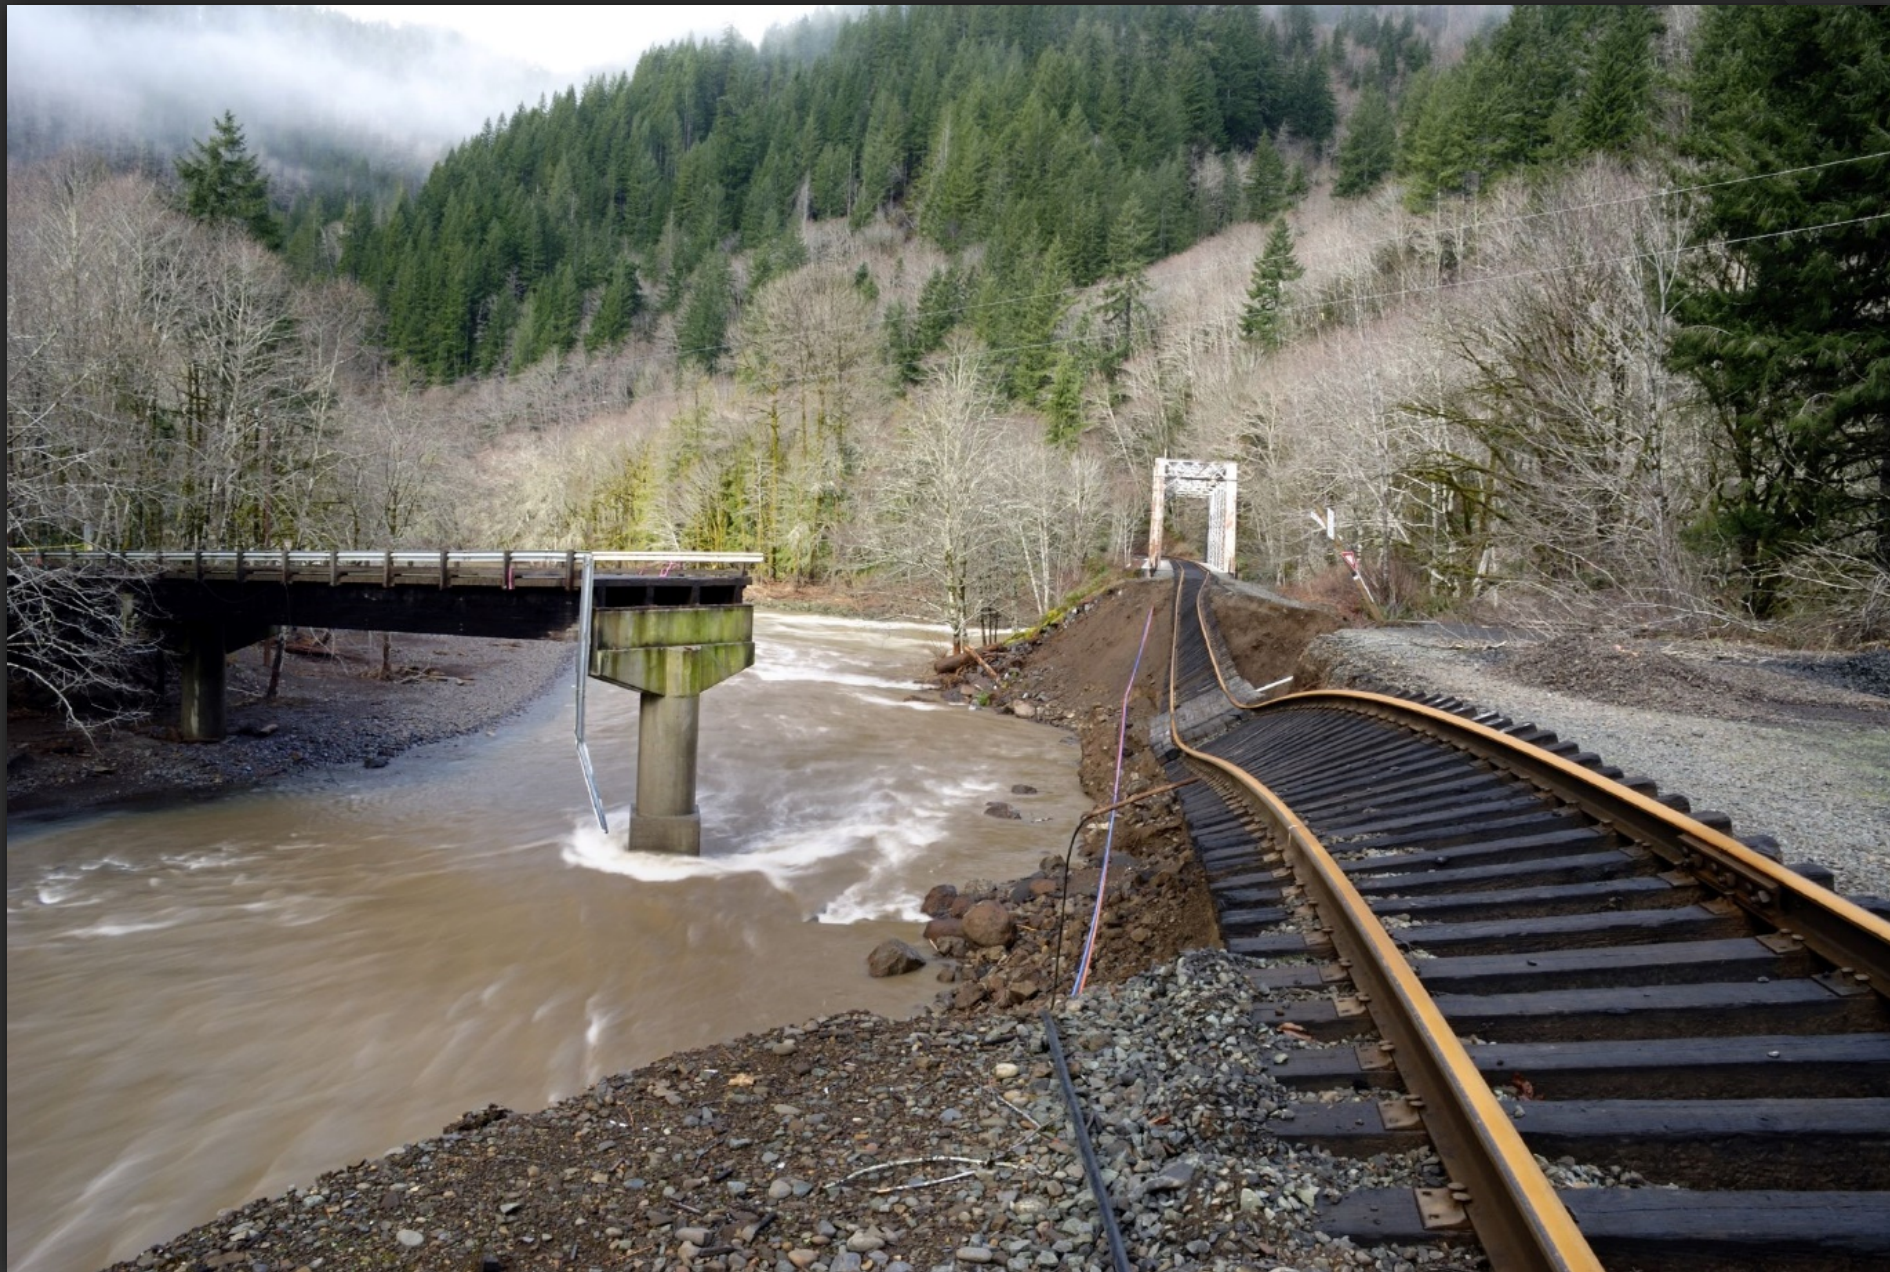
Figure 2: Damage to the Port of Tillamook Bay railroad from channel migration of the Salmonberry River
(Courtesy Chris Updegrave, 2/9/2008, <https://www.flickr.com/photos/cupdegrave/2253462031/in/photostream/>)
