# Channel incision causes floodplains to dry

# Borland (and Lane's) Balance – what can cause a channel to erode?

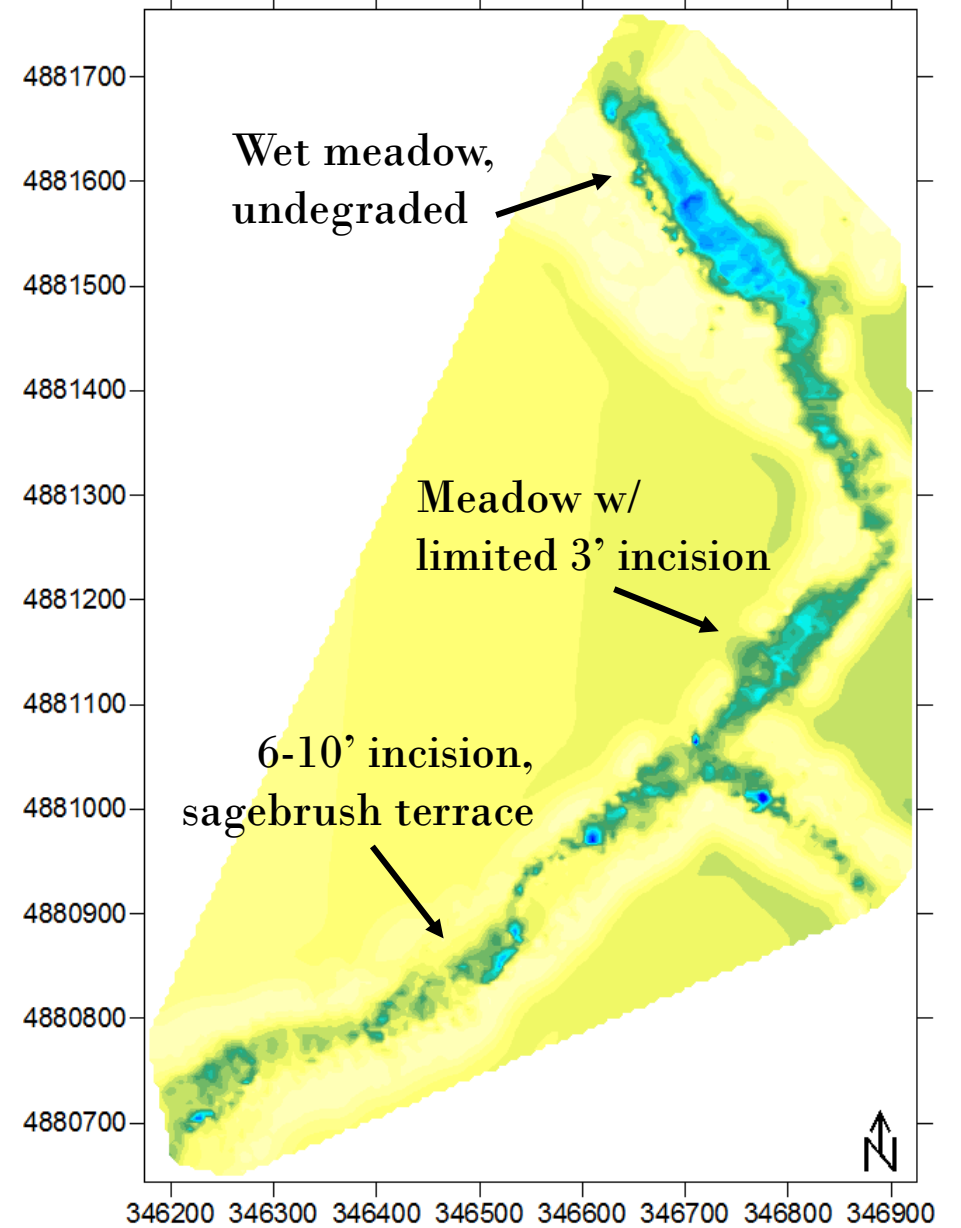
Electromagnetic Induction on Cottonwood Creek

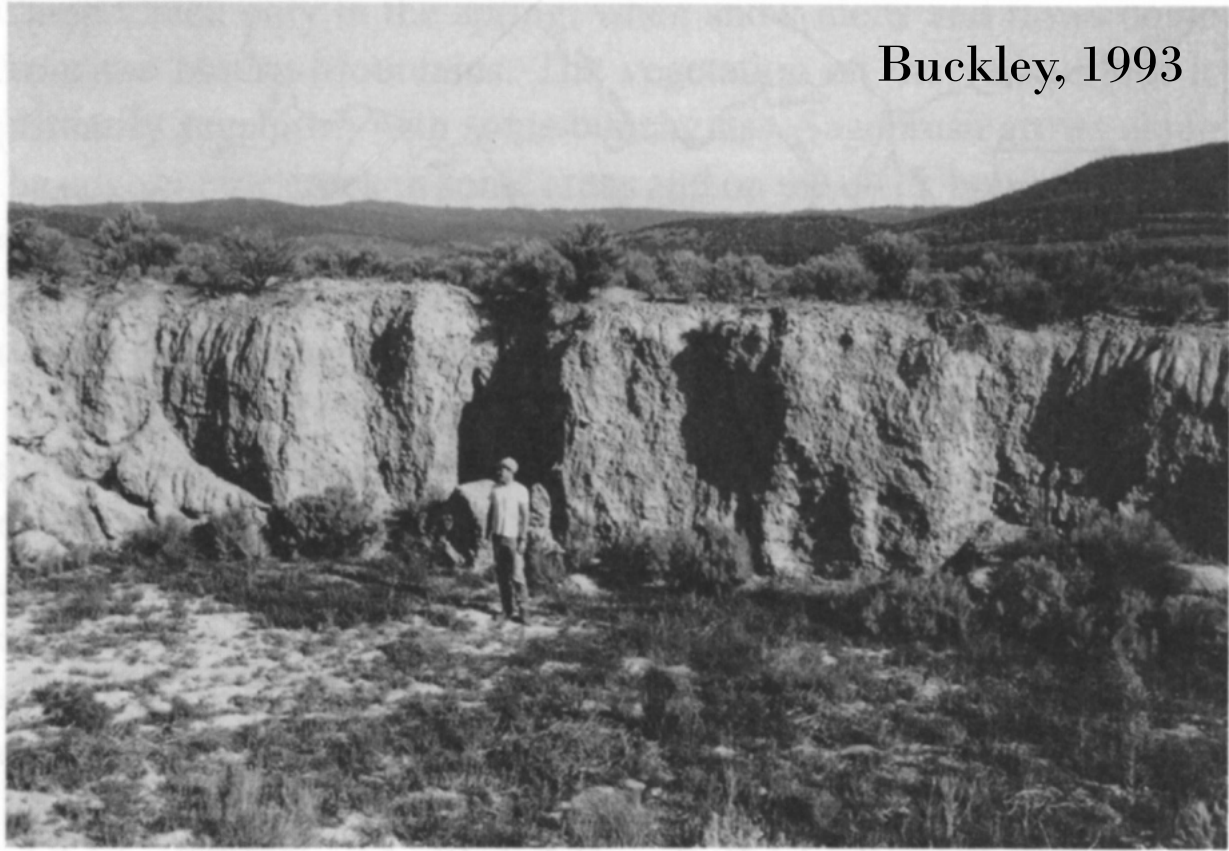
near Izee, Oregon  
2015

Historical floodplain (now a terrace)

Modern floodplain

~20'

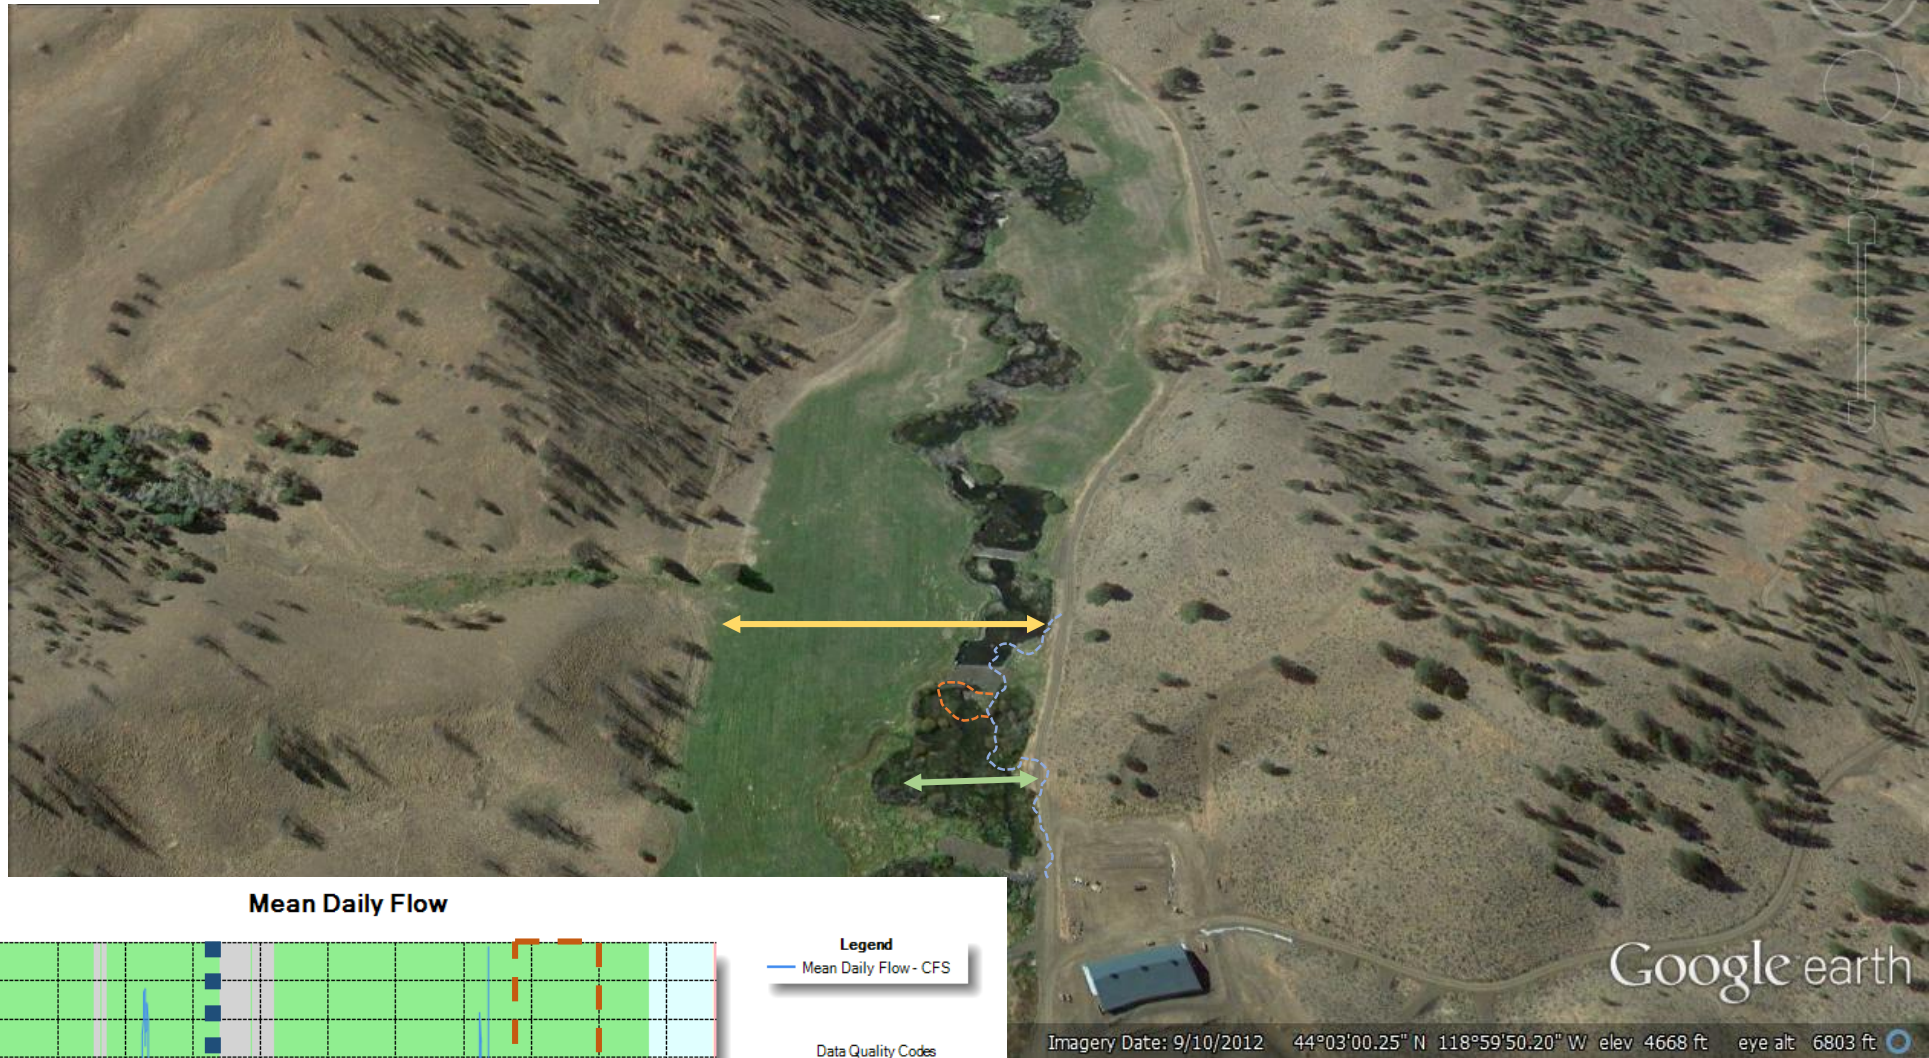
*Camp Creek  
Silvies River Basin, OR*

September 10, 2012

Mean Daily Flow

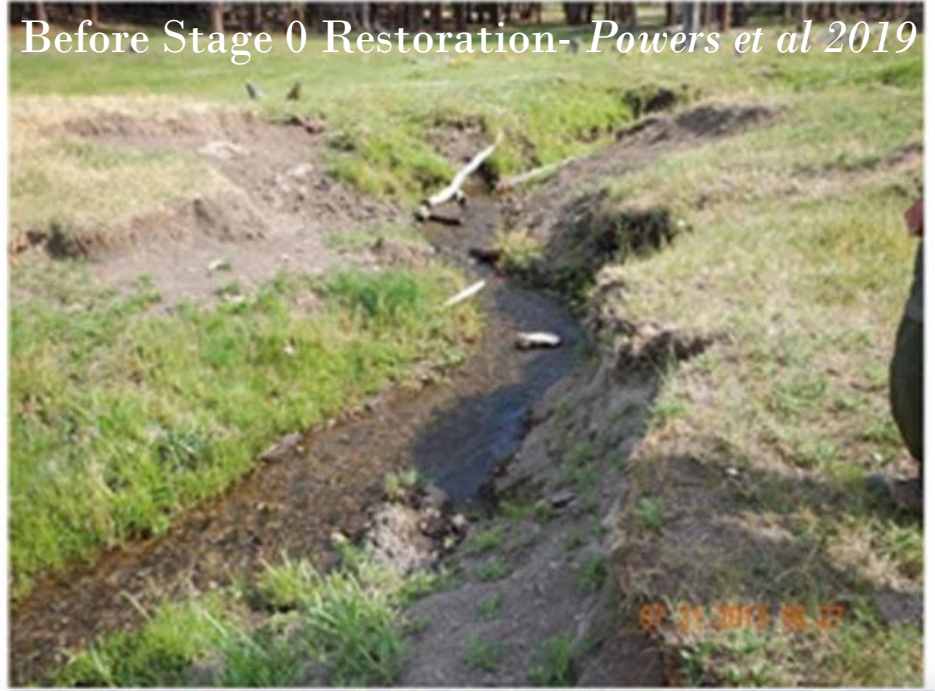
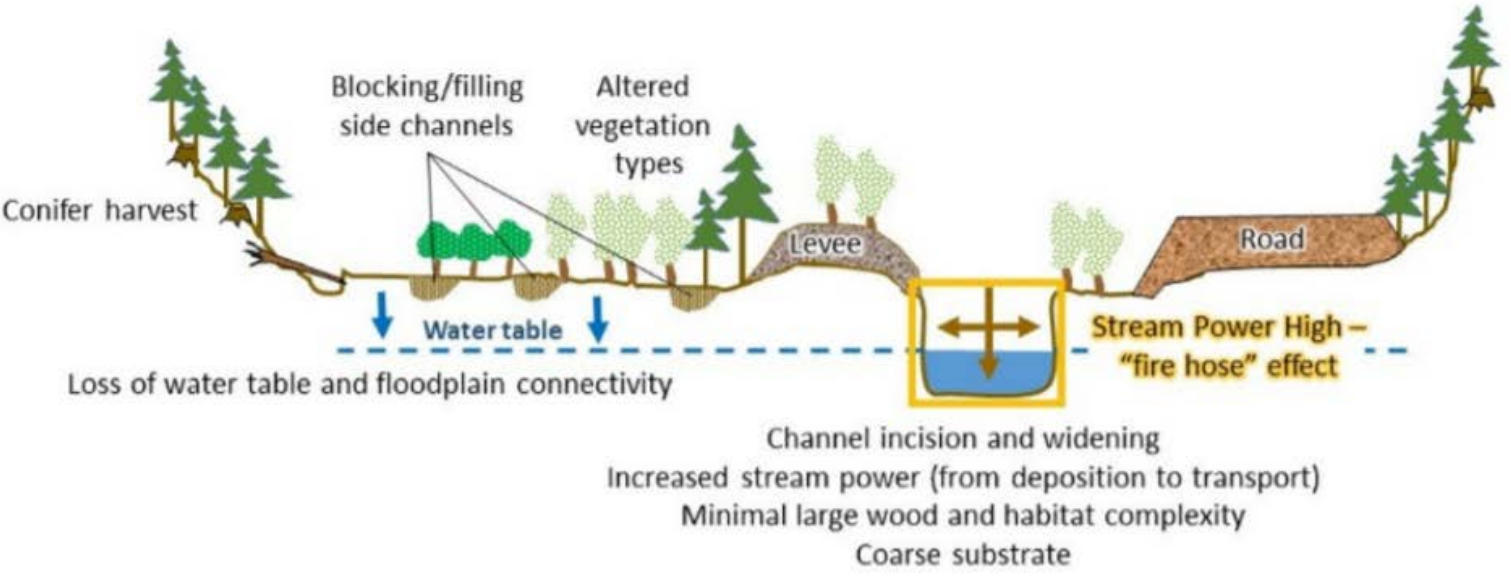
Before Stage 0 Restoration- Powers et al 2019

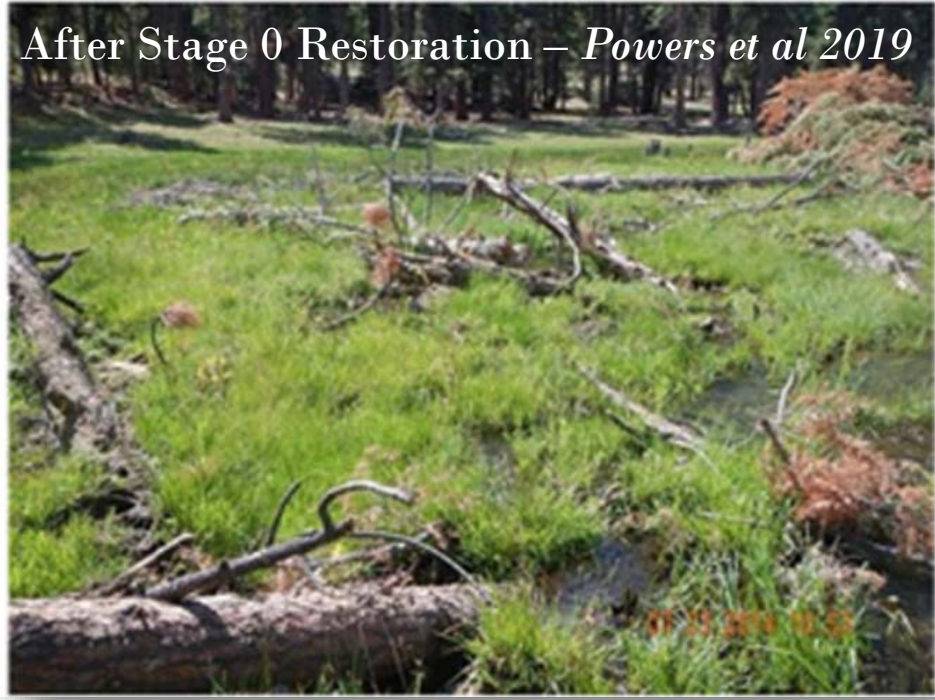
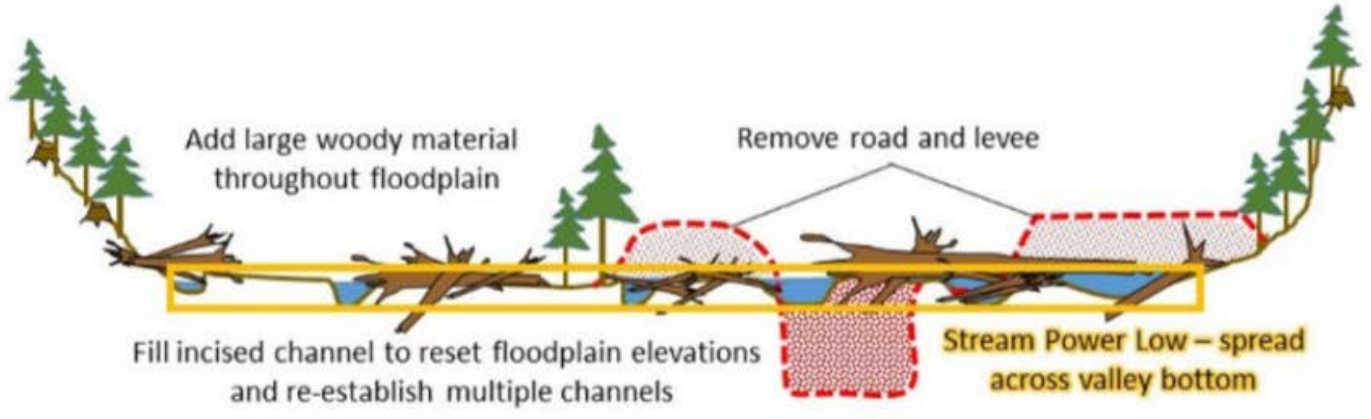
After Stage 0 Restoration – Powers et al 2019
