Red Clover/McReynolds Creek Restoration Project Monitoring Report 2010

**Feather River Coordinated Resource Management
Plumas Corporation
Spring 2011**

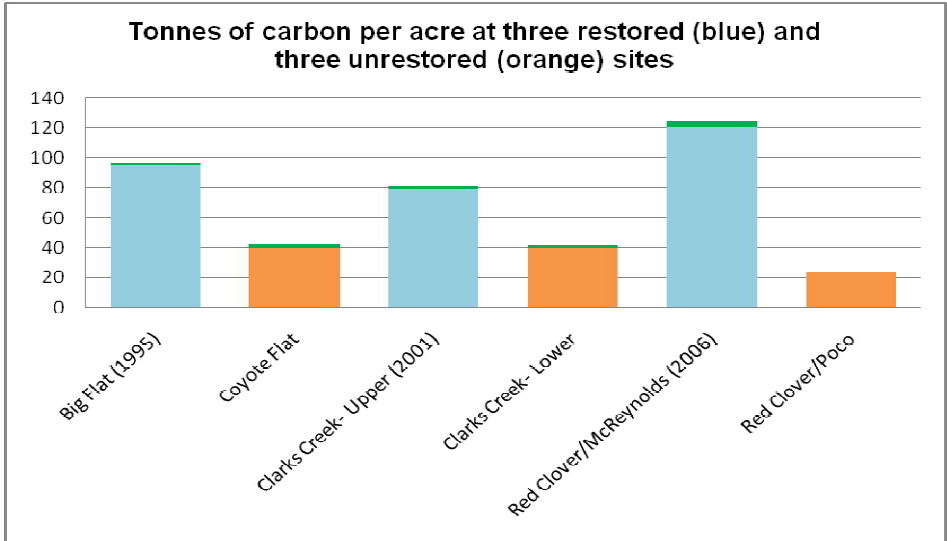
Figure 8. Metric tons of carbon per acre in each sample meadow. Green at the top of each column represents aboveground biomass carbon.

The columns in Figure 8 are arranged so that loosely comparable sites are next to each other, with the construction date given for the site treated with pond-and-plug. Big Flat and Coyote Flat are both in the Last Chance drainage, three miles apart from each other. The two Clarks Creek sites are on the same creek, less than one mile from each other. The Red Clover Poco site is two miles downstream of the Red Clover McReynolds site. On average, the restored meadows show a 177% increase in total carbon per acre over the unrestored meadows. Figure 9 demonstrates that the largest difference for carbon occurred below ground within 12 inches of the meadow surface, where most of the carbon is present for both restored and unrestored meadows.

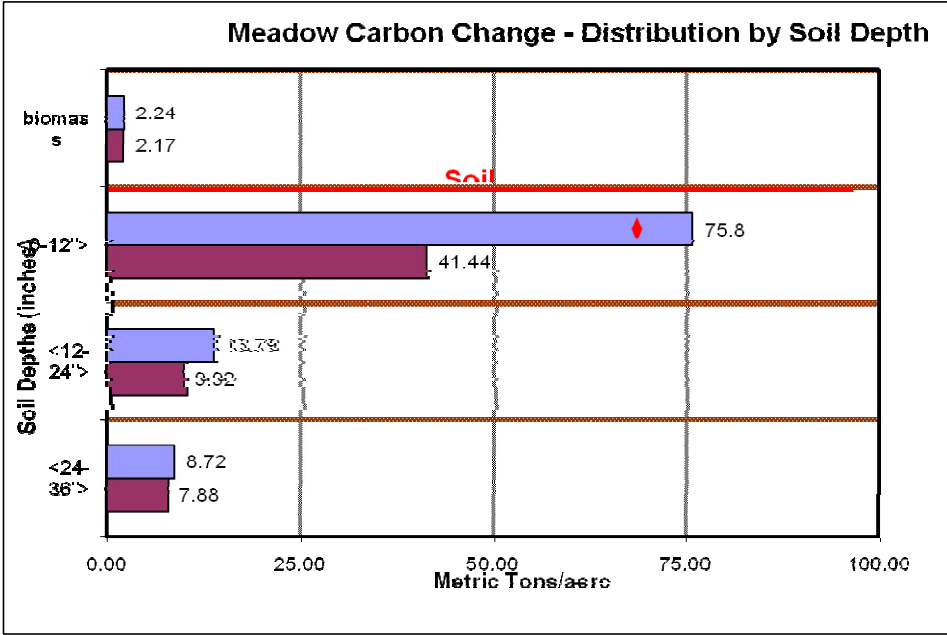
Figure 9. Total metric tons per acre of carbon in restored (blue) and unrestored (maroon) meadows displayed by depth. The soil surface is shown as a red line.

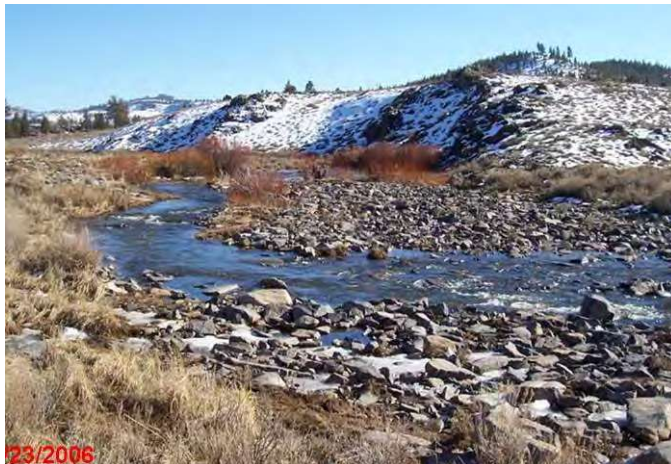
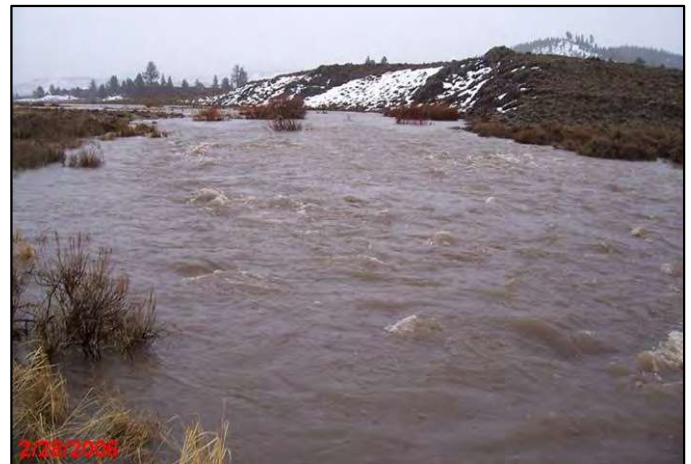
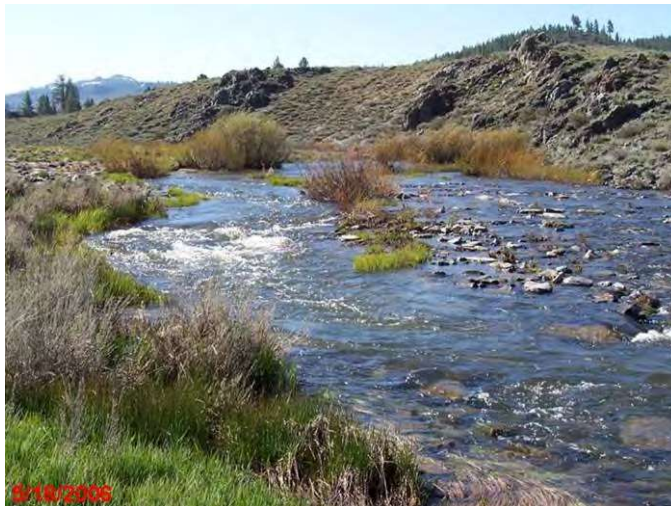
Figure 10: Alkali grade control structure on Last Chance Creek demonstrates the stability of the current design method during a flood in spring 2006. First photo is February 23, 2006, second photo taken on February 28, and third photo in May 2006. Note in the first and third photos that low flows remain in the constructed riffle-pool base flow channel after the flood. (Photos: Jim Wilcox)

The CRM's design for these structures has changed considerably since earlier projects such as the Willow Creek project. Current grade control structures are built to be long spillways with no more than a 5% slope. The low flow channel is constructed within the spillway to confine base flows to a narrow channel that is fish-passable. The low flow channel meanders over the spillway so that its effective slope is less than 3%-4%. Riffle-pool sequences are built within this channel to dissipate flow energy and to aid fish passage. The structure is built with a soil core that is mixed and armored with a 3-4 ft thick layer of soil and small rock intermingled with large rock (typically 2-3 feet in diameter). Willow and sod transplants are installed on the soil and rock mixture to improve shading and habitat on the structure and to further resist flow erosion. The dense root system of these plants further binds and strengthens the structure.

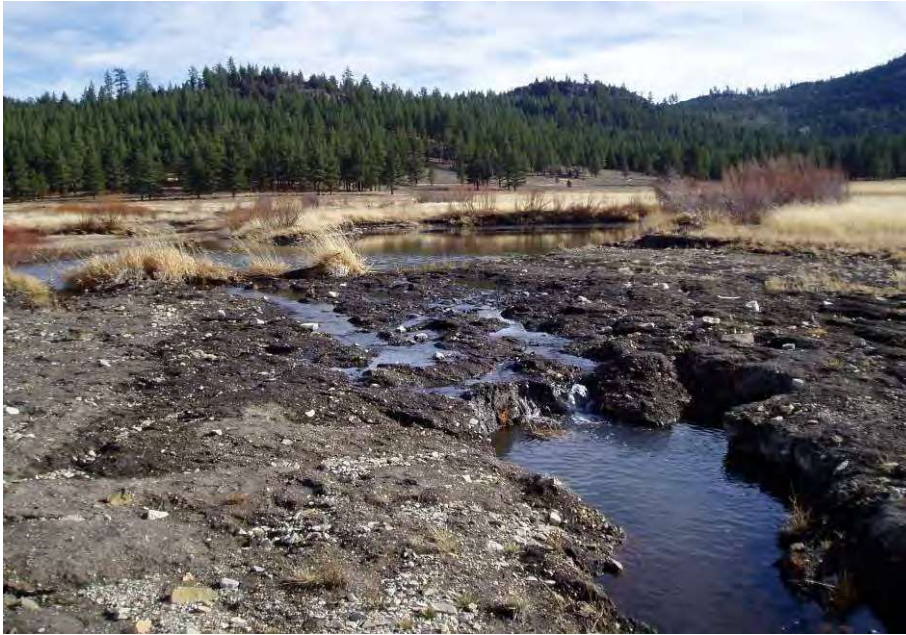
Figure 11: Excessive flow over this plug on Last Chance Creek at Jordan Flat during the 2006 floods caused the base flow to be diverted over the plug. Excessive flow was due to unforeseen dynamics between Last Chance Creek and a tributary stream. A berm was constructed and the problem corrected in 2007. Excessive flow over plugs could headcut through the entire plug, lowering the upstream pond elevation to the elevation of the downstream pond and essentially doubling the head on the next upstream plug. (Photo: Joe Hoffman)

If flow over a plug were to cause a nick point, that nick would usually occur at the downstream edge of the plug because the flow elevation drops abruptly at this edge, from the elevation of the pond upstream of the plug to the elevation of the downstream pond, potentially resulting in turbulent, erosive force at this edge of the plug during a large flood. The downstream edge of a plug with a small change in flow elevation (less than 0.5 ft to 1.0 ft) will be subjected to less erosive force than a plug with a larger change in base elevation and will thus be less likely to form a headcut. If a plug were to have concentrated flow that eventually cut through the entire plug, the plug immediately upstream would now have its head essentially doubled, placing further stress on that plug.

An abrupt drop at the downstream edge of plugs is susceptible to cutting during flood flows and can be ameliorated by sloping the surface of the plug. Again, this mitigation would be more difficult to achieve on plugs subjected to a larger difference in elevation of adjacent ponds because the slope of the plug surface would be steeper and shear stress due to flow

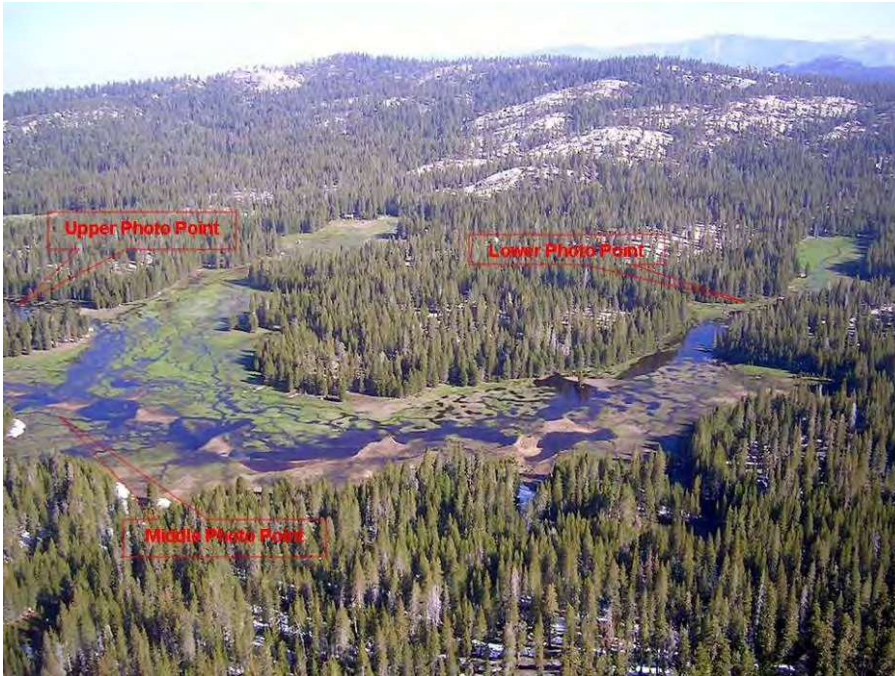
Figure 12: Big Meadows Pond-and-Plug Project, Sequoia NF. Project was constructed in fall 2007. Photo taken in spring, 2008 during the first runoff season. (Photo: Wayne Luallen)

A significant test of the integrity of plugs located within the floodplain during large flows occurred on the Big Meadows project on the Sequoia NF (Wilcox 2010b). Several of the design elements discussed above to reduce risks associated with flood flows on plugs were incorporated in the Big Meadows project (constructed in 2007, Figure 12). In October 2009, the project area was subjected to a high volume, high intensity precipitation event with over 8 inches of rain falling in less than 20 hours. Post-event field observations and stream gage records from the Kings River watershed indicated that flow through the project peaked at approximately 1200 cfs, estimated to be the flood with a 50- to 100-year return interval (i.e. a 1% - 2% chance of occurring in any given year). Post-flood observations indicated that all project plugs sustained some overland flow. Despite flood depths on the plugs of up to 2 feet and estimated flow velocities of up to 3.5 feet per second, no headcut was observed on any plug and very little mobilization of surface soil particles was observed.

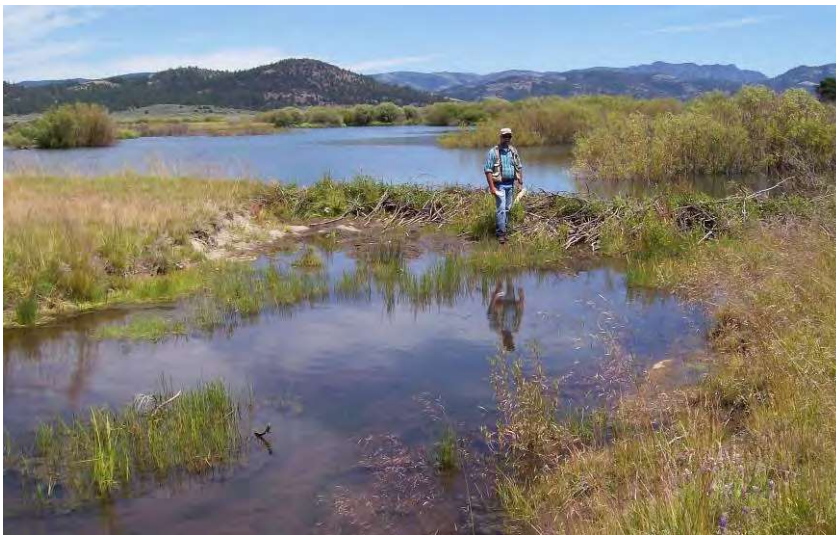
Figure 13: At the Red Clover – McReynolds Project, flow had cut through a plug shortly after construction due to damming of the designed base flow channel. Beaver subsequently dammed the cut at the plug so that base flow elevation is maintained upstream of the plug. (Photo: Joe Hoffman)

Beaver may also help to maintain the surface of plugs and the base level of pond-and-plug projects. As an example, the CRM recognized during the design phase for Red Clover - McReynolds (on Goodwin Ranch) that beaver would likely move into the project area, which in fact they did shortly after construction began. The beaver constructed a dam on the low flow, remnant channel, diverting the low flow back toward the obliterated gully and over one of the plugs. In anticipation of this, the CRM designed the difference between all ponds on the project to be less than 6 inches, so that when the low flow was diverted, stresses on the plug would be lower and plug vegetation would eventually keep the new, diverted channel stable. Since the beaver dam described above occurred before the plug was vegetated, flow did cut through the entire plug. However, the beaver apparently were not satisfied with a lower baseflow elevation at this point and fixed the elevation change by damming the new baseflow channel at the cut plug (see Figure 13).

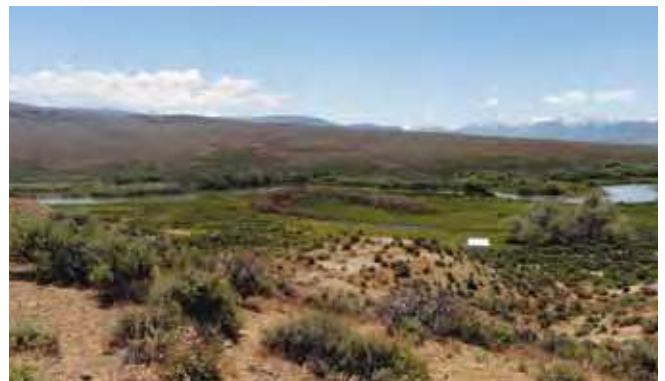
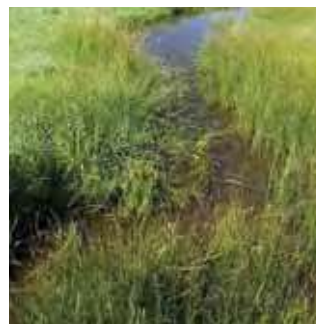
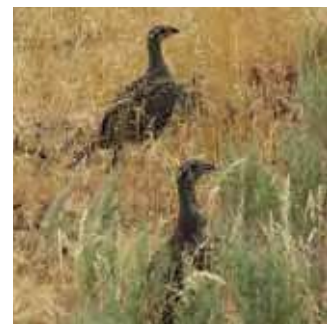
In late summer, wet meadows, riparian edges, and irrigated fields become islands of green in the sagebrush sea – vital foraging habitat for growing sage grouse broods. Photo credits: top - Dan Taylor; bottom left - Conservation Media; bottom right - Ken Miracle.

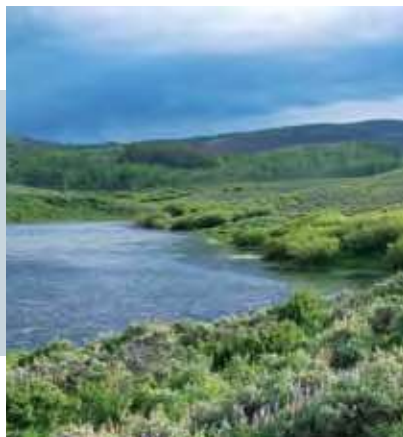
In late summer, sage grouse seek out productive wet habitats in both natural and agricultural areas. In this study, natural sites included riparian habitats, seasonal and temporal wetlands, and the edges of reservoirs, lakes, and playas with moist vegetation. Agricultural sites included alfalfa fields and wet meadows, which were most often associated with irrigation.

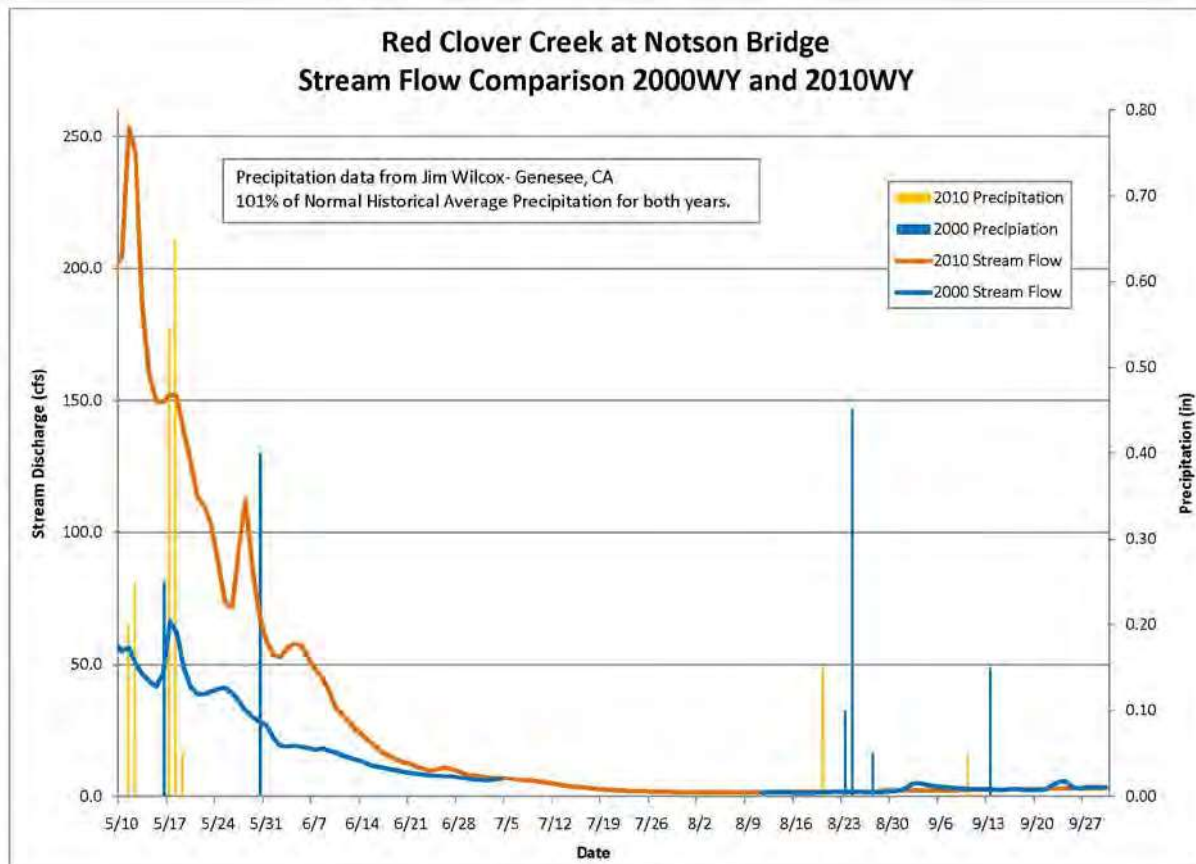
Figure 1. Pre-project vs. Post-project hydrograph at Notson Bridge.

Figure 1 displays pre- and post-project base flows at Notson Bridge in 2000 and 2010. 2000 and 2010 were compared because of the similarity in amount of precipitation (101% of normal precipitation) between these water years. The baseflow discharge in both years is very similar, though 2000 was the end of a wet decade and 2010 was the end of a dry decade. Data are missing from July 5 to August 10, 2000 due to problems with the equipment. The normal historic average precipitation is from the California Department of Water Resources' (DWR) California Data Exchange Center website (<http://cdec.water.ca.gov/>).

In Table 2 (pg 6) the rapid decline in flows from June to July (>90% decrease) seen in pre-project conditions indicates the poor condition of the watershed, and the lack of seasonal storage and release in the project area. It is also interesting to note that there is less water at the bottom of the project area than at the top for every measurement pre- and post-project, except June 2005. The loss may be due to evapotranspiration, or it may be lost into a deep aquifer. The increase of flow in September suggests that the loss is due, at least in part, to evapotranspiration.

The major decline in flows between pre- and post-project conditions was most likely due to three years of drought after project completion. However, in 2007 through 2009, despite the lack of precipitation, there was a less dramatic decline in flows from June to July. The 2010 water year had 20-40% more precipitation than the past few water years and surface water flowed through the project area all year.

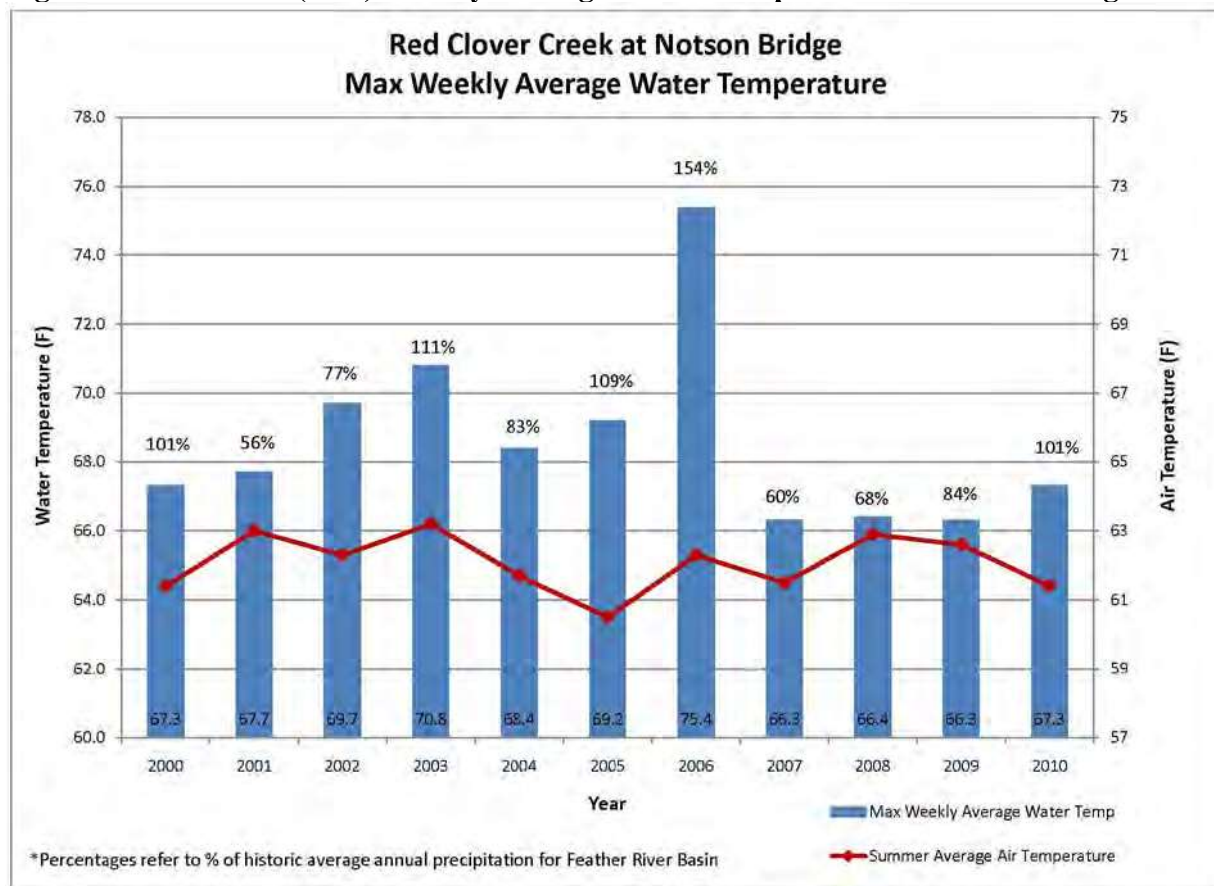
Figure 2. Maximum (max) Weekly Average Water Temperature at Notson Bridge.

Figure 2 shows the maximum weekly average water temperature at Notson Bridge, compared with summer average air temperature and historic average annual precipitation for the Feather River Basin. Summer average air temperature is an average of DWR weather stations at Antelope Lake, Doyle Crossing, Quincy, and Grizzly Ridge from June 1 through September 30. This graph shows that even though 2007 through 2010 were some of the lowest water years in the past 10 years of monitoring at Notson Bridge, they had the lowest maximum weekly average water temperatures. A comparison between 2000 and 2010, both with 101% normal annual precipitation and 61.4 °F summer average air temperature, shows that both years have the same maximum weekly average water temperature (67.3°F).
