Tier 1 Report of
Facility Condition Assessment

For
Department of Administrative Services
Revenue Building
955 Center Street NE
Salem
Oregon 97310

Date of Report: November 07, 2014

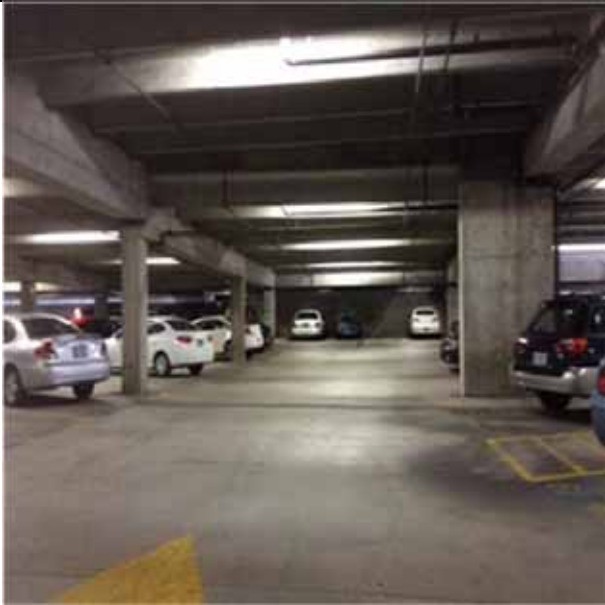
A1032 Structural Slab on Grade.1:- View of typical slab-on-grade concrete.

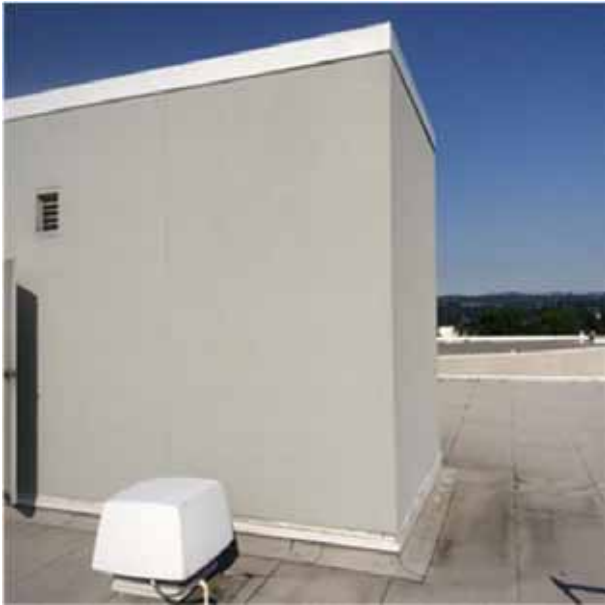
B2011 Exterior Wall Construction.2:- View of typical stucco over stud walls.

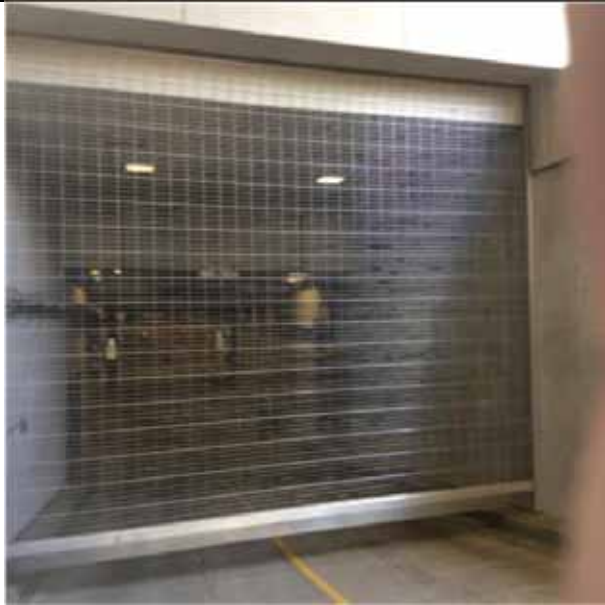
B2034 Overhead Doors.1:- View of rolling overhead door.

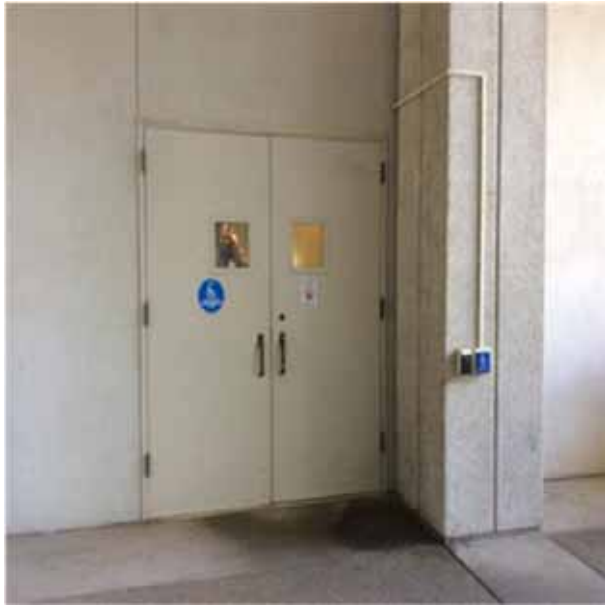
B2039 Other Doors & Entrances.2:- View of typical double hollow metal doors.

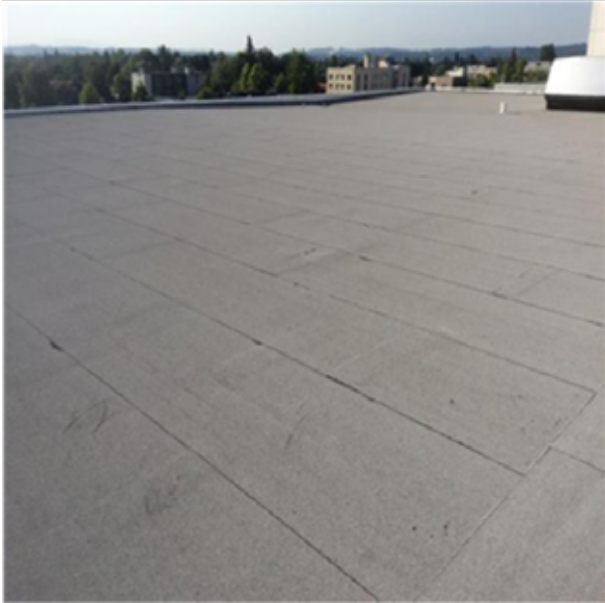
B3011 Roof Finishes.2:- View of typical built-up roof covering.

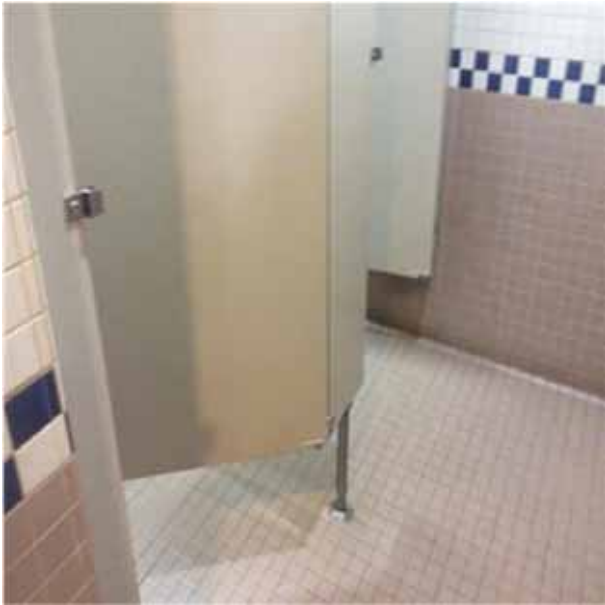
C1014 Site Built Toilet Partitions.1:- View of typical metal toilet partitions.

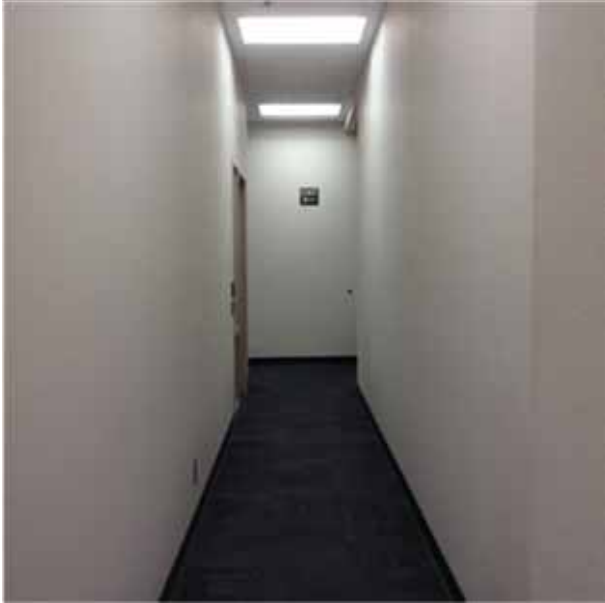
C3012 Wall Finishes to Interior Walls.1:- View of typical painted walls.

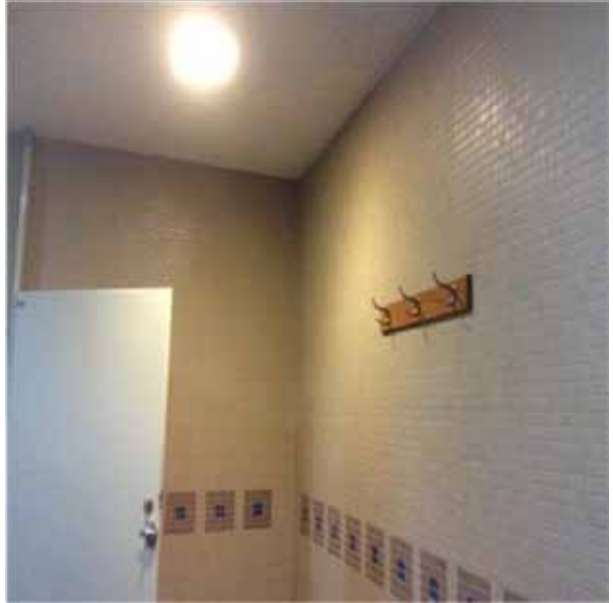
C3012 Wall Finishes to Interior Walls.2:- View of typical ceramic wall tiles.

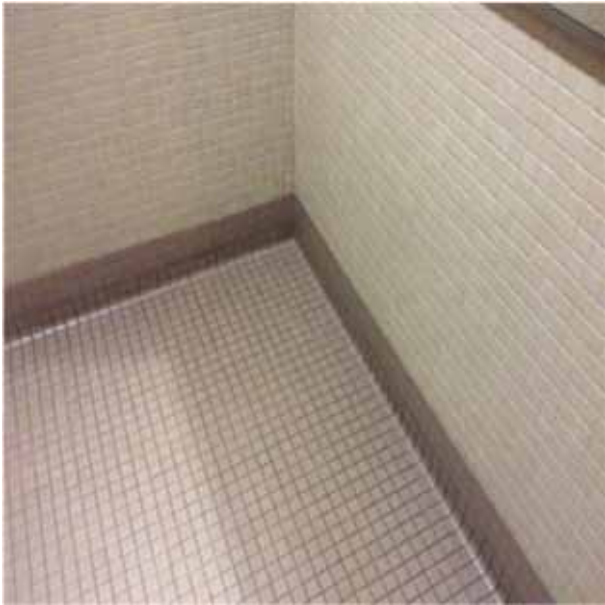
C3024 Flooring.1:- View of typical ceramic floor tiles.

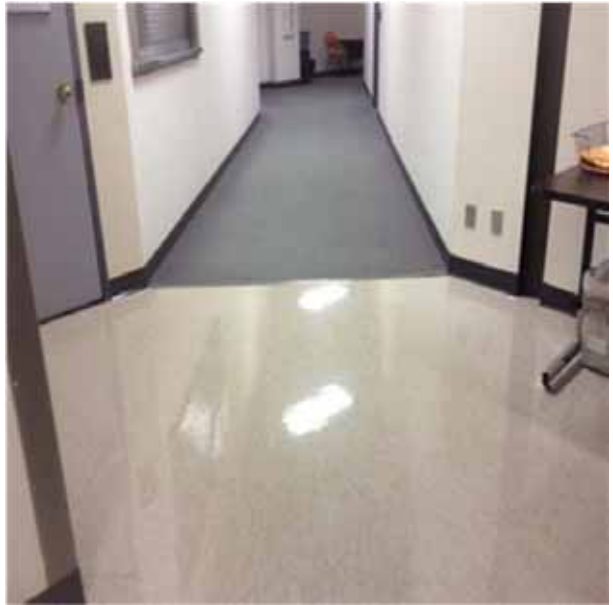
C3024 Flooring.1:- View of typical vinyl tiles.

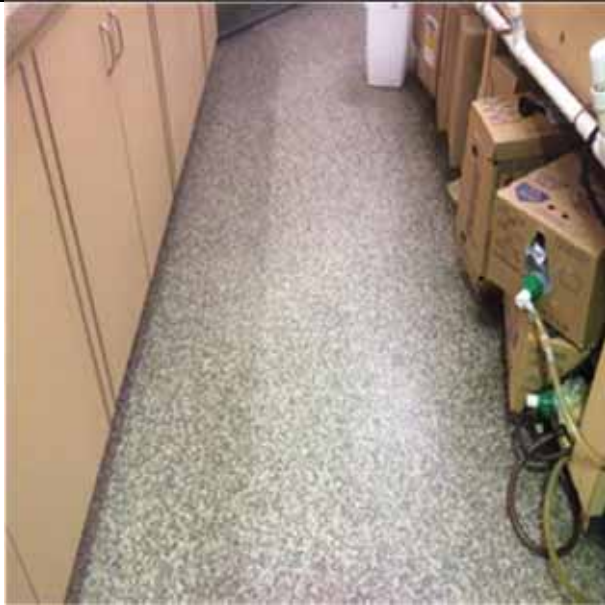
C3024 Flooring.2:- View of typical vinyl sheet.

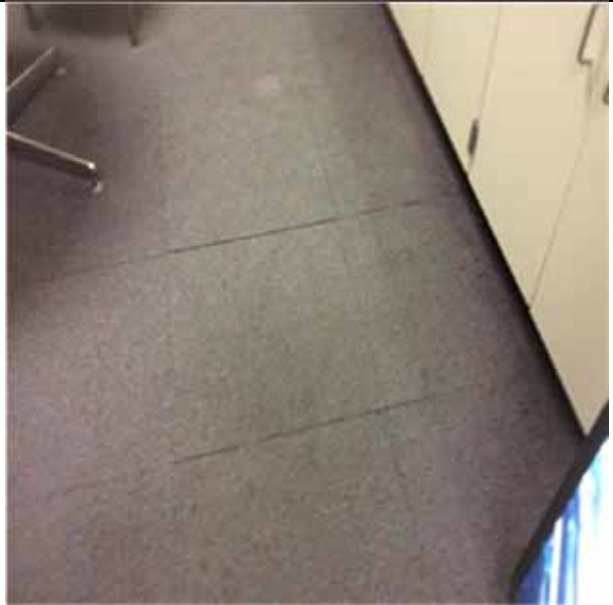
C3025 Carpeting.1:- View of typical carpet tiles.

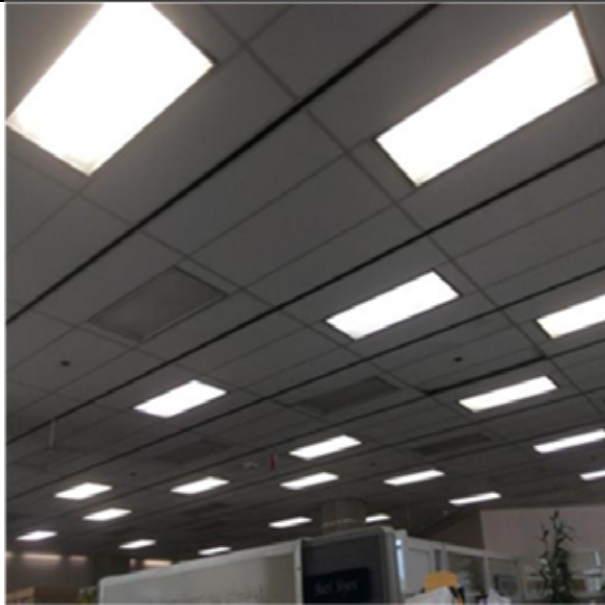
C3032 Suspended Ceilings.1:- View of typical acoustic ceiling system.

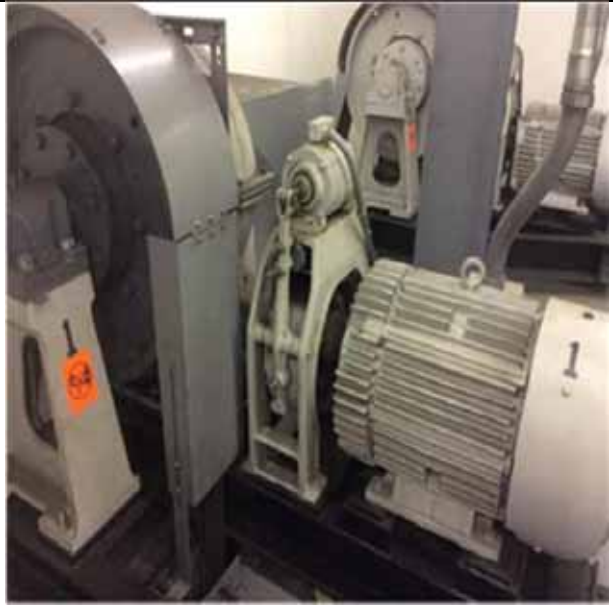
D1011 Passenger Elevators.1:- View of the hoist equipment at elevator 01P.

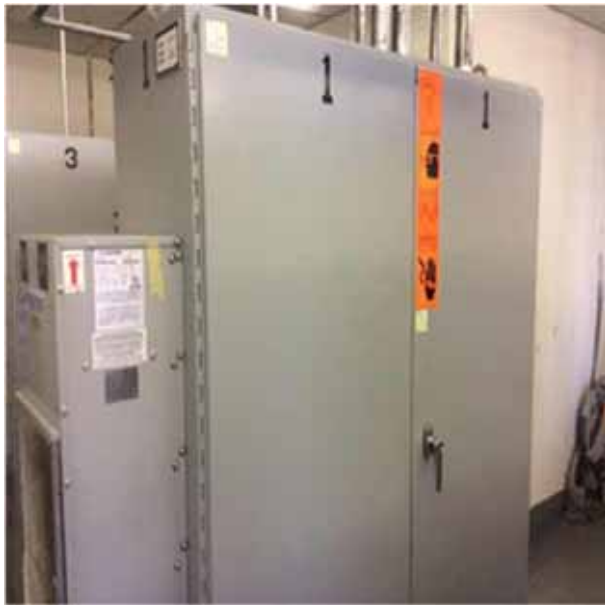
D1011 Passenger Elevators.2:- View of the controller unit for elevator 01P.

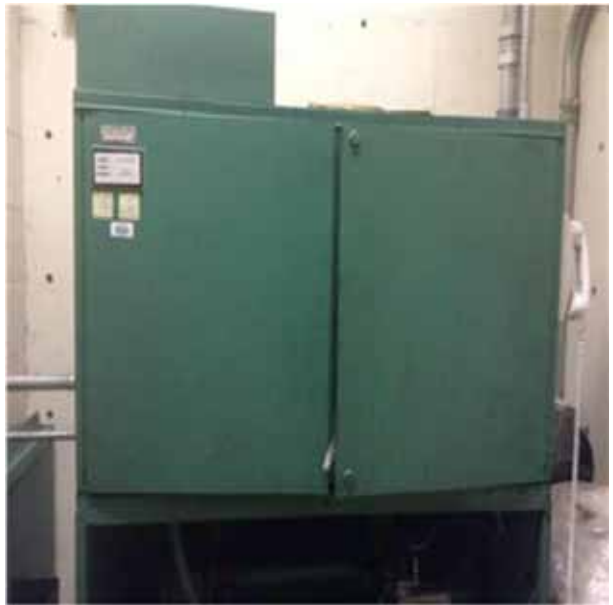
D1011 Passenger Elevators.3:- View of the hydraulic elevator equipment.

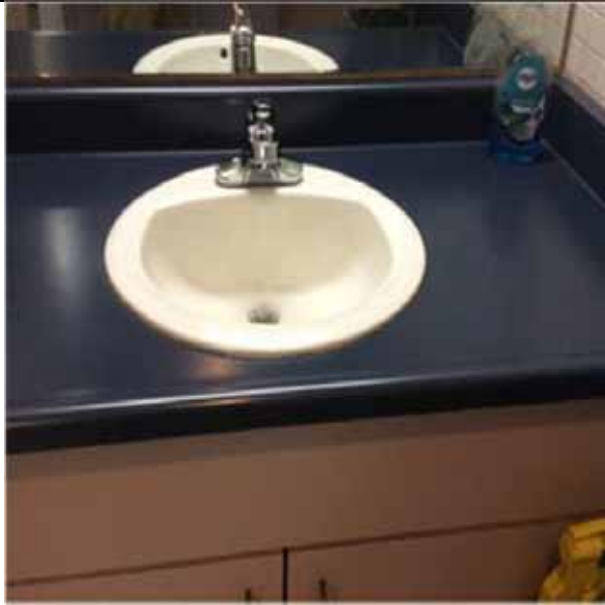
D2013 Lavatories.2:- View of one of the vanity counter top lavatories.

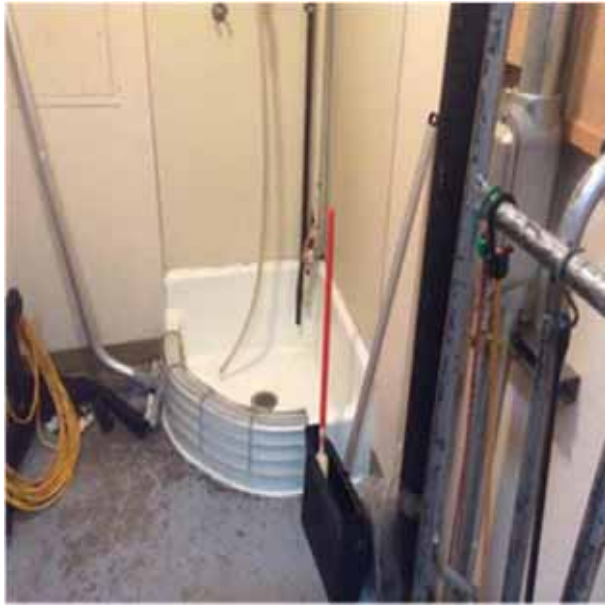
D2014 Sinks.2:- View of the custodial sink.

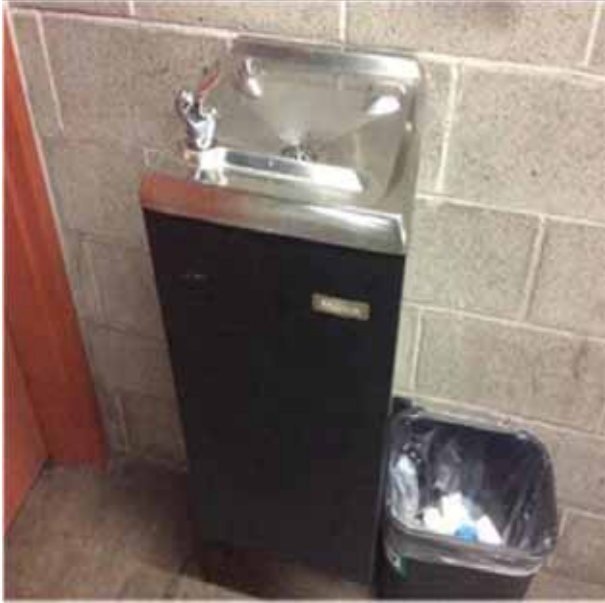
D2018 Drinking Fountains and Coolers.2:- View of the floor mounted drinking fountain.

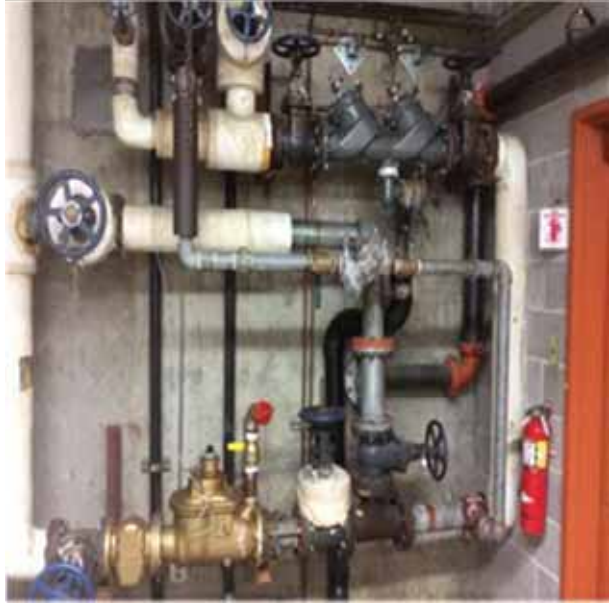
D2021 Cold Water Service.1:- View of the cold water supply system.

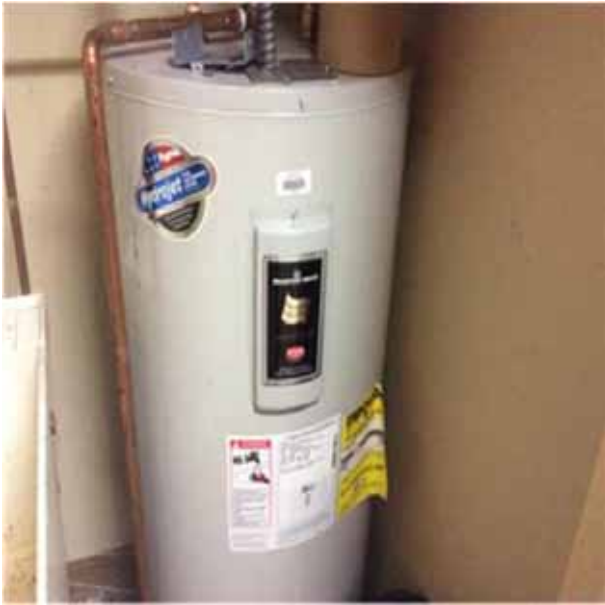
D2022 Hot Water Service.1:- View of domestic water heater DWH-01.

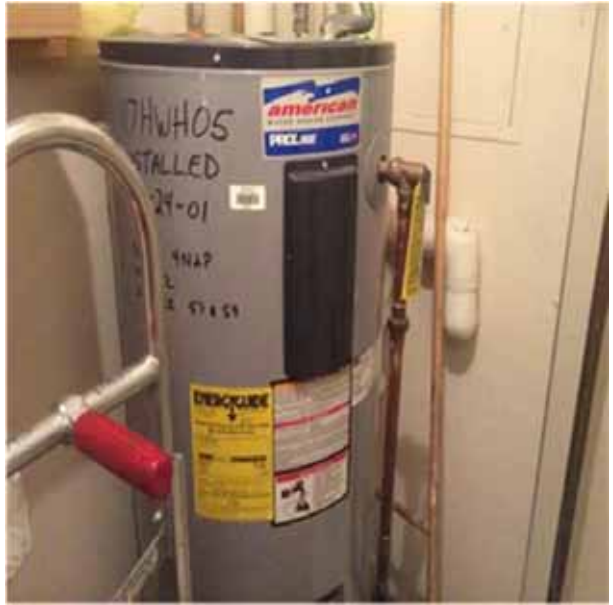
D2022 Hot Water Service.2:- View of domestic water heater DHW-05.

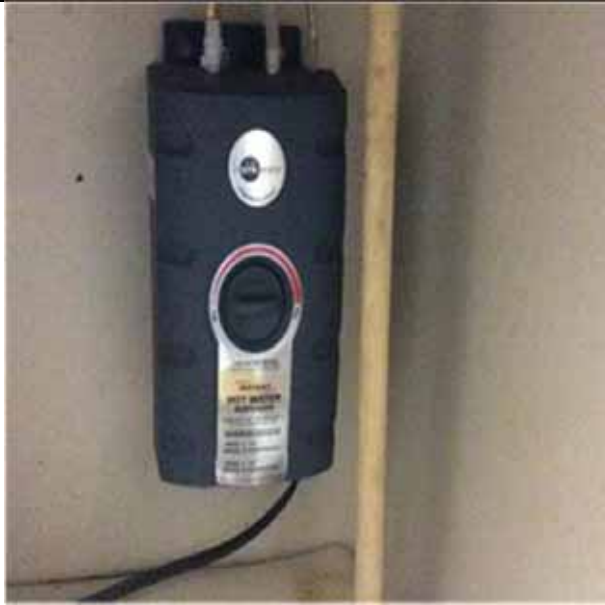
D2022 Hot Water Service.3:- View of one of the point-of-use water heaters.

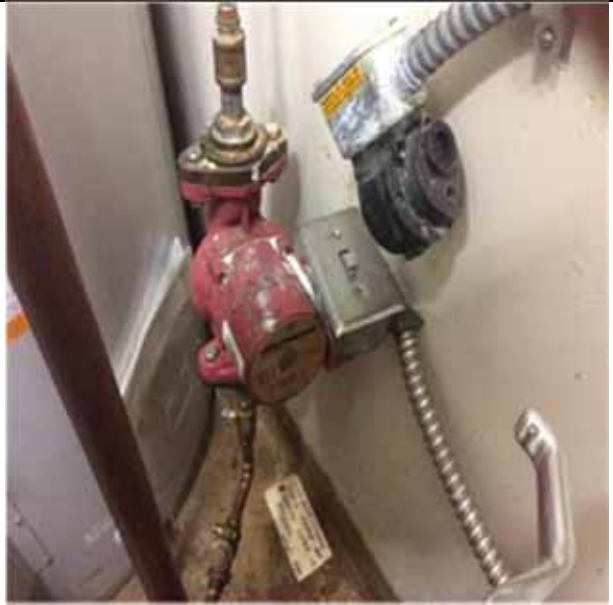
D2023 Domestic Water Supply Equipment.1:- View of a domestic water circulation pump/motor.

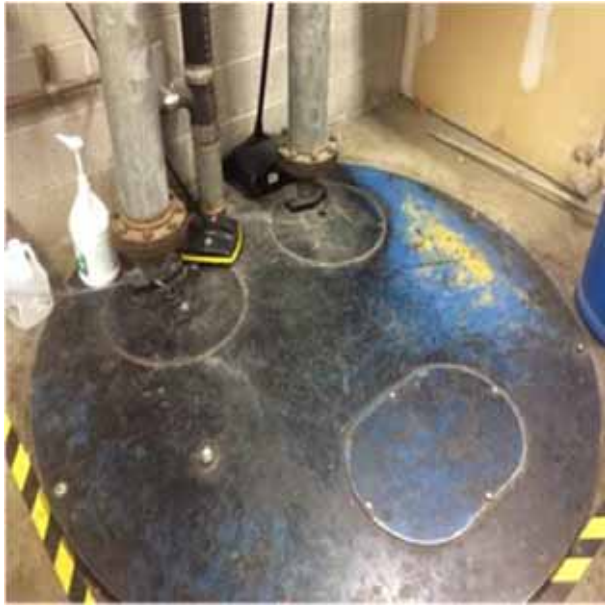
D2043 Rainwater Drainage Equipment.1:- View of one of the sump pump chambers.

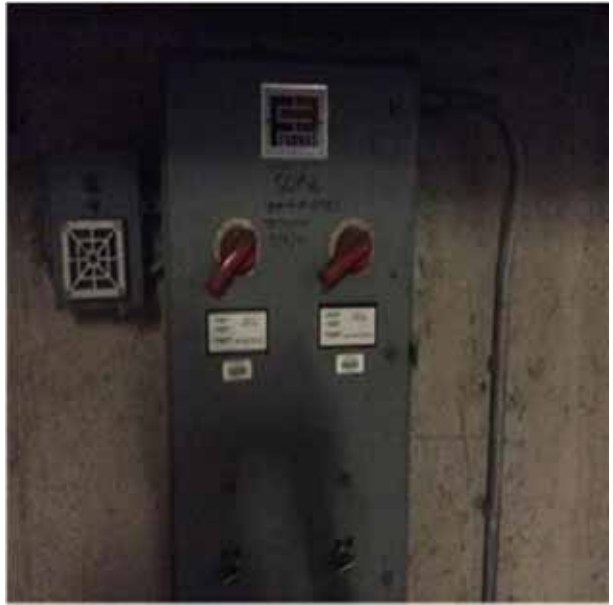
D2043 Rainwater Drainage Equipment.2:- View of one of the sump pump control panel units.

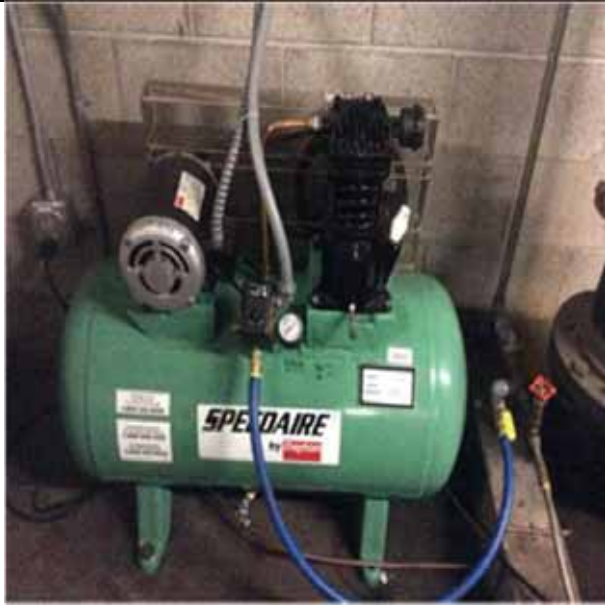
D2099 Other Piping Systems.1:- View of the fire compressor unit.

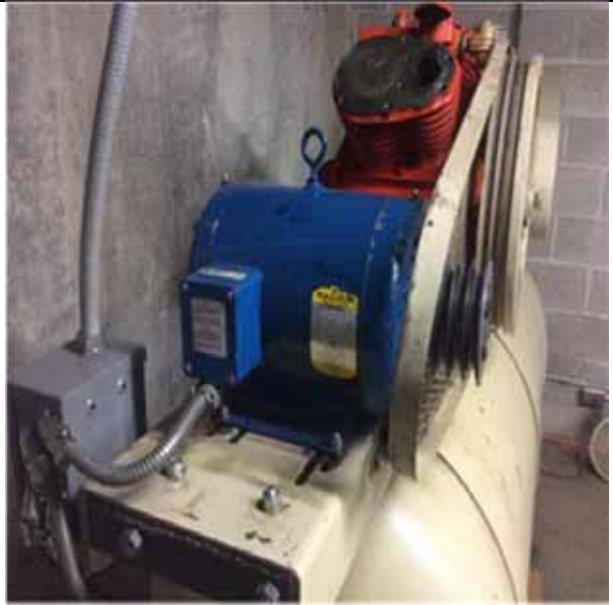
D2099 Other Piping Systems.2:- View of HVAC compressor 02.

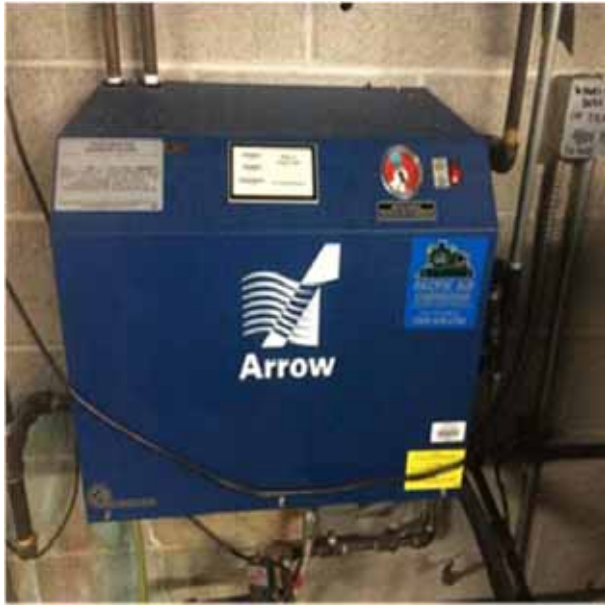
D2099 Other Piping Systems.3:- View of the air dryer unit.

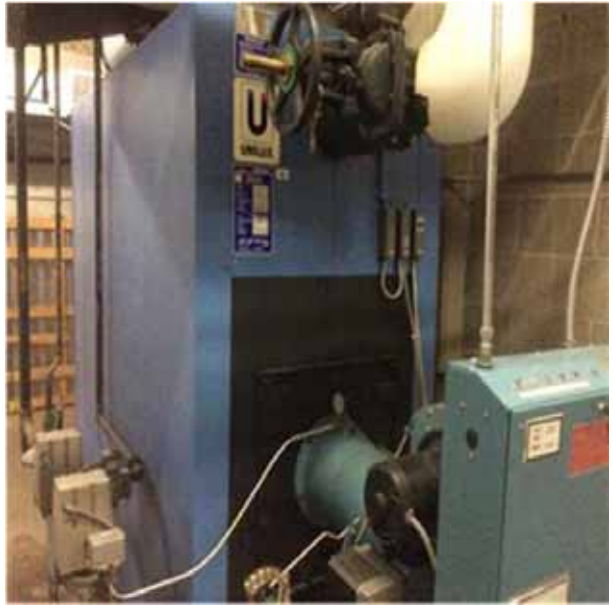
D3021 Boilers.1:- View of the HVAC boiler.

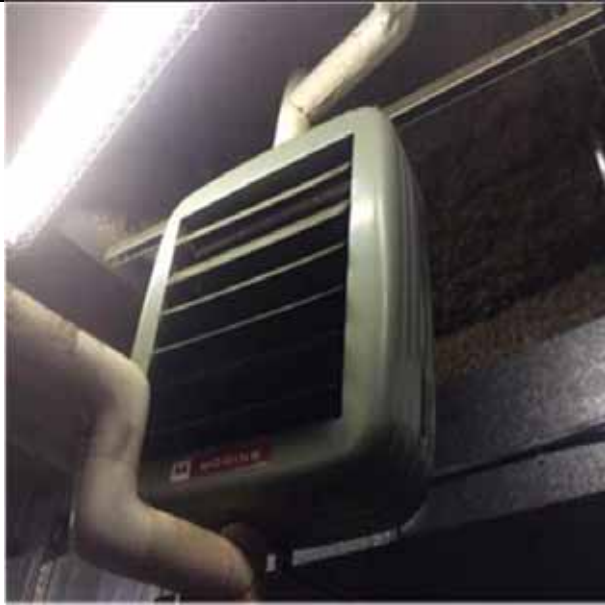
D3023 Auxiliary Equipment. 1:- View of the hot water unit heater.

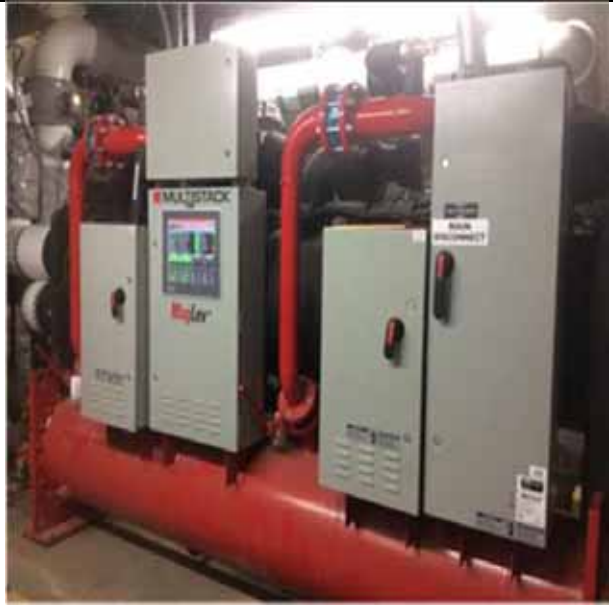
D3031 Chilled Water Systems.1:- View of chiller CH-01.

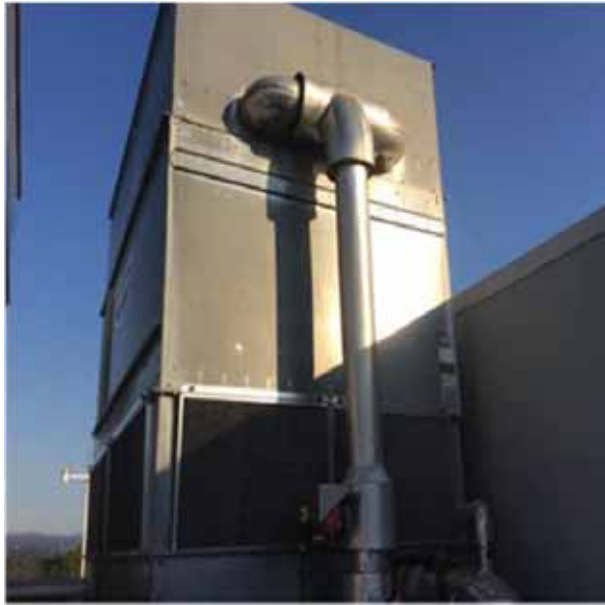
D3031 Chilled Water Systems.2:- View of cooling tower CT-01.

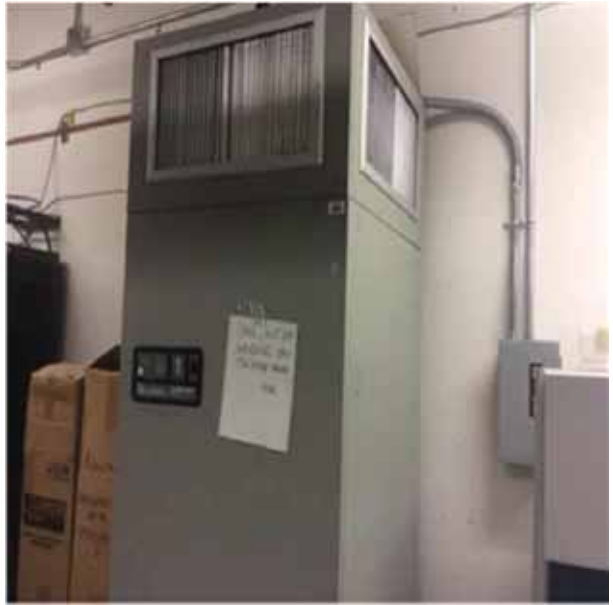
D3032 Direct Expansion Systems.1:- View of the indoor unit of the Liebert split-system.

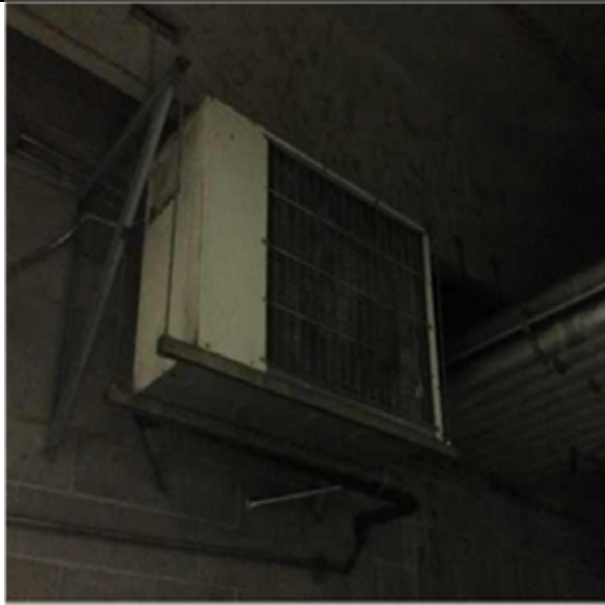
D3032 Direct Expansion Systems.2:- View of the outdoor unit of the Liebert split-system.

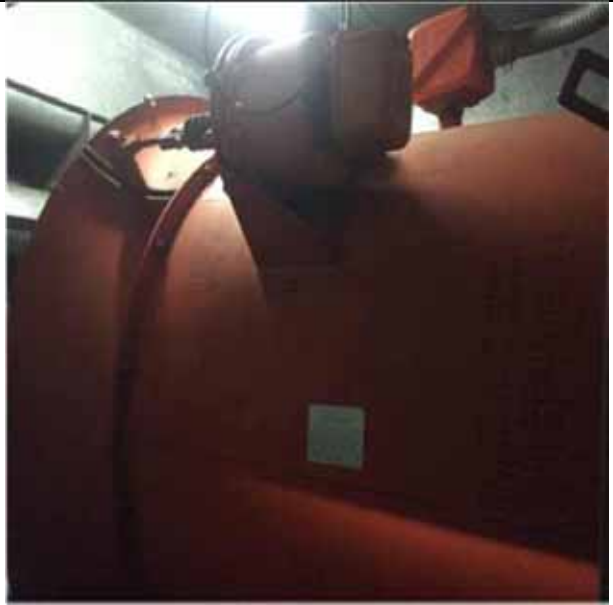
D3041 Air Distribution Systems.1:- View of supply fan SF-02.

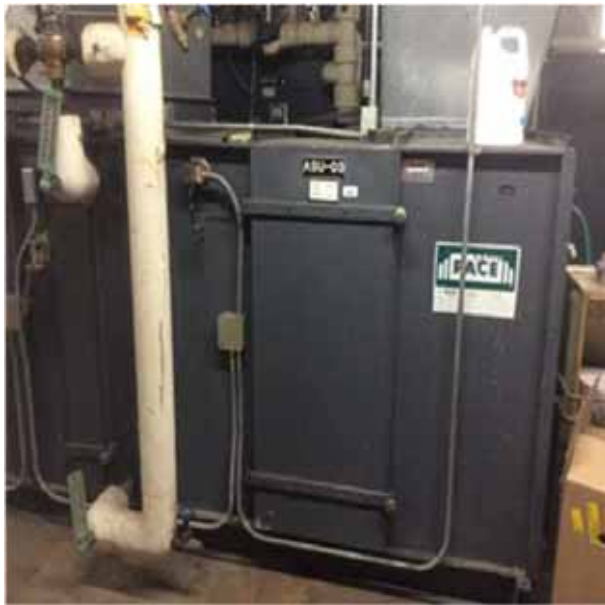
D3041 Air Distribution Systems.2:- View of AHU ASU-03.

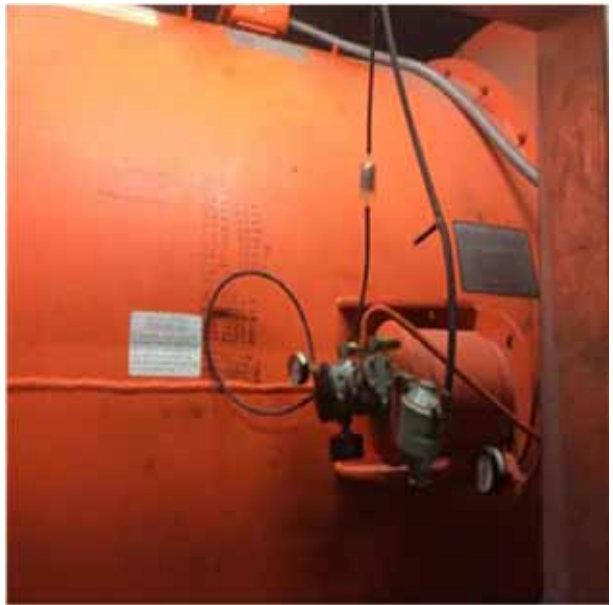
D3041 Air Distribution Systems.3:- View of return fan RF-07.

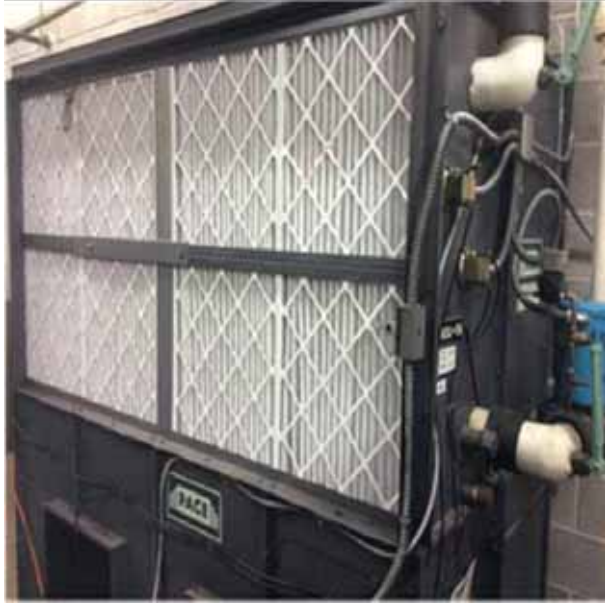
D3041 Air Distribution Systems.4:- View of water cooled fan coil unit ASU-11A and 11B.

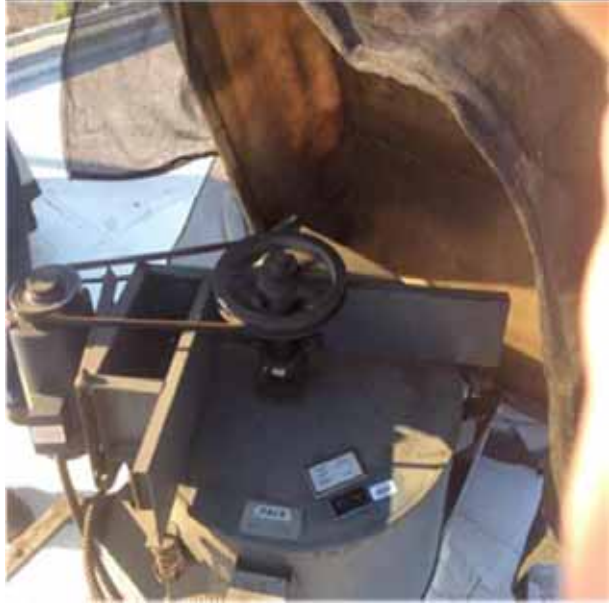
D3042 Exhaust Ventilation Systems.1:- View of one of the roof level exhaust fan units.

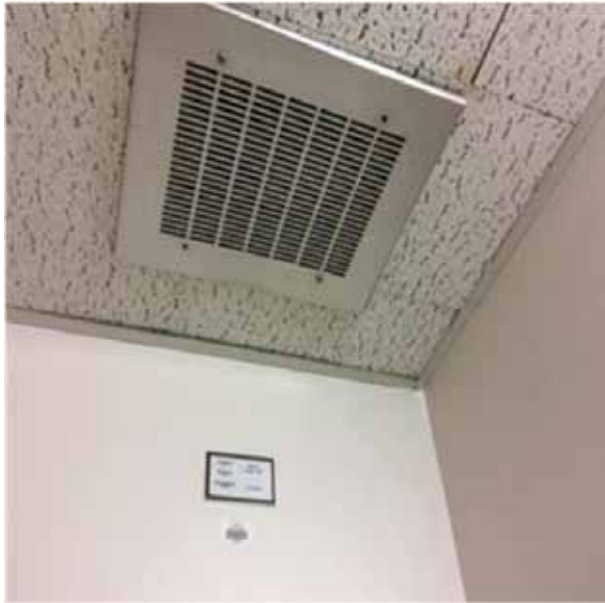
D3042 Exhaust Ventilation Systems.2:- View of a small capacity restroom exhaust fan unit.

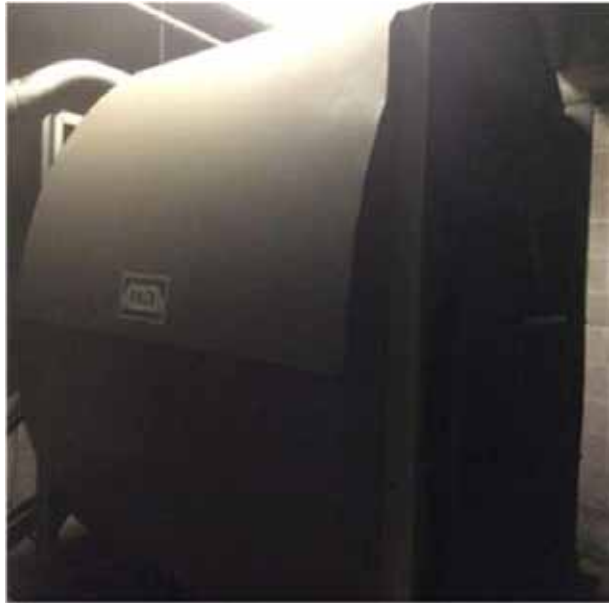
D3042 Exhaust Ventilation Systems.3:- View of one of the garage exhaust fan units.

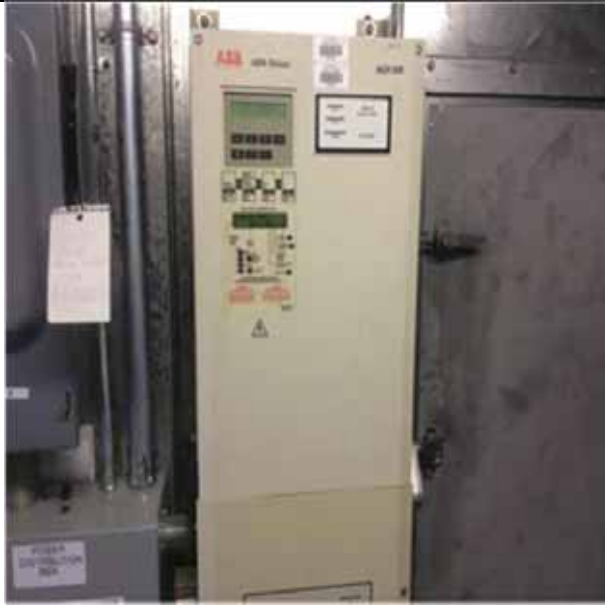
D3069 Other Controls & Instrumentation.1:- View of the ABB type VFDs.

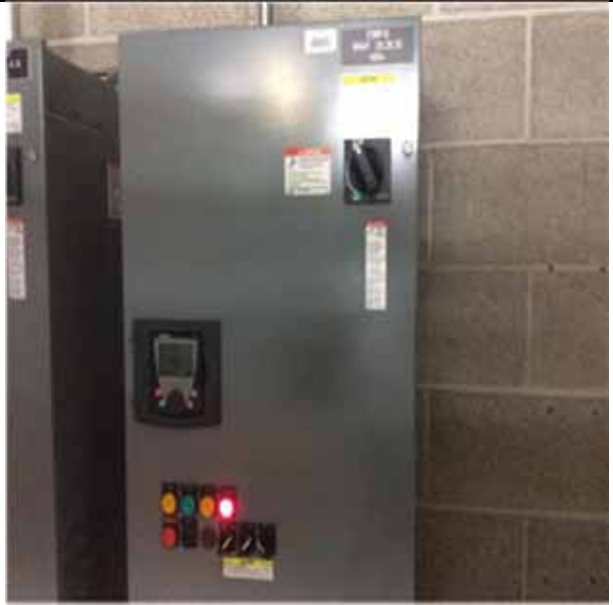
D3069 Other Controls & Instrumentation.2:- View of the newer GE type VFDs.

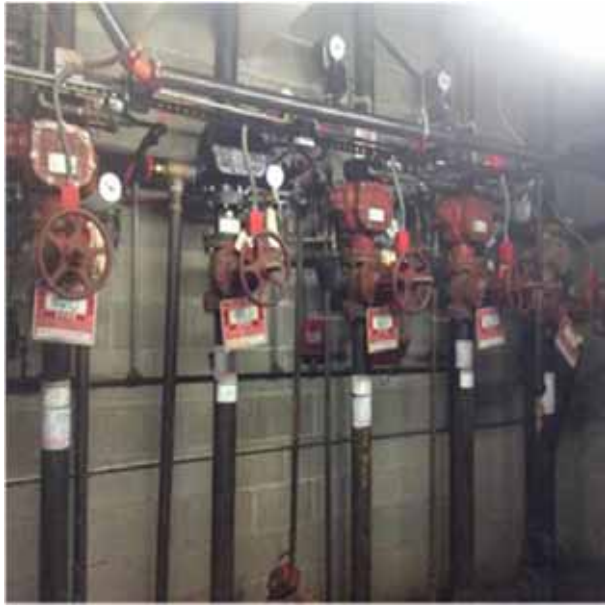
D4011 Sprinkler Water Supply.1:- View of the fire suppression system riser and valves.

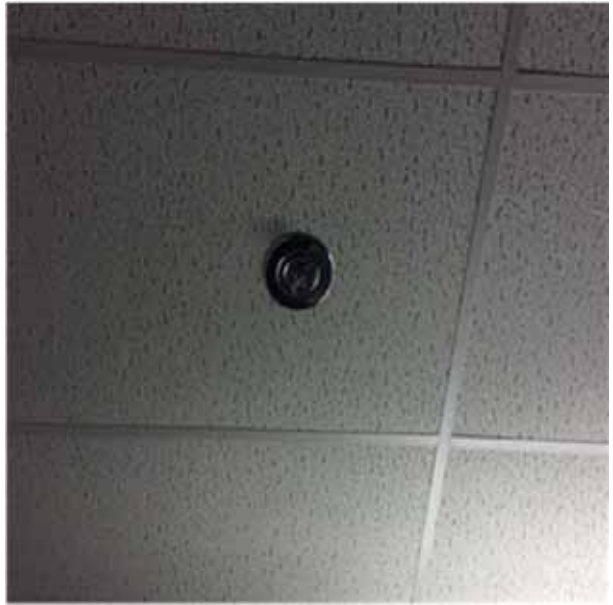
D4011 Sprinkler Water Supply.2:- View of a typical sprinkler head.

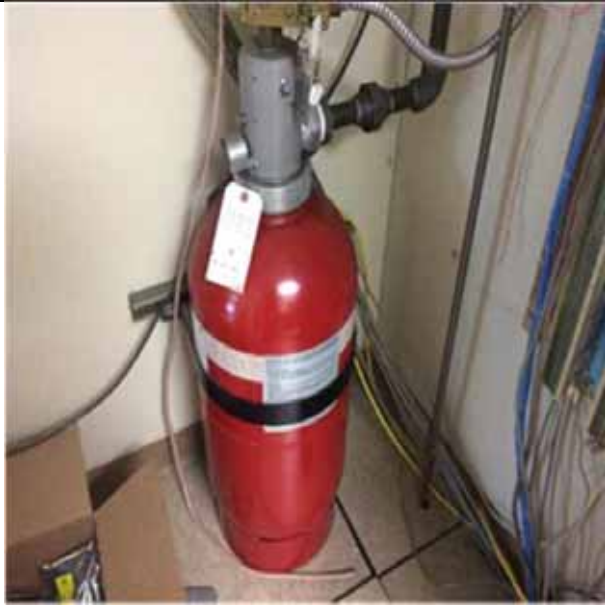
D4091 Carbon Dioxide Systems.1:- View of the clean agent storage tank.

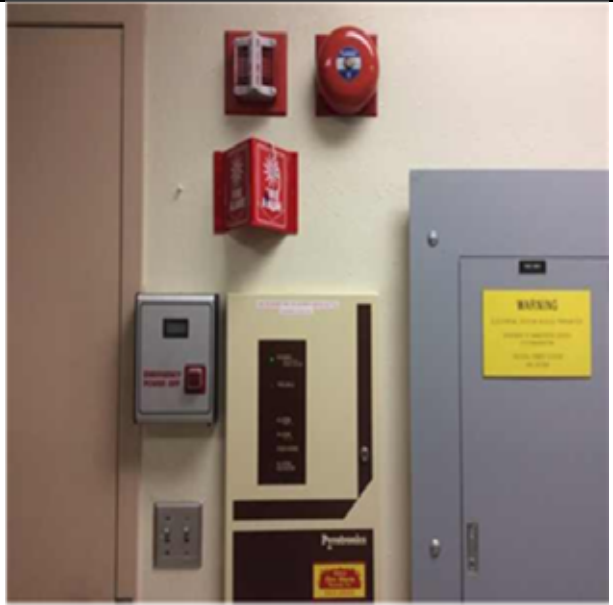
D4091 Carbon Dioxide Systems.2:- View of the control panel.

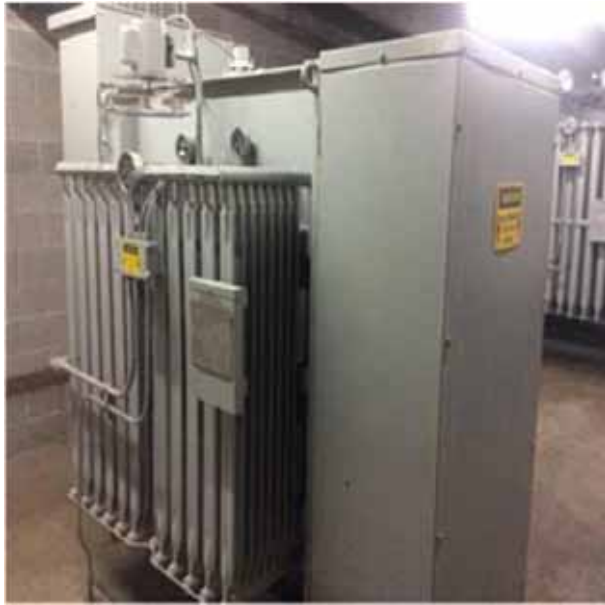
D5011 High Tension Service & Dist.1:- View of one of the main transformers.

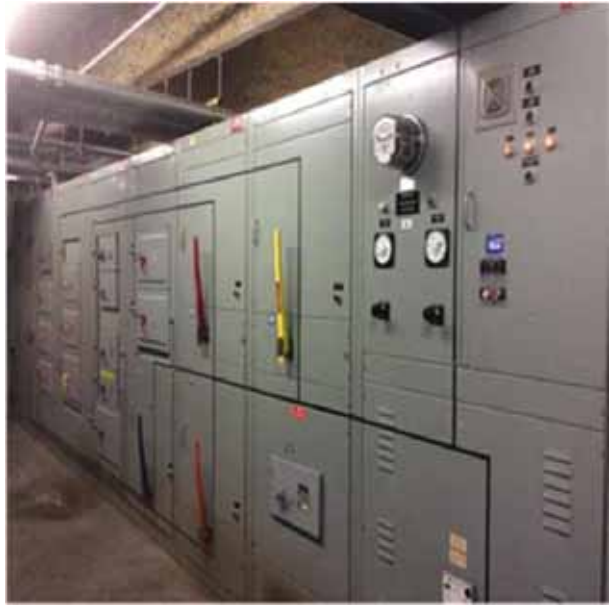
D5012 Low Tension Service & Dist.1:- View of the 480/277 voltage MDP.

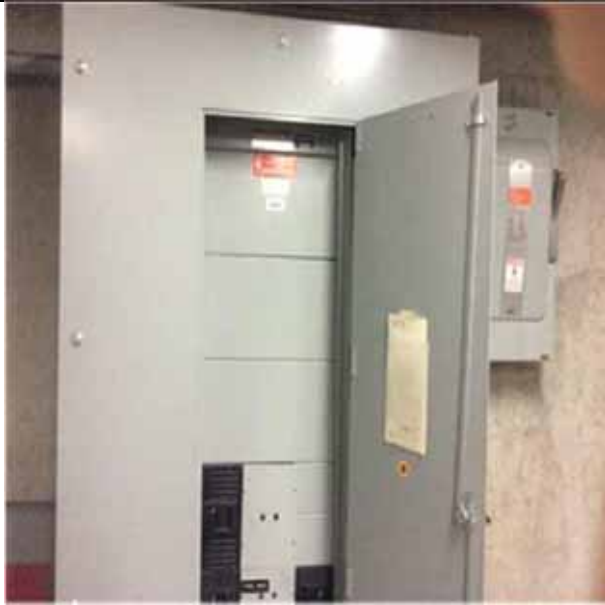
D5012 Low Tension Service & Dist.2:- View of secondary distribution panel EC2.

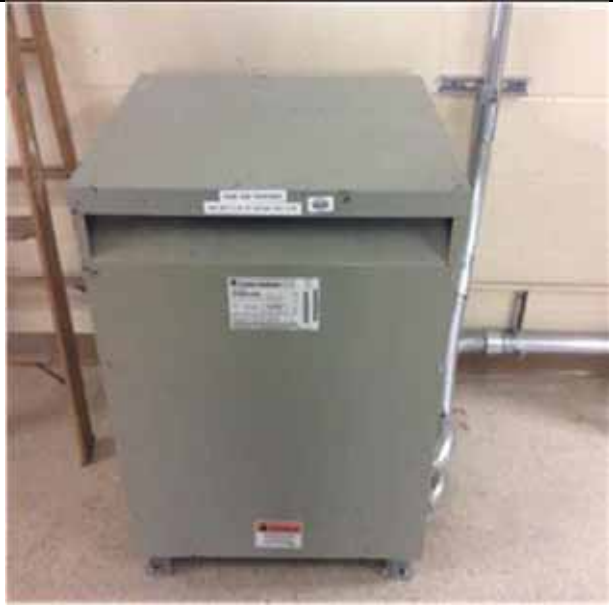
D5012 Low Tension Service & Dist.3:- View of a 75 KVA transformer.

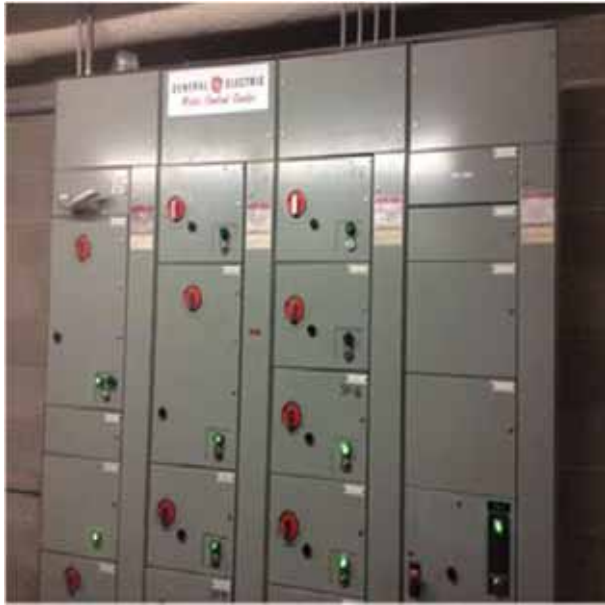
D5012 Low Tension Service & Dist.4:- View of MCC 1.

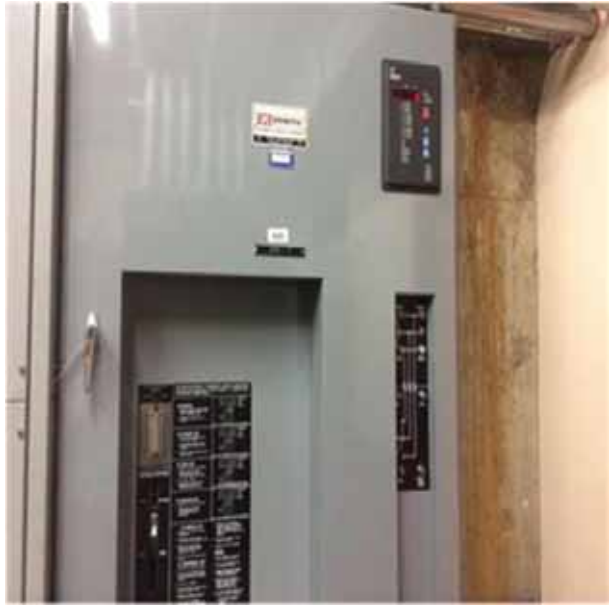
D5012 Low Tension Service & Dist.5:- View of one of the emergency transfer switches.

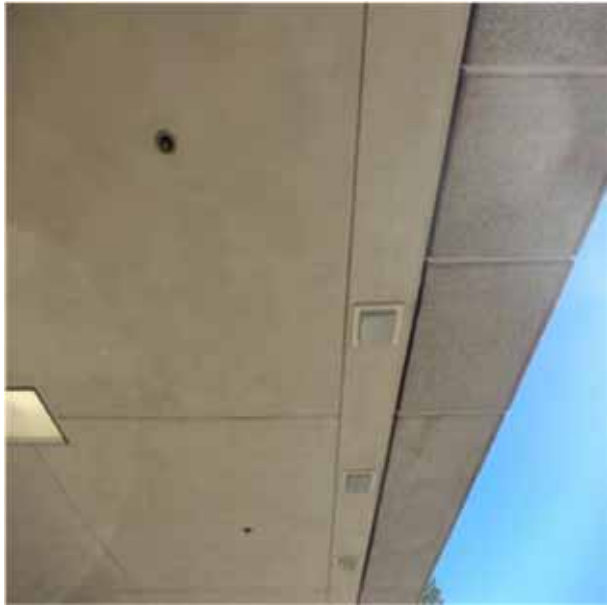
D5022 Lighting Equipment.3:- View of the smaller 1' x 1' light fixtures at the exterior soffits.

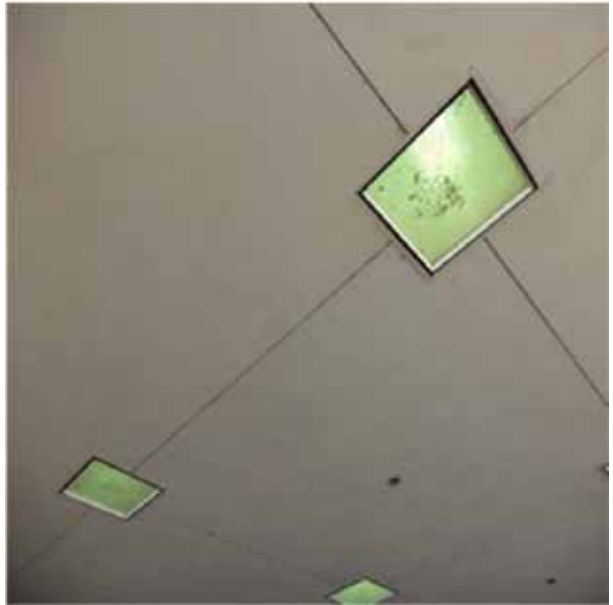
D5022 Lighting Equipment.4:- View of the 2' x 2' light fixtures at the exterior soffits.

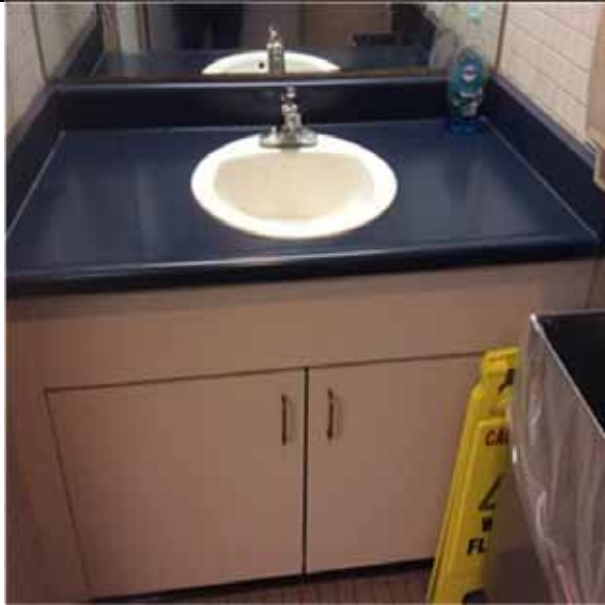
E2012 Fixed Casework.1:- View of typical floor mounted base cabinet with laminate counter top.

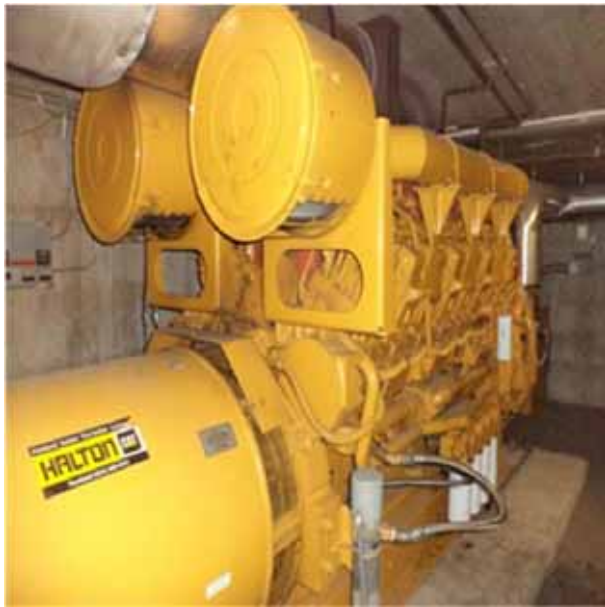
G4092 Site Emergency Power Generation.1:- View of the emergency generator.

137864	G4090	Capital Renewal	Replace Emergency Generator - 1,500 kW	1	LS	\$455,535.00	\$455,535	\$455,535
2022	\$19,386	137753	D2020	Capital Renewal	Replace Domestic Water Circ Pump/Motor (DOM-1)	1	EACH	\$658.00	\$658	\$658
		137800	D3040	Capital Renewal	Replace Hot Circulation Pump/Motors 7.5HP (HWP-05)	1	EACH	\$3,846.74	\$3,847	\$3,847
		137811	D3040	Capital Renewal	Replace Hot Circulation Pump/Motors 3HP (HWP-03)	1	EACH	\$3,340.59	\$3,341	\$3,341
		137812	D3040	Capital Renewal	Replace Hot Circulation Pump/Motors 7.5HP (HWP-02)	1	EACH	\$3,846.74	\$3,847	\$3,847
		137813	D3040	Capital Renewal	Replace Hot Circulation Pump/Motors 7.5HP (HWP-04)	1	EACH	\$3,846.74	\$3,847	\$3,847
		137788	D3040	Capital Renewal	Replace Hot Circulation Pump/Motors 7.5HP (HWP-01)	1	EACH	\$3,846.74	\$3,847	\$3,847
