Bank erosion along the River Murray between Hume Dam and the Ovens Junction

With a focus on the impacts of vessel wash

April 2017

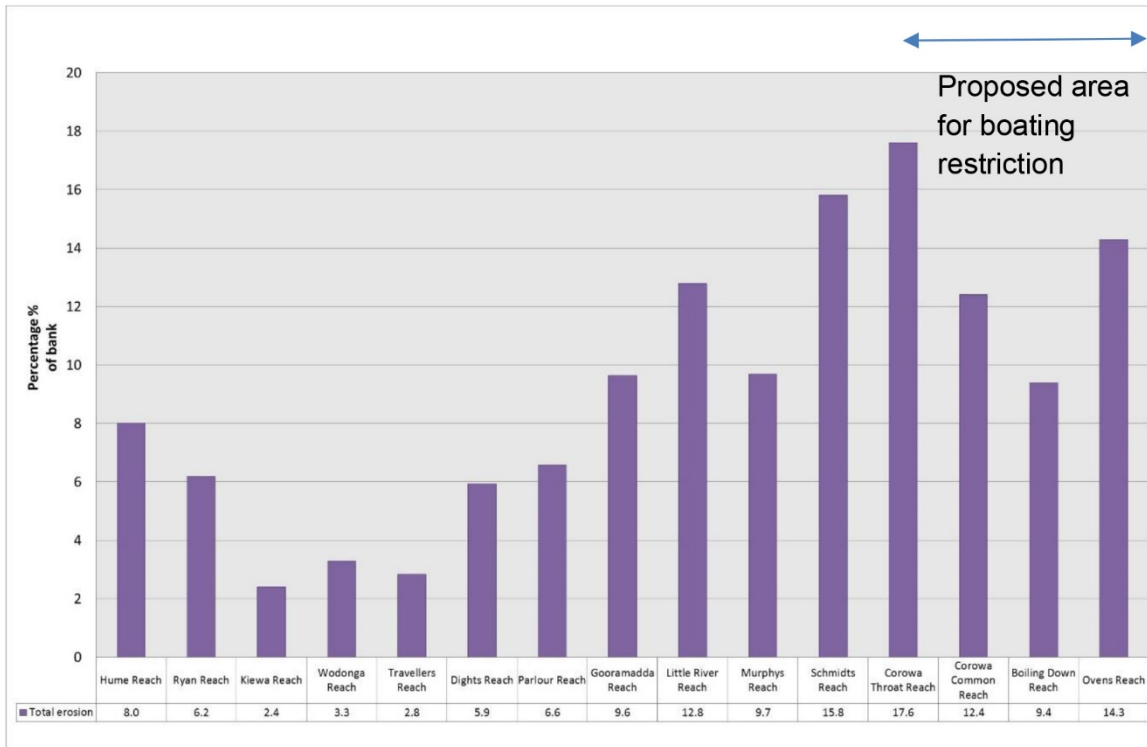
The monitoring program divides the reach into 15 sub-reaches along the main stem of the River Murray. The majority of erosion generally occurs in the mid and lower parts of the reach, from just upstream of Corowa (Schmidt's reach) to the junction with the Ovens River (Ovens reach). This can be seen from the 2012 monitoring when there was a full set of comparative data (Figures 5 and 6). In 2012, several lower reaches had more than 14% of the river bank identified as a priority for erosion works (Figure 6).

Figure 6: Percent of total bank erosion in each sub-reach in 2012. Upper reaches are shown to the left and lower reaches are shown to the right.

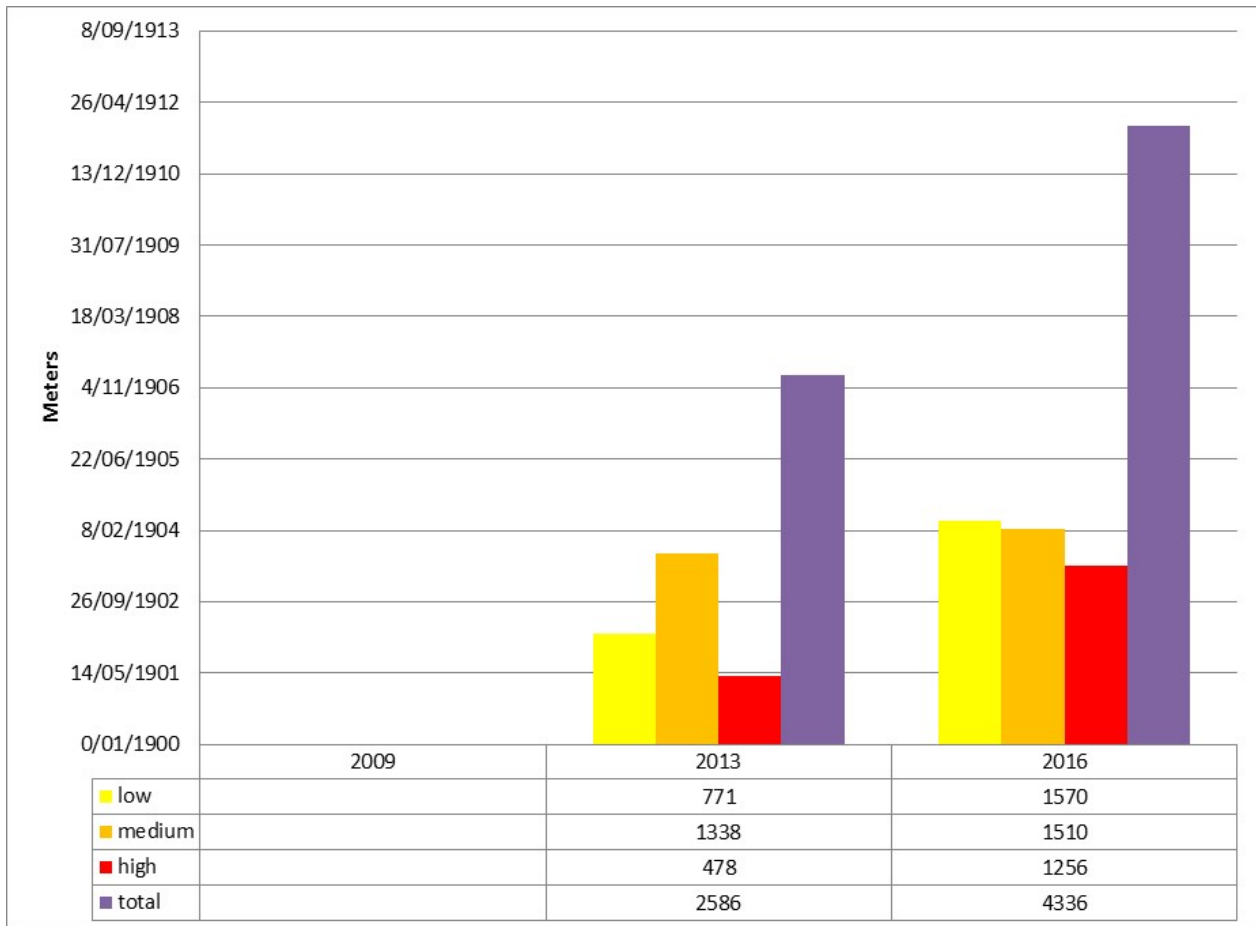
The recent increase in erosion is not isolated to the Ovens reach. There has also been a significant increase in high priority sites occurring in the Corowa Common reach between 2013-2016 (Figure 8).

Figure 8: Length of low, medium, high and total erosion in the Corowa Commons sub-reach from 2013 to 2016.
