### ***Landowner Property Damage*** (2019-03-05v7)

What follows are a small sample of the costs incurred by Property Owners within the Willamette River Newberg Pool. These ten properties are shown as “Property Owner #1, #2, #3, etc.: Location”. We have been asked to omit their names and addresses so that these do not appear in the public record (for obvious privacy and safety reasons). If the Committee wishes to contact a homeowner directly, please ask us to obtain permission. Below is a Summary Table of Costs incurred for the last 5-6 years or planned. Please keep in mind that this is just a sample of the growing impact of larger and larger high-energy wake.

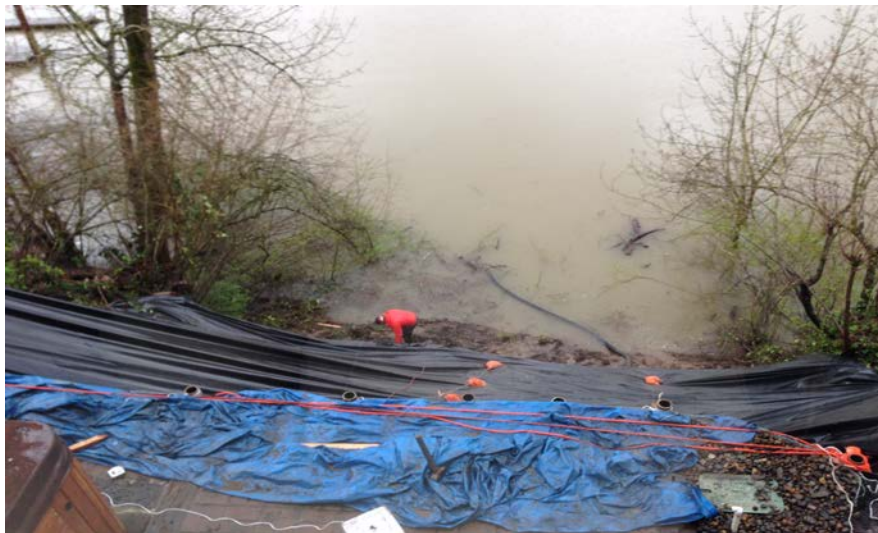
Our neighbors directly to the west of us experienced a major slide similar to ours about 18 months ago. They lost their stairs and decking as well as a sizeable portion of their bank. Last winter they also lost their dock. I do not know if any river activity contributed to their losses, although it seems likely to me the loss of their dock was a result of high-energy waves.

We have not included any copies of receipts as we have about a 3" thick stack of documentation and to be honest, we would like to protect our privacy a bit. We have not exaggerated any of the costs ~ we estimated at the conclusion of the three slides, we spent about \$100k including decorative rock installation, new soil and native plants.
