Testimony in Support of the Dayton Street Bridge Replacement Project

Re: Falls City Pedestrian Bridge over Little Luckiamute River Special Inspection
DOWL Job No. 2870.80850.01

Bridge Inspection Report

REPAIR EXHIBIT

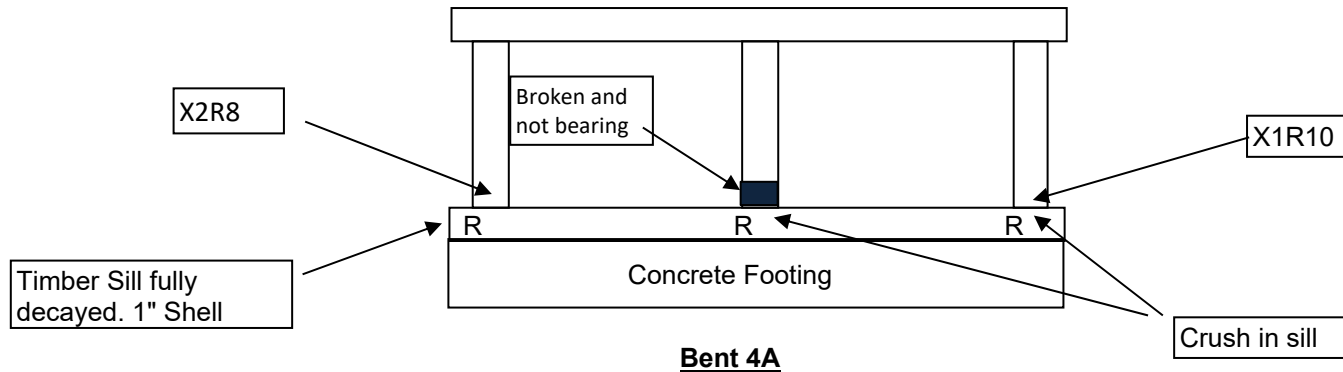
The timber columns are in very poor condition with many being a 1-inch shell. Most of the decay is located in the bottom portion of the column. The middle column at bent 4A appears to be heavily decayed and had been struck by drift shifting the column to the north. Due to this movement, the middle column at bent 4B has also shifted approximately 8-inches and has lost 75% of its bearing.

Bent 4A Middle Column Broken

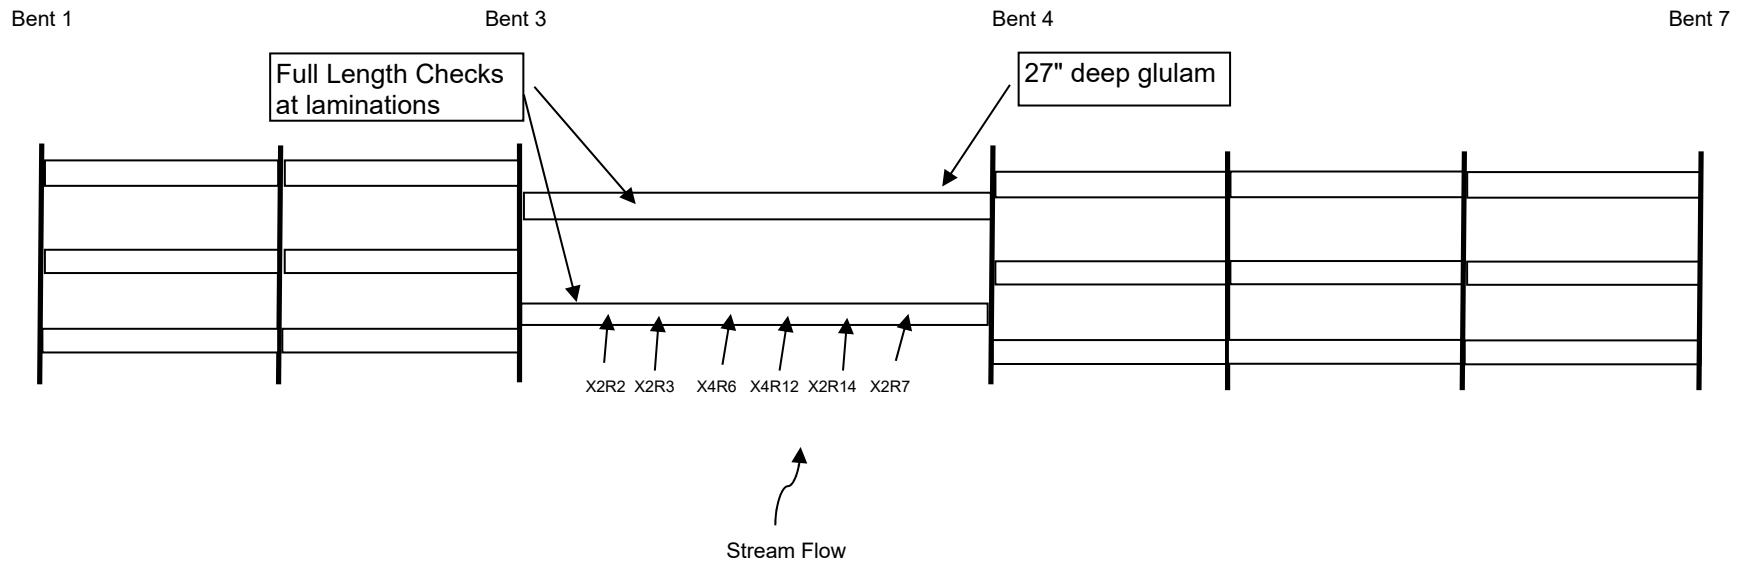
GIRDER DIAGRAM

The bridge superstructure is comprised of timber girders in all 6 spans. The approach spans are constructed of three (3) rough sawn timber girders, while the main span is two (2) 27-inch-deep glulam timber girders. All girders were visually inspected as well as sounded to identify any decay. The approach spans were accessed using a ladder and were found to be in fairly good condition; only minor checks were identified. Span 3 over the river was not accessible and so the girders were drilled, using a Resistograph drill, from the top. The drill utilizes a 1/8-inch diameter drill bit that is 16-inches long. The girders were drilled in a 5-foot pattern to identify any decay. Decay was found throughout the upstream girder with areas of severe section loss in the middle half of the girder. The extent of the decay was not fully identified as the glulams are 27-inches deep and we were only able to drill up to 14-inches into the girder, so in some areas we were not able to get to the bottom of the decayed section. Based on our drillings, there is a minimum of 14-inches (>50% section loss) of decay in this member. This decay would explain why this girder is sagging approximately 2-inches.
