House Bill 2485 Exhibits *Low Head Diversion Examples*

*Example When the POD is
Fixed at A Single Location*

House Bill 2485 Exhibits *Low Head Diversion Example*

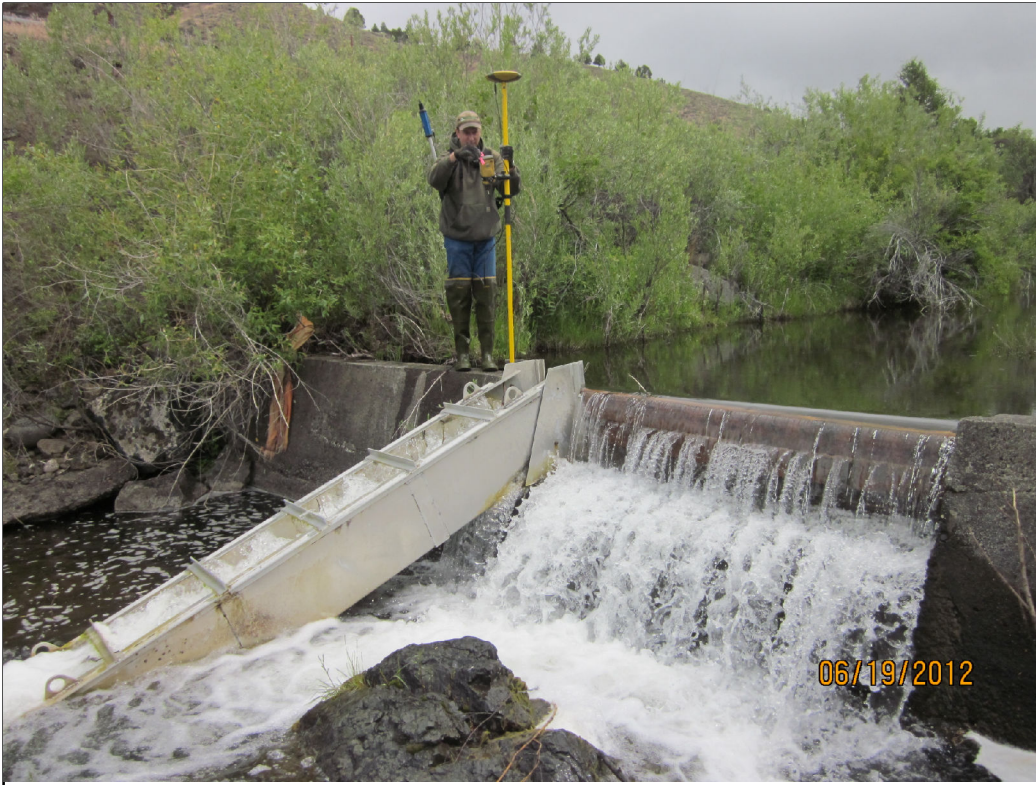
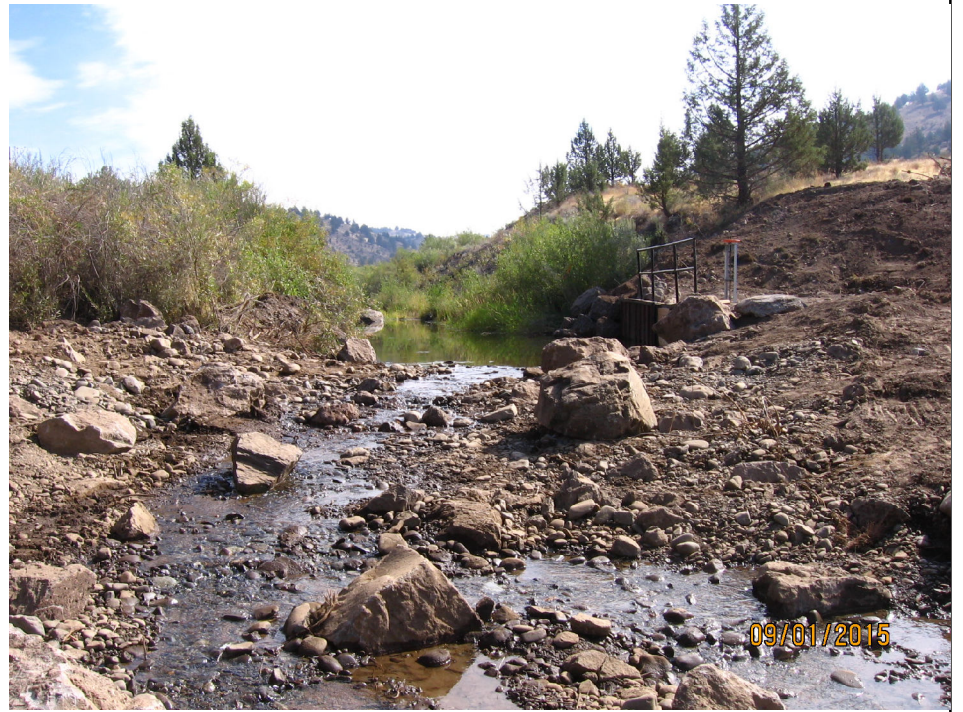
Irrigation diversion depicted above was replaced with a Low Head Diversion and an Engineered Riffle providing natural fish passage depicted to the right.

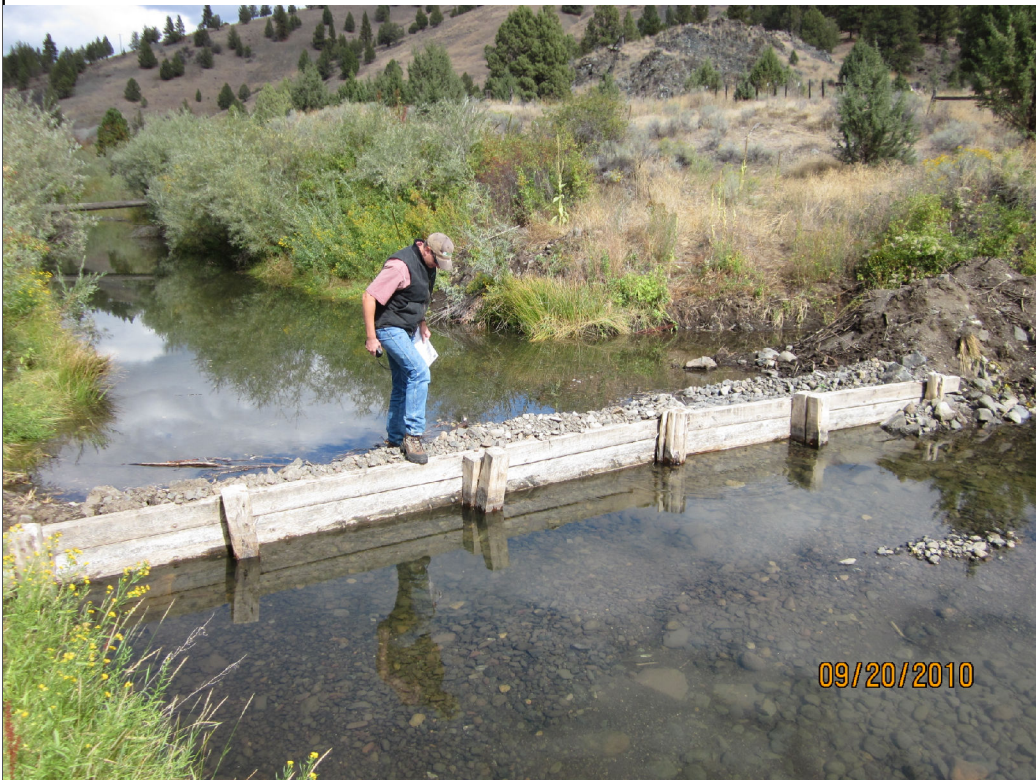
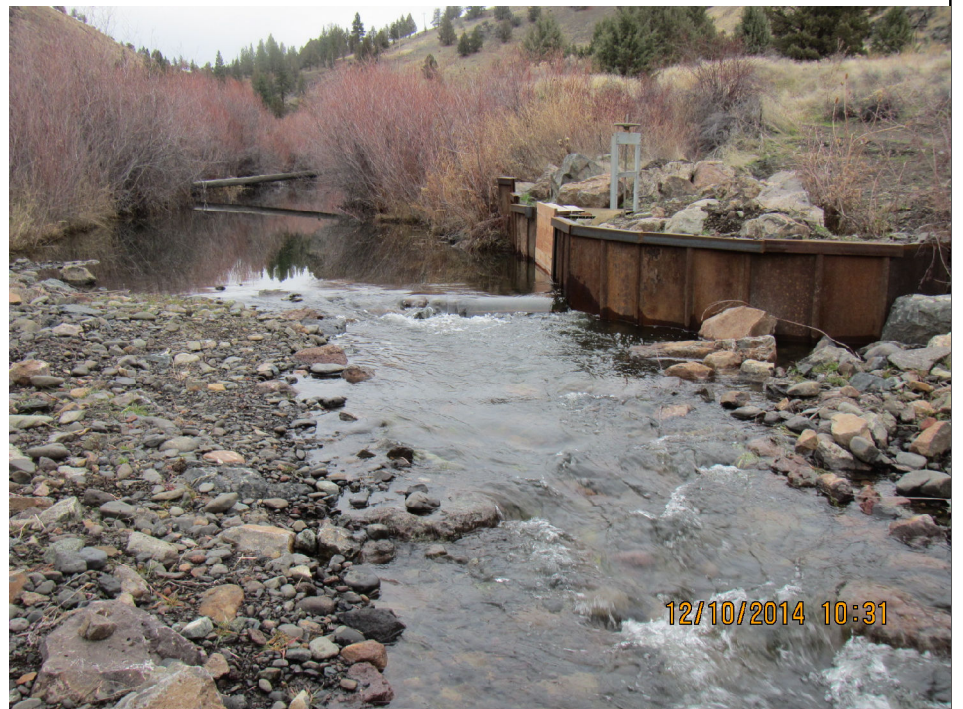
Irrigation diversion depicted above was replaced with a Low Head Diversion and an Engineered Riffle providing natural fish passage depicted to the right.

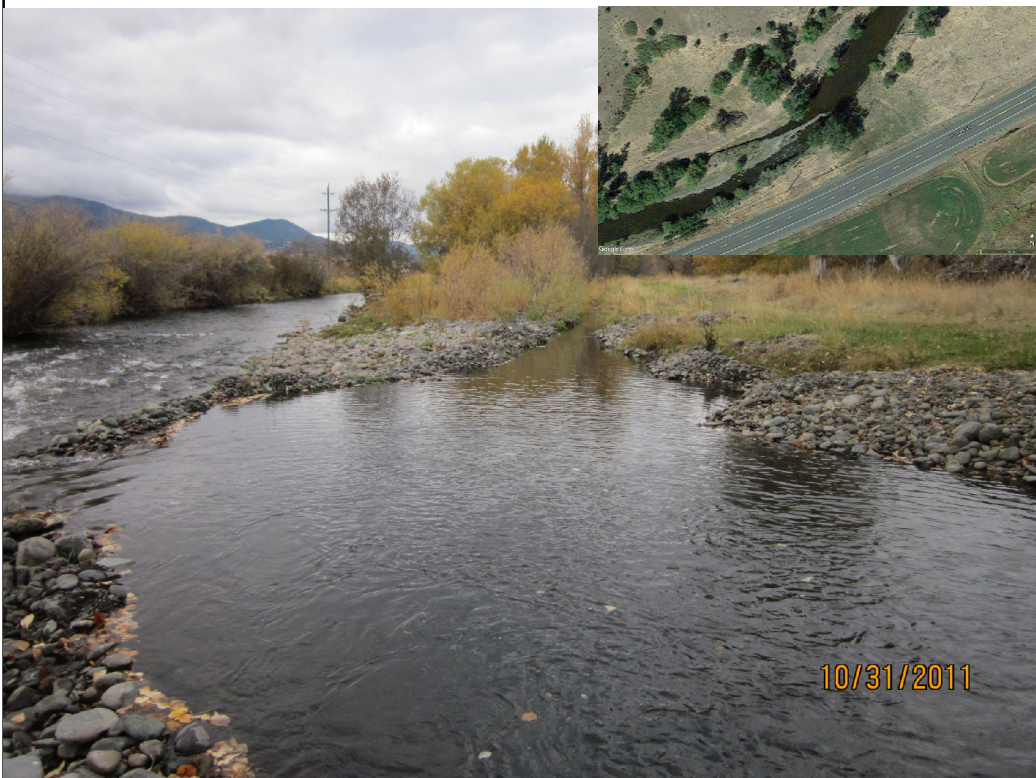
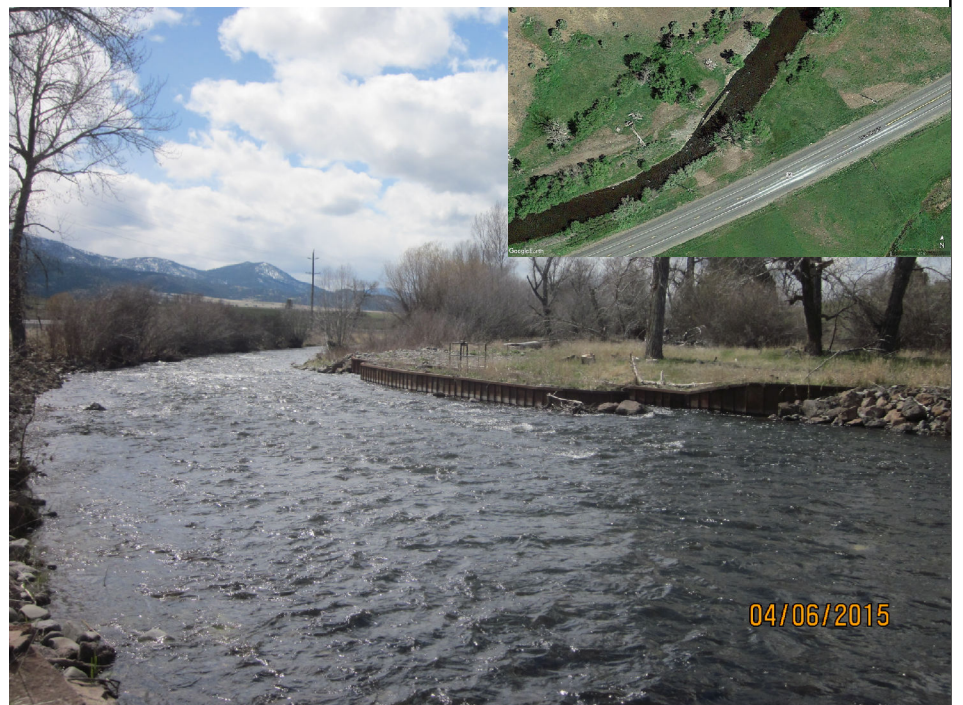
Irrigation diversion depicted above was replaced with a Low Head Diversion and an Engineered Riffle providing natural fish passage depicted to the right.

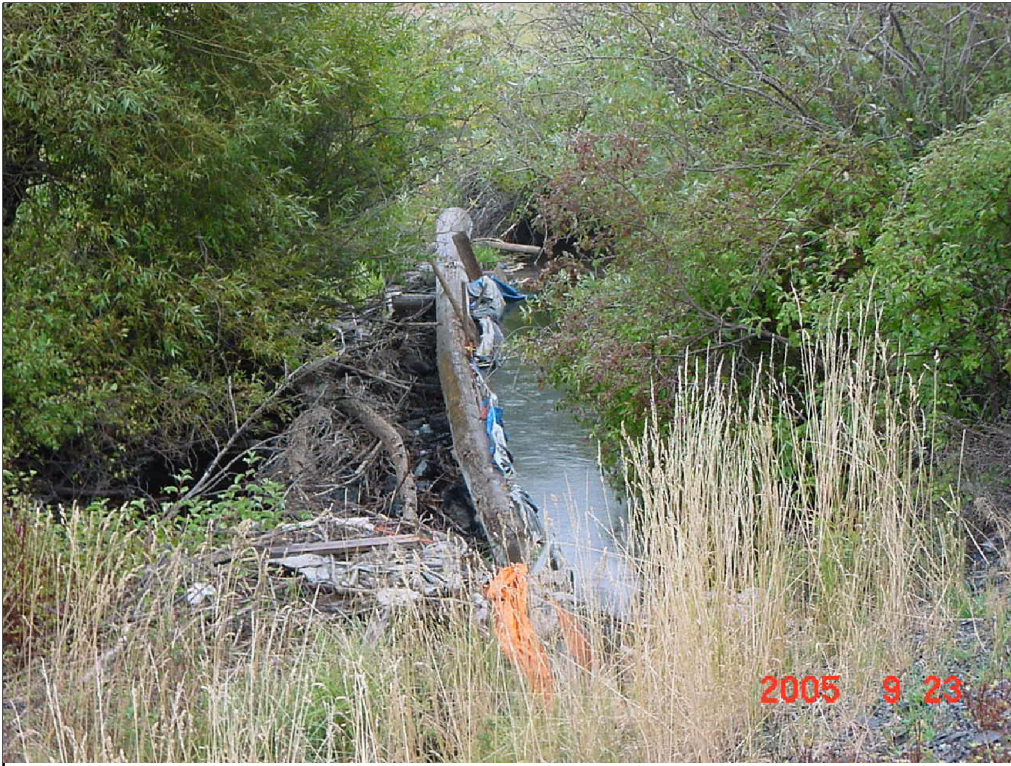
The irrigation diversion (above) is on a fish bearing tributary to the John Day River; the creek is used by spring Chinook salmon, redband trout, westslope cutthroat trout and ESA-listed summer steelhead. The diversion consisted of logs and plywood reinforced by poly-tarps.

Movement of the authorized POD in this case was restricted by a paved roadway; Grant SWCD engineers were limited in their design options and the resulting replacement structure (below) involved a significant check of the water level.

This situation represents how restrictions in the movement of PODs impacts engineering design options. The inability to take advantage of natural river changes in elevation and morphology limits designs to the installation of structures which significantly raise the water elevation. The impact of increasing the water elevation carries through to the fish passage; a more complex, artificial and expensive fish passage is needed to meet agency requirements.

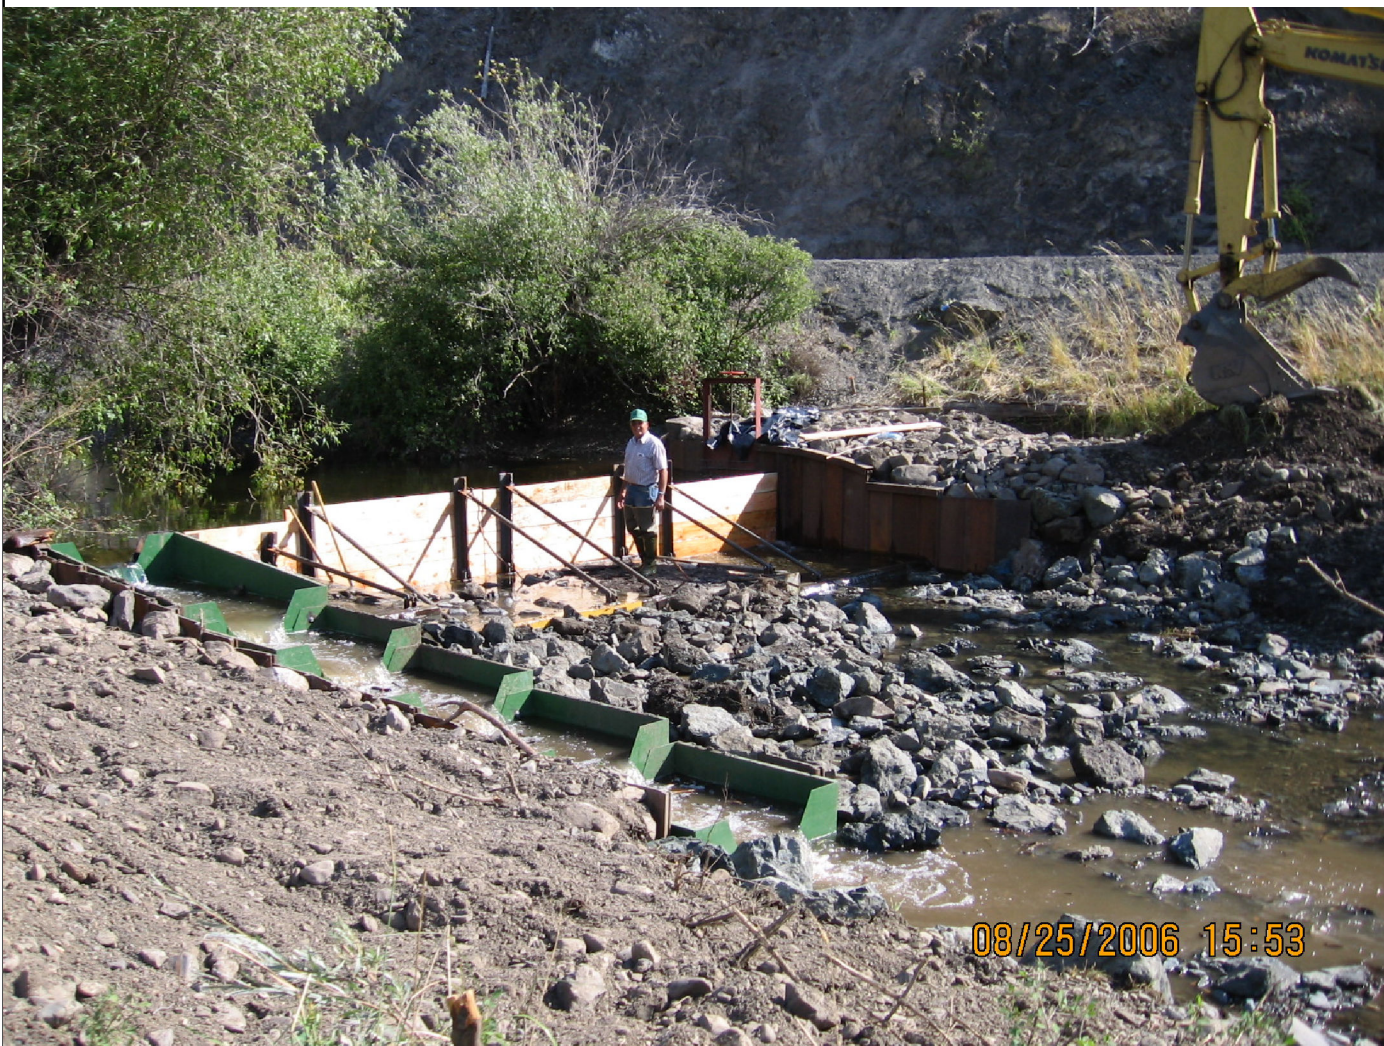
Issues with the fish ladder in the photo above became apparent due to an agency condition at the time which required the fish passage be located opposite the headgate. This condition was later relaxed and Grant SWCD was able to retrofit the fish passage resulting in the current structure shown to the right.

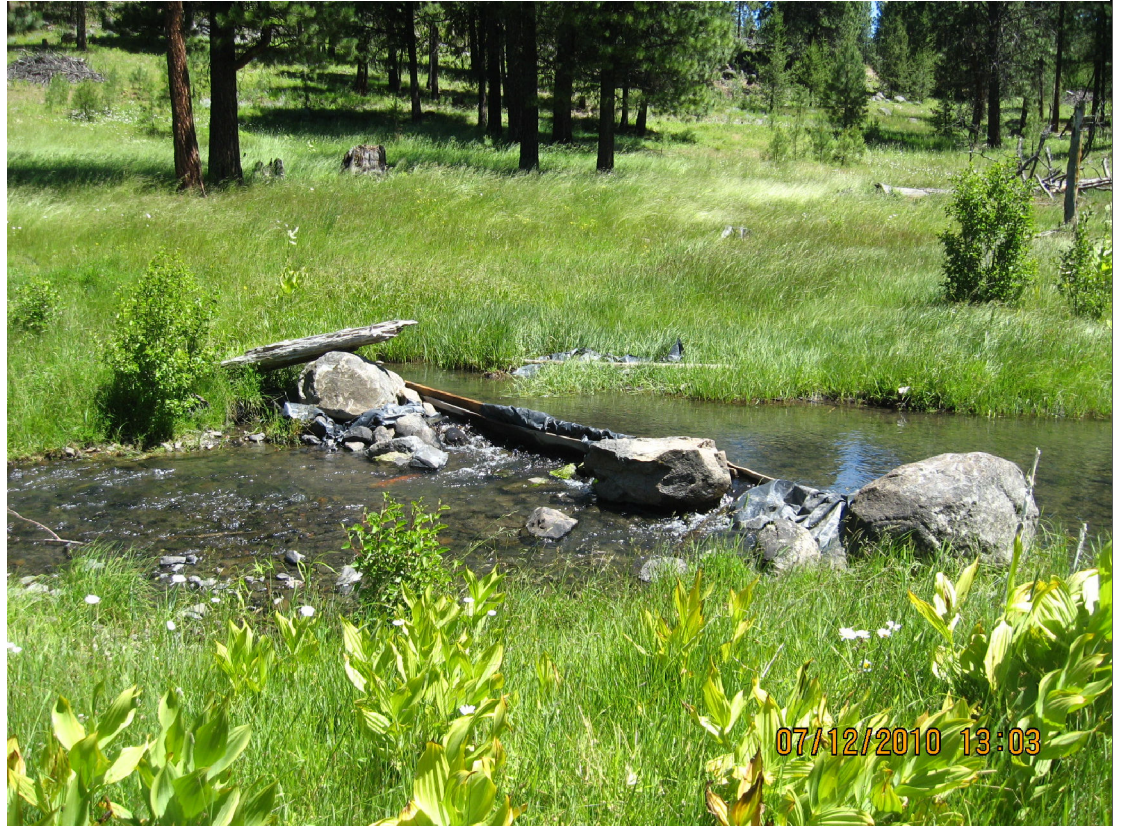
This irrigation diversion (above and right) is on a tributary to the Middle Fork John Day River; the creek habitat is used by spring Chinook salmon, redband trout, ESA-listed summer steelhead and ESA-listed bull trout. It consisted of large rock reinforced with boards, gravel, plastic sheeting throughout the season as flows dropped.

In this case, the Authorized POD was located upstream of the existing, so, we had more flexibility in the placement of the new irrigation structure.

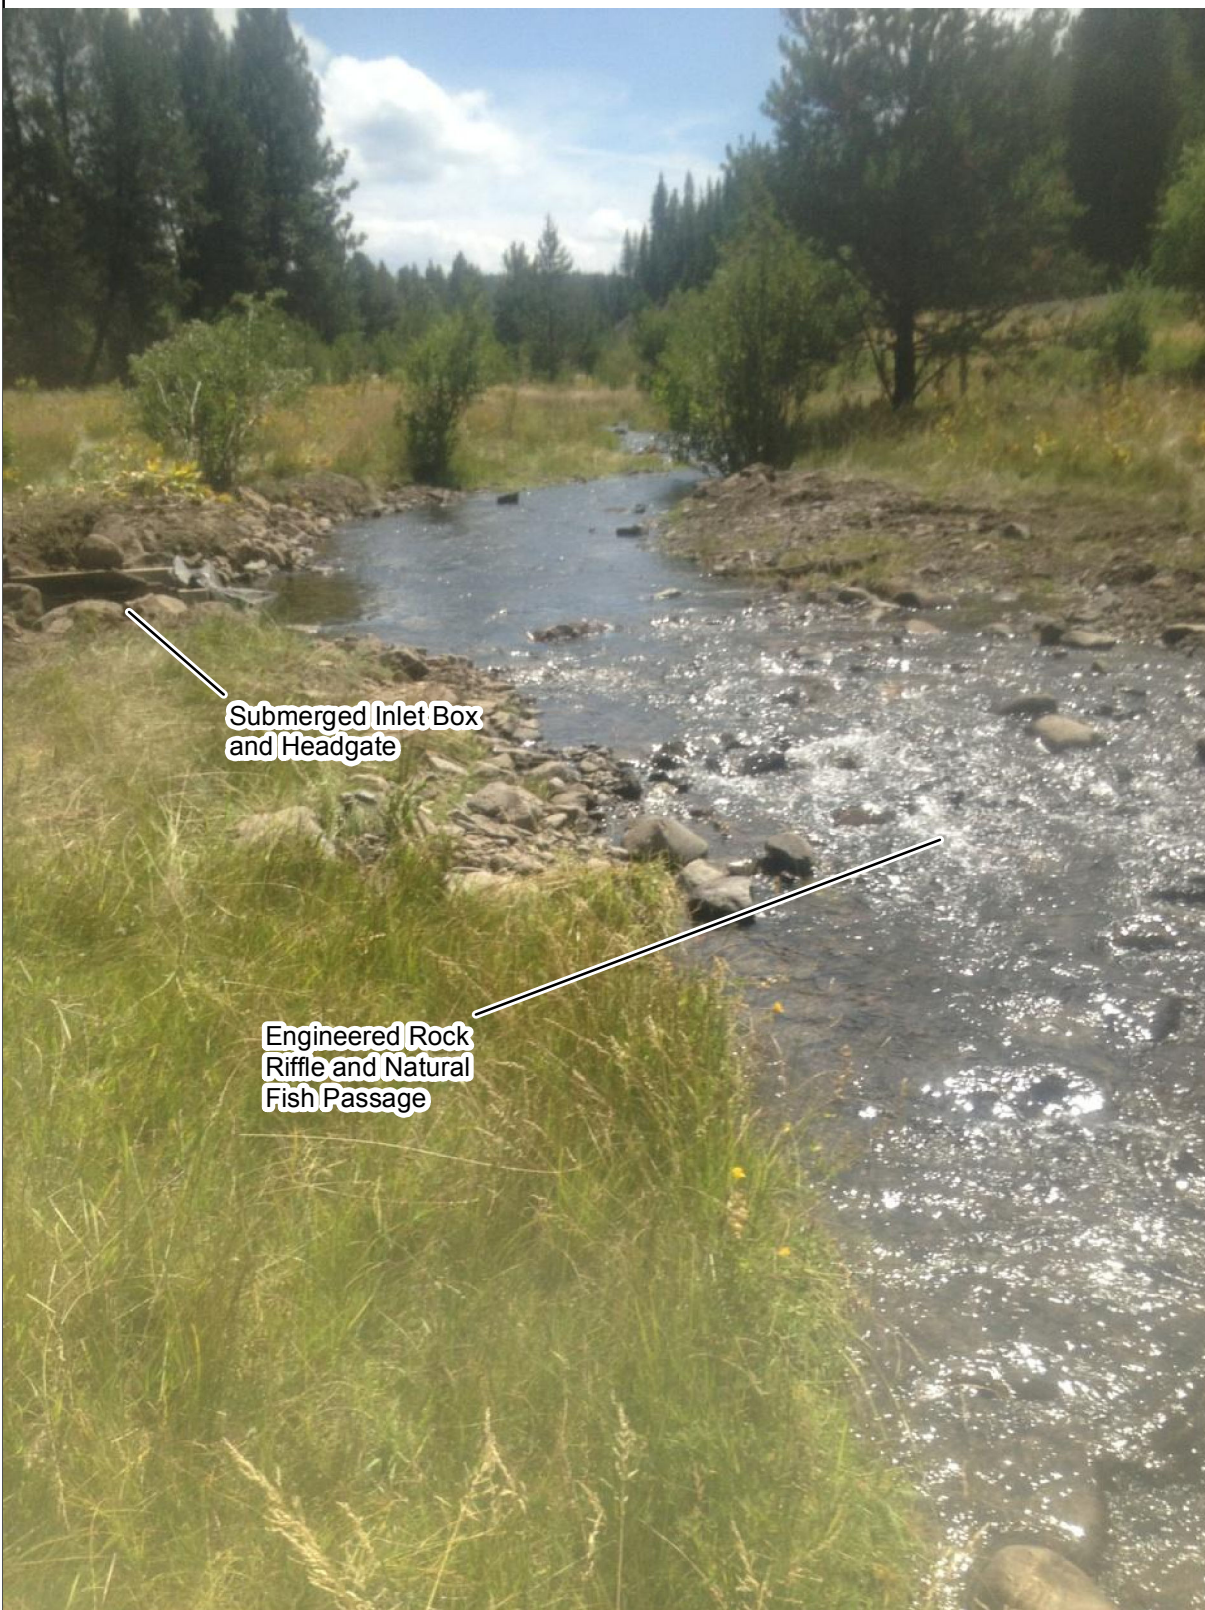
The replacement structure (left) is a low head, engineered riffle diversion structure which utilizes a submerged inlet structure and headgate for improved flow control; a flow measuring device was also installed just downstream of an existing fish screen.

By utilizing pipe flow efficiency characteristics, elevation was gained by reducing the slope of the delivery pipe and moving the POD upstream. By doing this, designers were able to take advantage of an existing pool and riffle structure on a stable outside bend.

The replacement structure provides fish passage in the center of the stream during all flows and requires no in-stream operation by the irrigator. The low head structure provides a low energy fish passage which is very unlikely to erode and deteriorate over time meaning the likelihood of maintenance being required to provide fish passage is very low.
