Liquid Storage Tanks at the CEI Hub

Seismic Assessment of Tank Inventory

CEI (Critical Energy Infrastructure) Hub

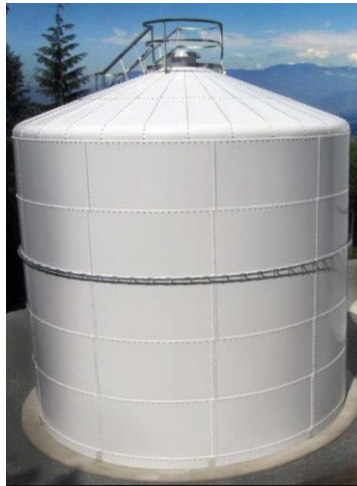
smaller storage

cone fixed roof

roof

riveted or
welded steel shell

soil supported
base plate

ring conc.
foundation

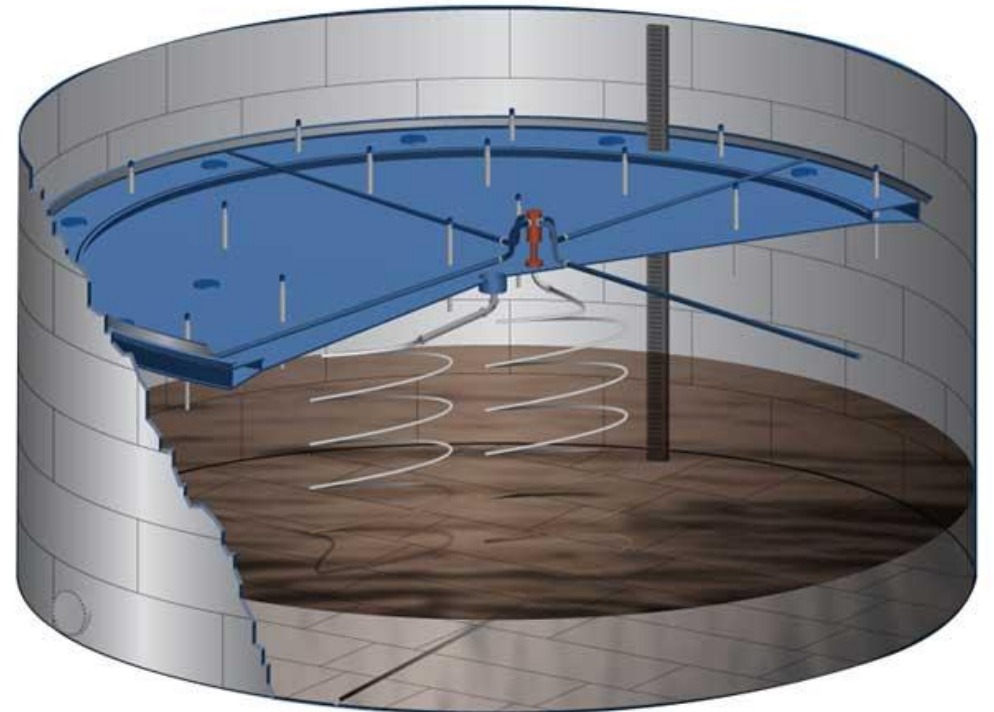
Floating roof (internal / external)

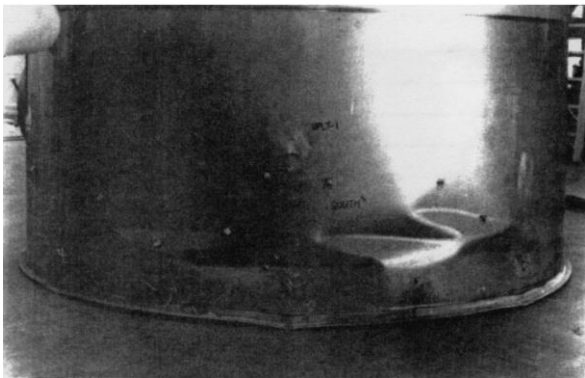
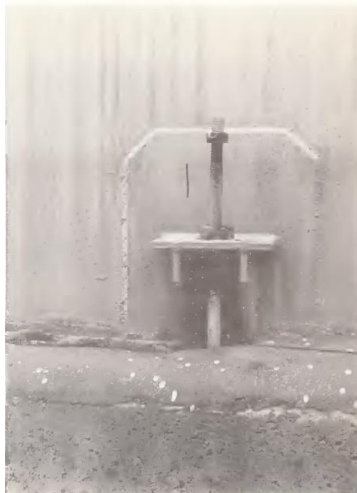
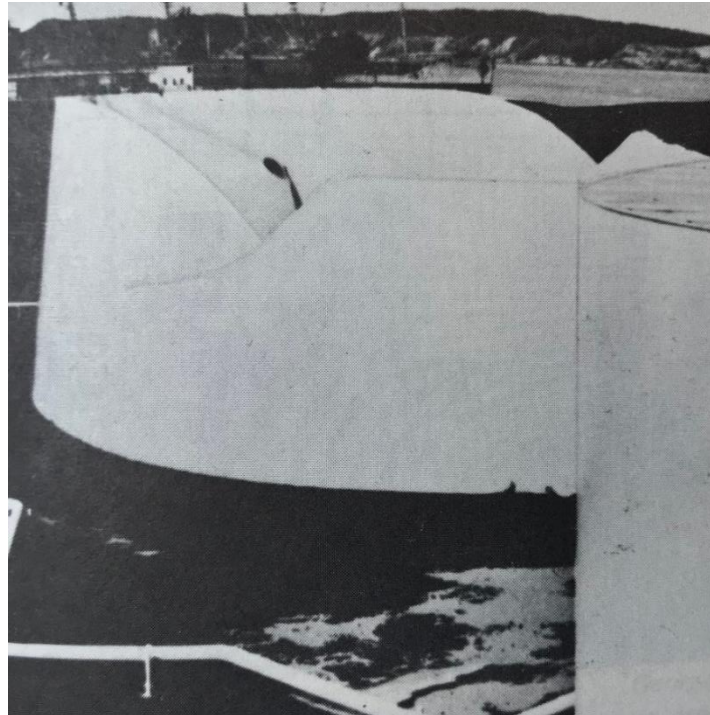
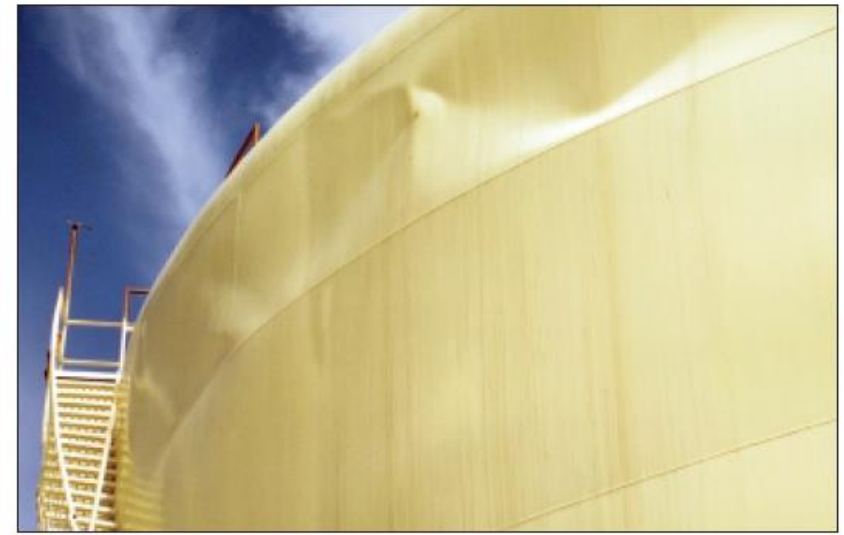
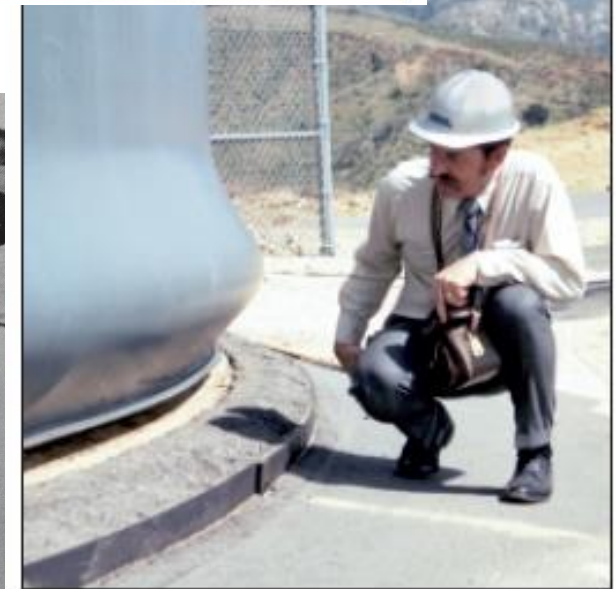
Structural Damage

- buckling of tank wall
 - top – sloshing, low pressure
 - bottom – compression stresses
- roof collapse/sinking
- bottom plate rupture – uplift
- sliding of tank

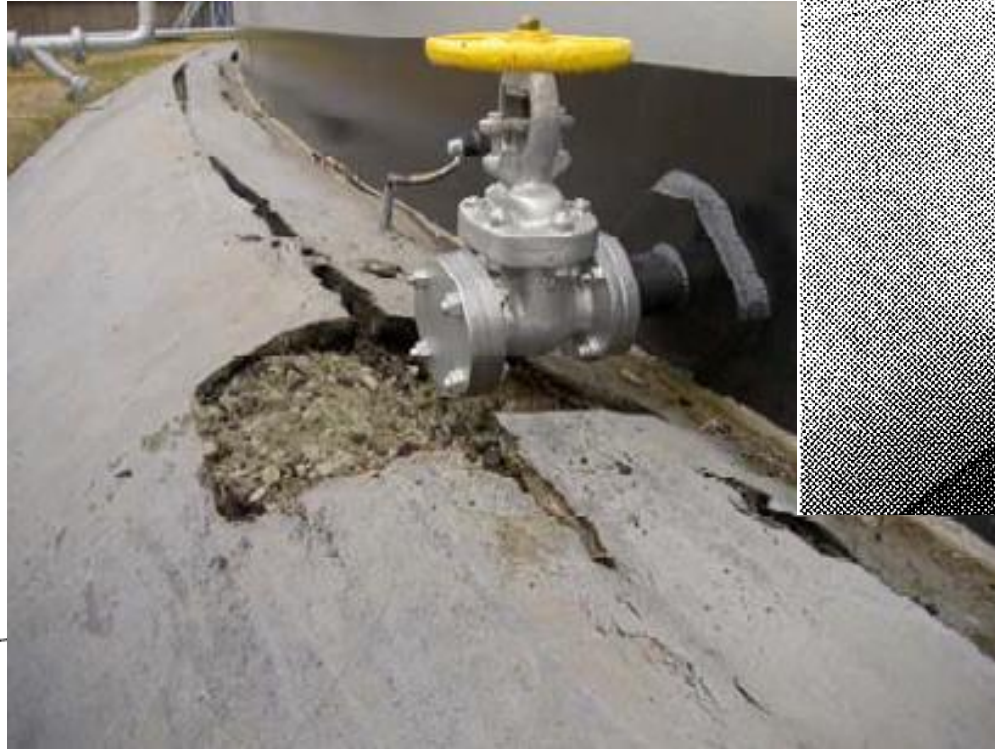
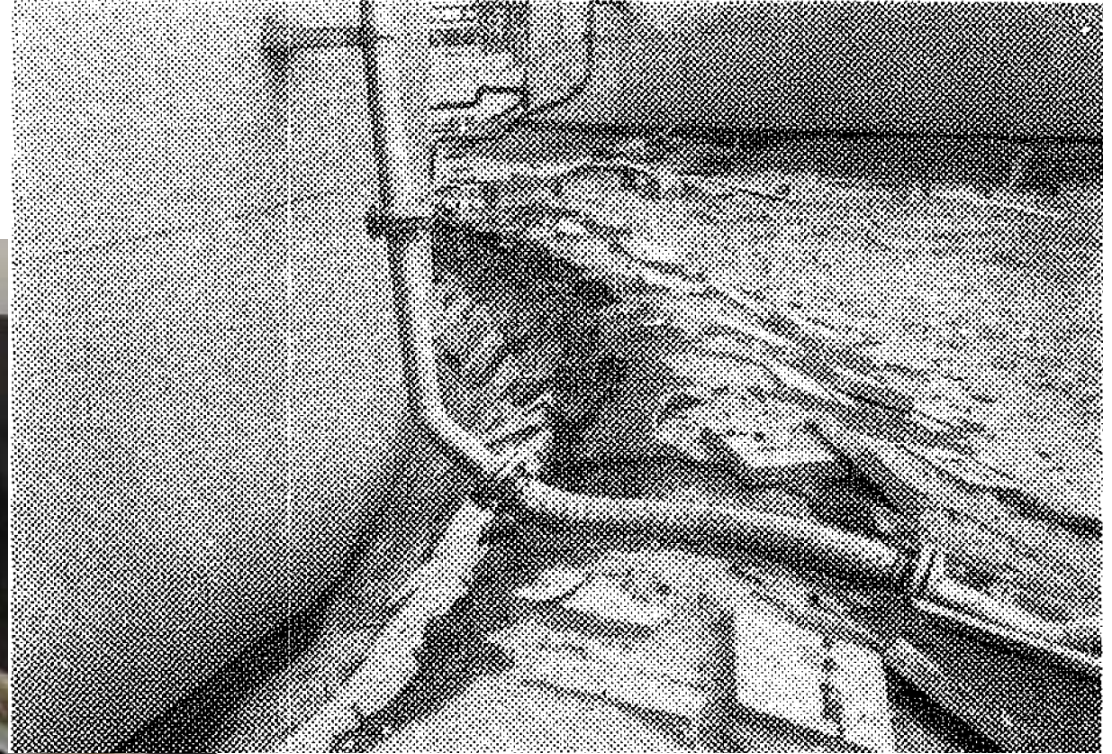
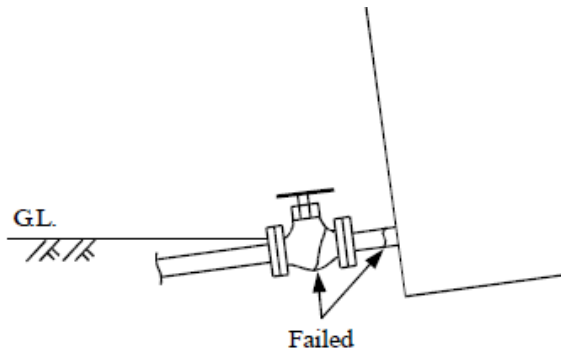
Soil Induced Damage

- liquefaction settlement
- liquefaction lateral spread

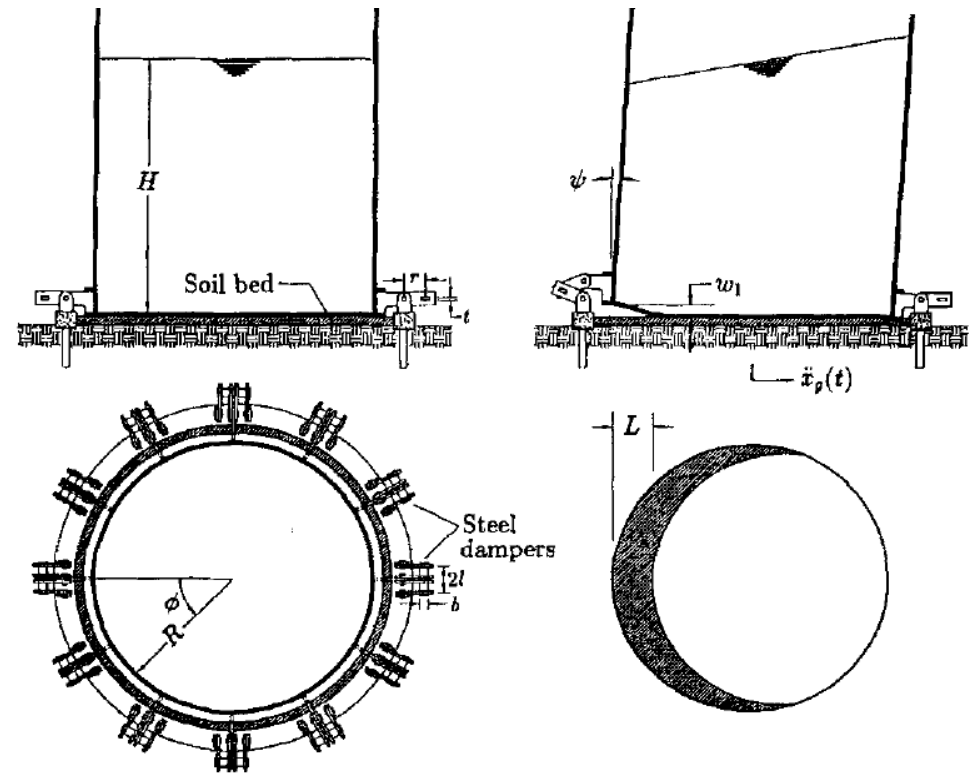
Mitigation - Structural

- Anchoring of tank walls
 - sliding, uplift, wall buckling
- Strengthening of walls
 - thickness or perimeter rings
- stabilization of roofs
- reduction of liquid storage

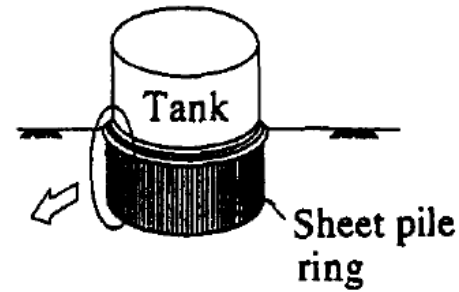
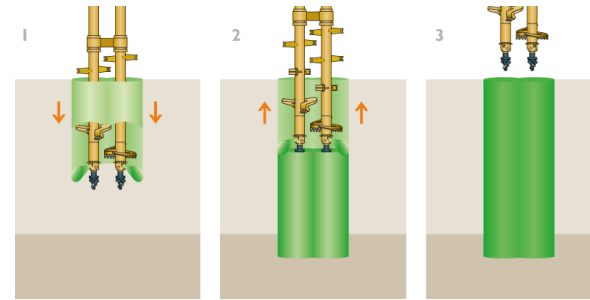
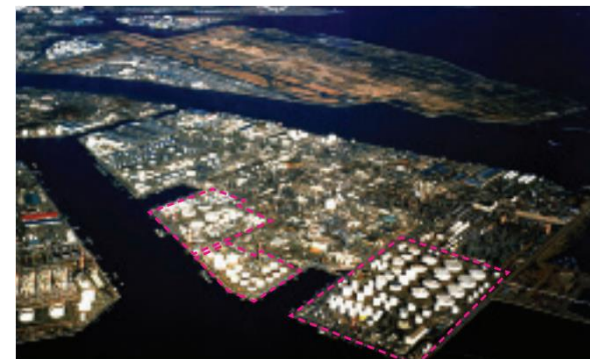
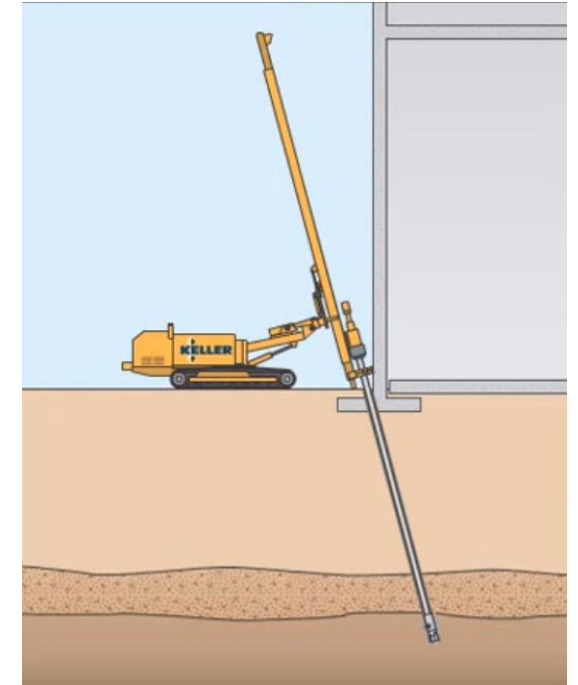
Mitigation - Soil

- Sheet pile ring around perimeter
- Deep soil mixing
- Jet grouting
- Lowering of ground water table
