TO: House Committee on Transportation and Economic Development

FROM: Paul Mather, Administrator
Highway Division

SUBJECT: Studded Tire Study

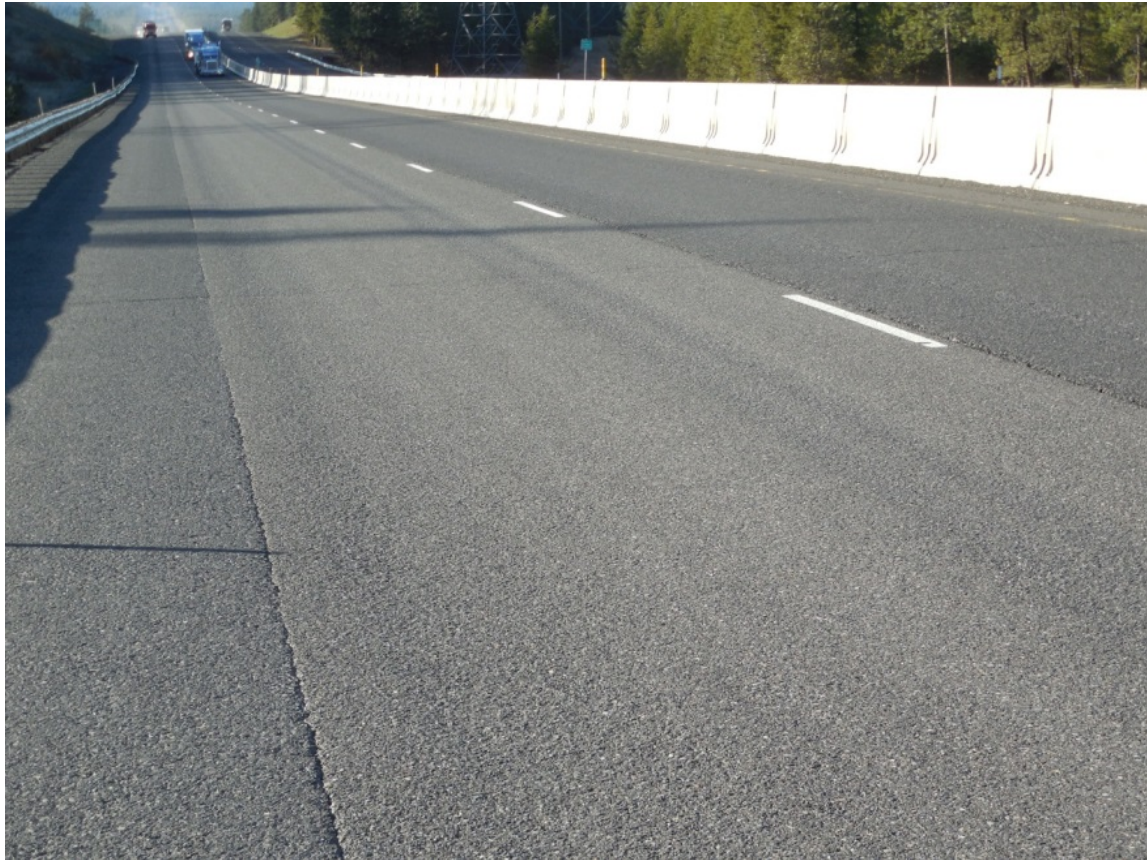
Ruts from heavy trucks—notice the 'W' shape.

caused predominantly by studded tire use and not heavy truck use, by looking at the shape and location of the ruts (see attached photos).

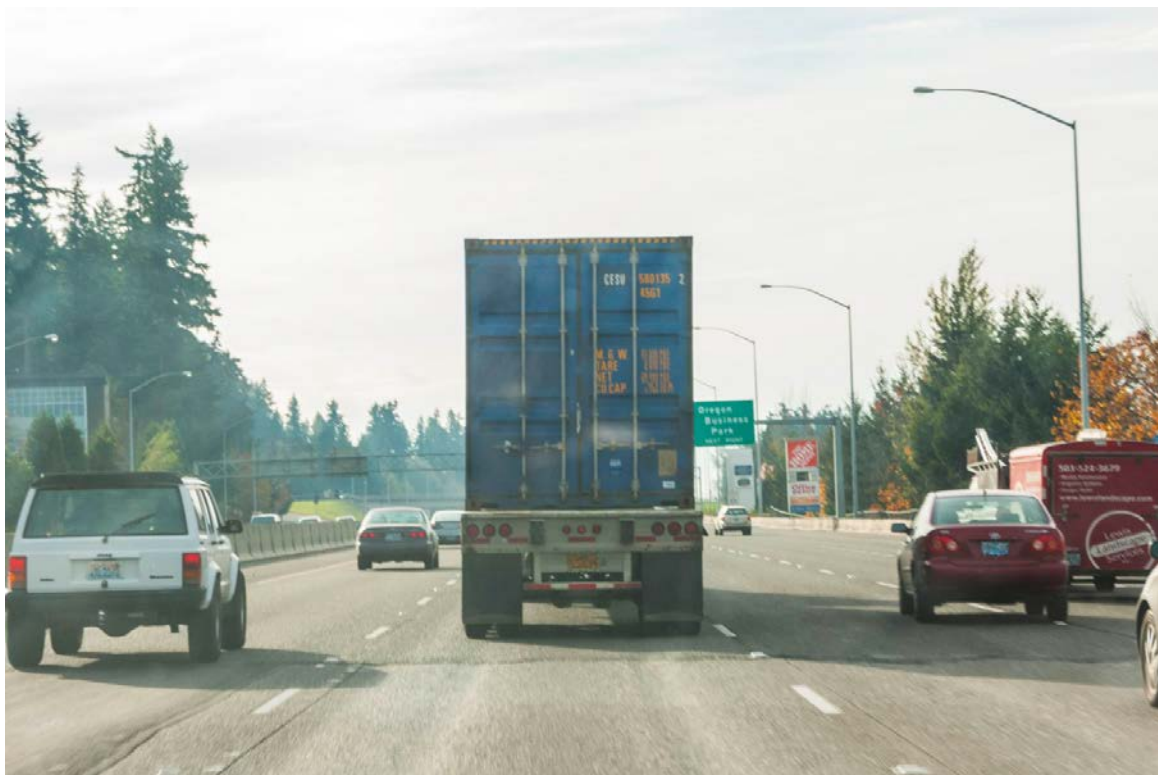
Ruts from studded tires—notice how the wheels of the truck do not align with the ruts.
