# The Mosier Train Derailment – How the City Responded

The purpose of this article is to establish the approximate timeline of the June 3, 2016 derailment of 16 oil tanker cars in the city of Mosier. It describes in detail how the incident unfolded and the immediate impact on Mosier.

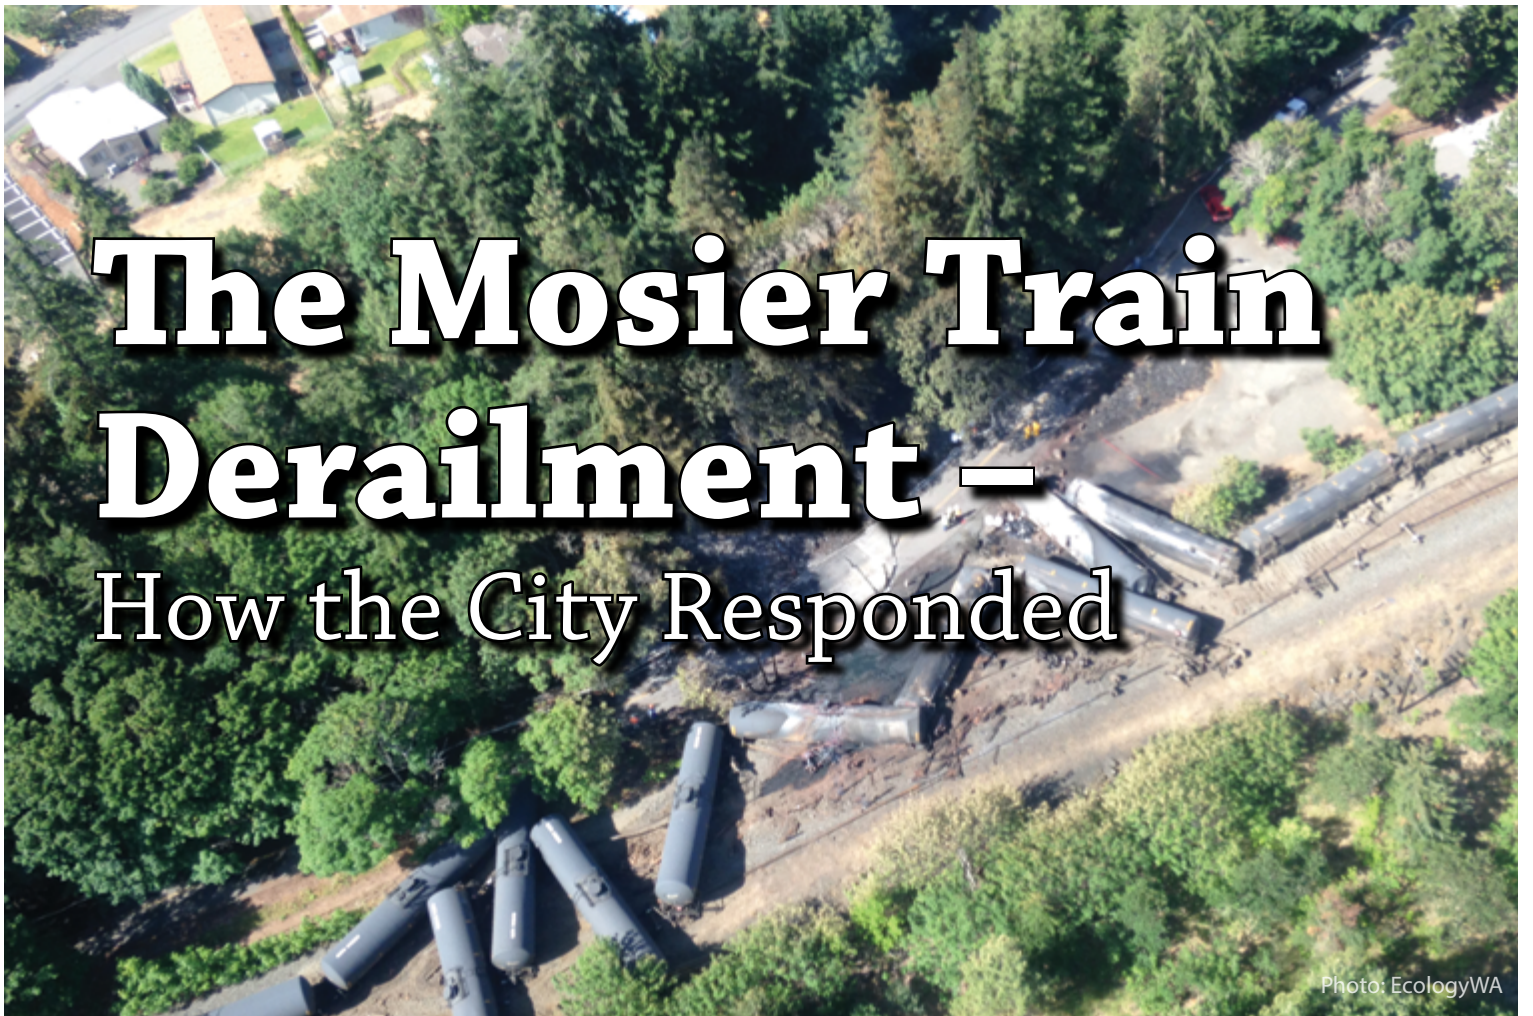
Photo: EcologyWA

- 12:15 p.m.: Oil train derails in the city of Mosier. Sixteen cars of a 96-car train carrying Bakken crude oil.
- 47,000 gallons of oil escaped from four rail cars. During the derail, one of the cars tore off the lid of a sanitary sewer manhole and as a result, approximately 13,000 gallons of the oil flowed into the nearby wastewater treatment plant, where it was contained. The oil was later pumped out and taken to an off-site disposal facility. The wastewater treatment plant and associated piping was later restored to operating condition.
