Bob Ortblad reports that the IBR's Supplemental Environmental Impact Statement includes 26 technical reports, but a critically important geotechnical report is missing, and the IBR has offered no explanation

Geotechnical Data Report

Columbia River & North Portland Harbor Bridges

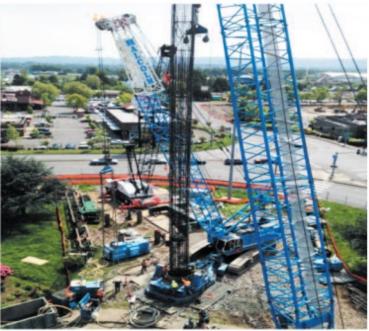
Cage with testing apparatus.

> one set of five 6,000 kip cells 6.9 feet up from the bottom, and a layer of three 6,000 kip cells 22.9 feet from the top. Installing such extensive instrumentation in a single 250 foot long cage, and allowing for only one splice, presented a significant challenge.
