Tier 1 Report of
Facility Condition Assessment

For
Department of Administrative Services
Revenue Building
955 Center Street NE
Salem
Oregon 97310

Date of Report: November 07, 2014

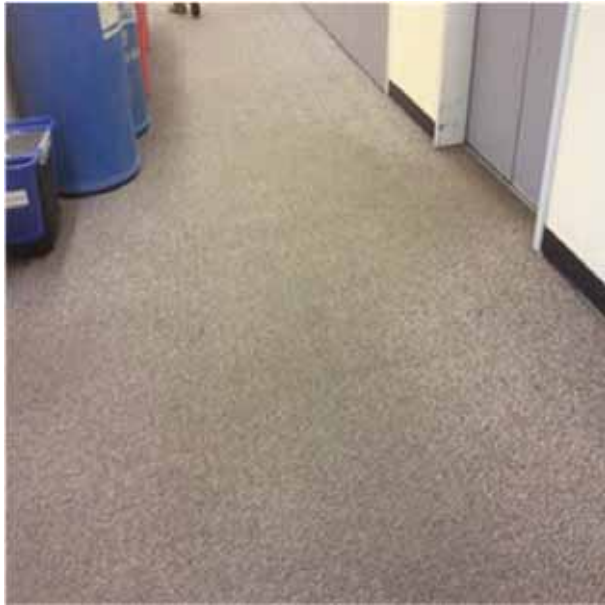
C3025 Carpeting.1:- View of typical broadloom standard carpet without padding.

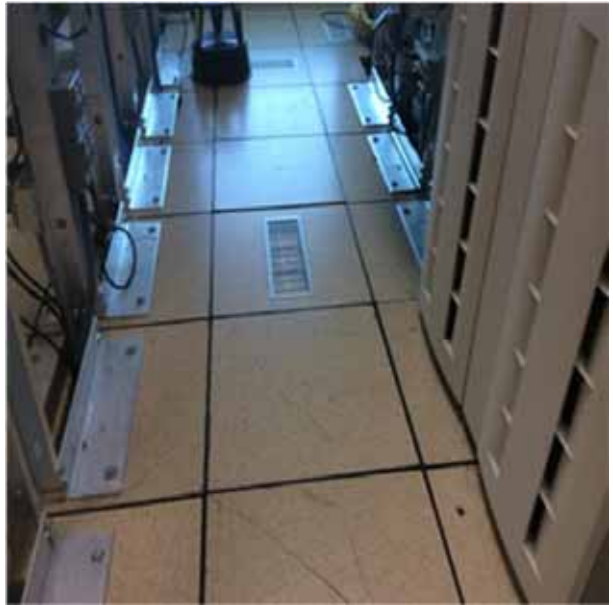
C3027 Access Pedestal Flooring.1:- View of typical access pedestal flooring.

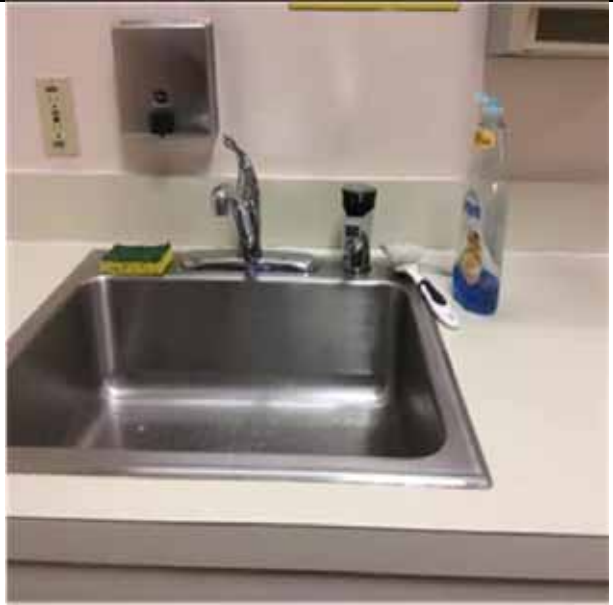
D2014 Sinks.1:- View of the single bowl sink.

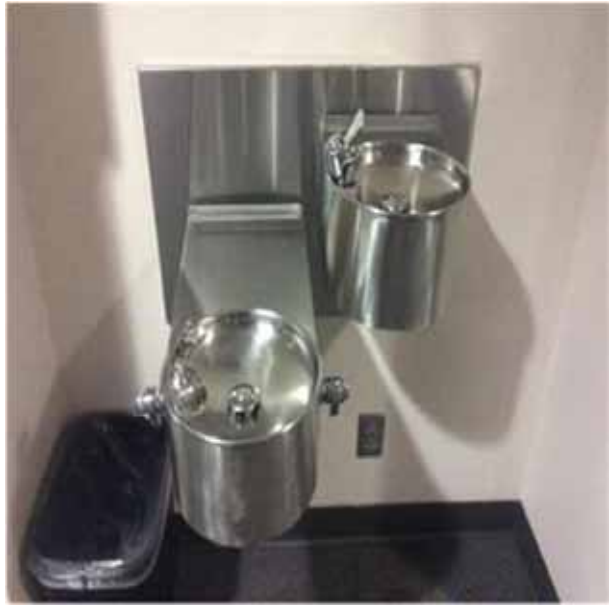
D2018 Drinking Fountains and Coolers.1:- View of dual drinking fountain.
